# Customer Satisfaction Campaign – USA Only Code: 91Q1

**Modular Infotainment System Software Update**

U.S.A.: Certain 2017 MY Golf, GTI, Golf SportWagen and Golf Alltrack

Install software to bring the infotainment system up to current production standards.

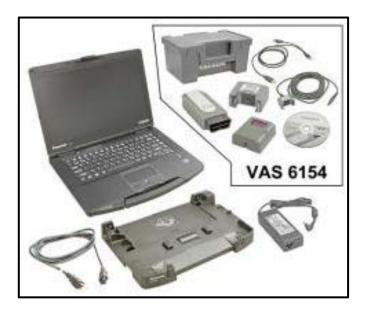
- VAS6150D Diagnostic Tester (or equivalent)
- VAS6154 Vehicle Communication Interface (or equivalent)

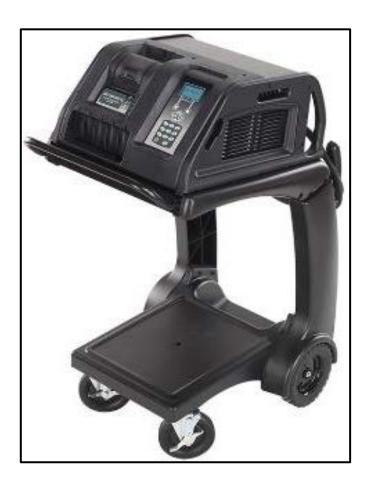
GRX3000VAS – Battery Tester/Charger (or equivalent)
