## **Technical Service Webinar**

April, 2017

## What's New:

## Diagnostic Tips:

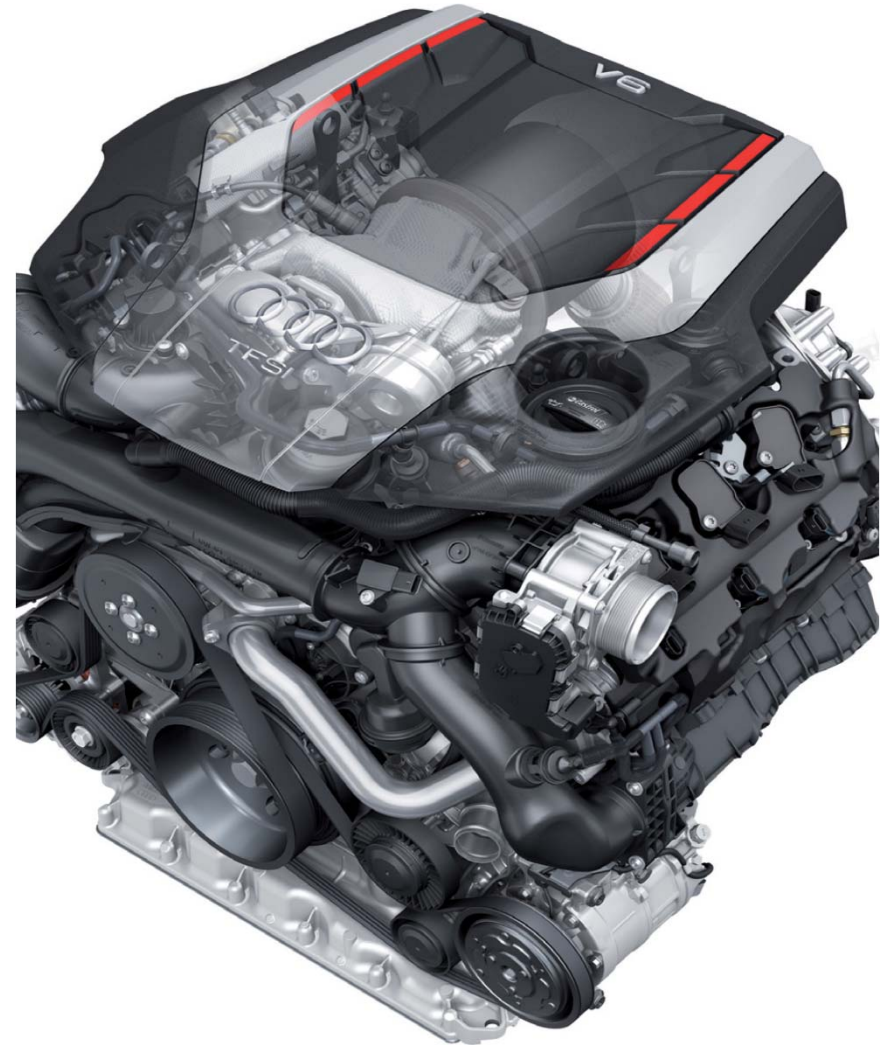
## TSB 2047204/1

### Repair Authorization for all new 3.0L EA839 V6 TFSI

#### Special Features:

- Direct injection with on-demand high and low pressure systems.
- Exhaust turbocharging in inner V ("Hot Side Inside").
- Air to Air charge air cooling.
- Power output :
  - 354 hp @ 5400 - 6400 rpm
  - 369 lb ft @ 4500 rpm

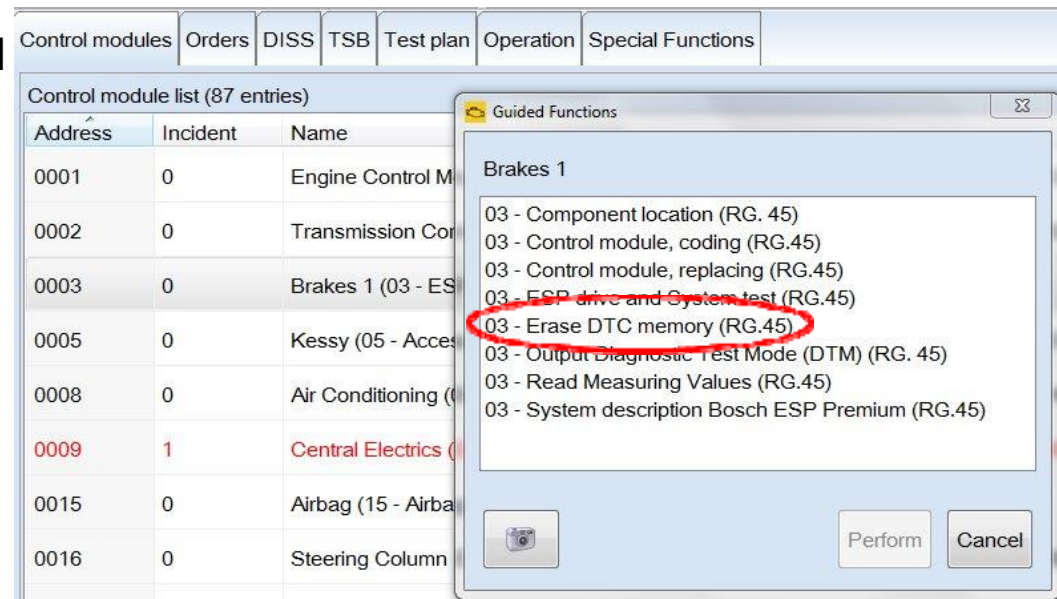
## Clearing faults using Guided Functions

- Fresh reboot of ODIS
- Hardwire or Bluetooth may be used
- Start a new GFF session
- Cycle the key one time.
  - (key Off and On after completed GFF scan)
- Right click ABS control module
- Select Guided Functions
- Select Check and erase DTC memory.
- Follow the test plan steps to clear faults
- On control modules tab select “Read all module DTC” to assure faults are cleared

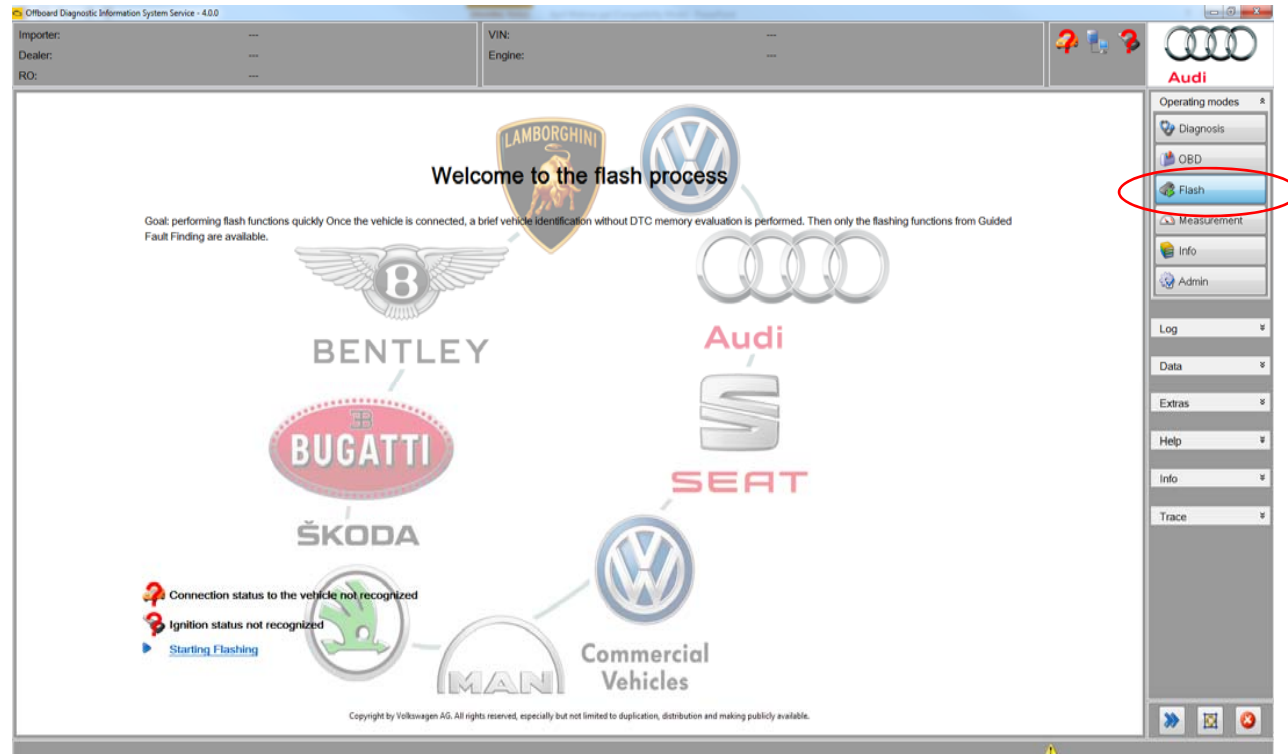
# Clearing passive faults in ODIS

## Clear faults using Flash

- › Exit your GFF session
- › Select and enter FLASH
- › Do not run any test
- › Then exit FLASH
  - › Flash will clear faults on exit
- › Verify if code is still present using the OBD button (it is the quickest way to verify)

**NOTE:** This method is best used if there are several modules with PASSIVE faults that will not clear.

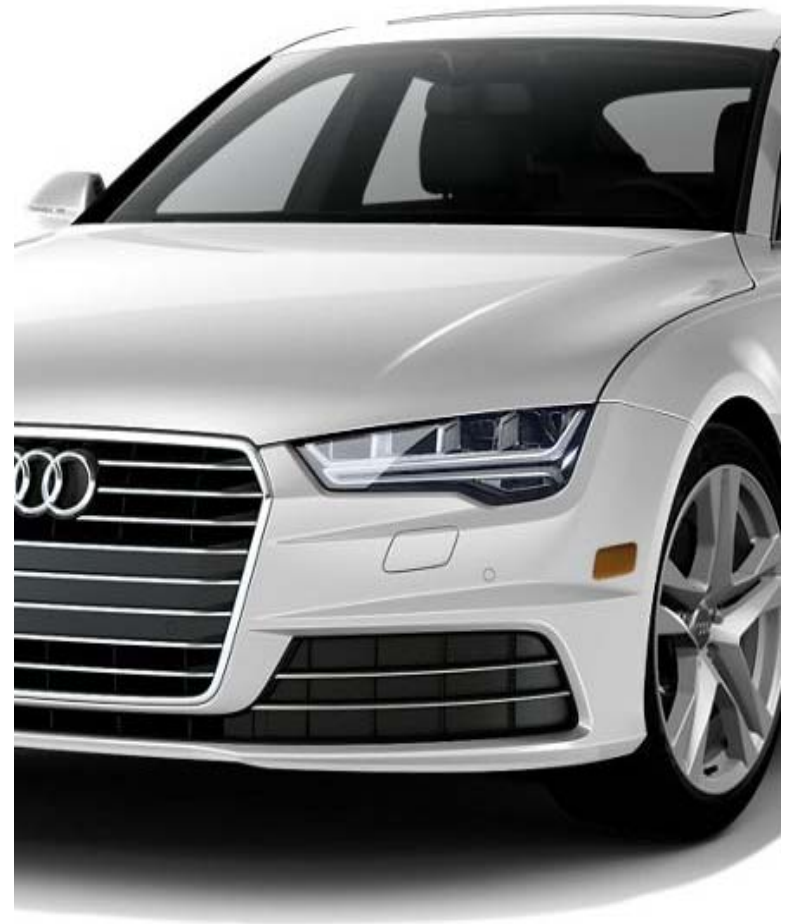
## TSB 2028842/2

### Checking for TD1 Detection of Unauthorized Chip tuning

- To detect TD1 a specified/actual or Vehicle Configuration will need to be performed. This can be done at start of diagnosis or in special functions tab of GFF.
- This should be run when major engine or transmission repairs will be performed under Warranty or Goodwill.
- If unauthorized engine tuning is detected during the specified/actual comparison, a “TD1” code is automatically populated within the Warranty Key section of Elsa.

Output: For this model, a specified/actual comparison is required at the start of Guided Fault Finding. This detects incorrect codings and parameterization and can correct them. If incorrect software or hardware is found in the control modules, SVM will provide a hardware change suggestion, but additional actions must be carried out by the technician to fix these hardware conflicts. SVM will not provide automatic software updates for control modules without a SVM code. If a specified/actual is not performed, the following GFF test plans may result in faulty repairs due to incorrect control module configurations, software or hardware. If only a software update using a SVM code is being performed, the specified/actual comparison does not need to be performed.
