Title: LT Cluster and Module Programming Information

Applies To: LTs that require a module kernel update with DLB

This document will guide the user through Module Kernel Updating with DLB.

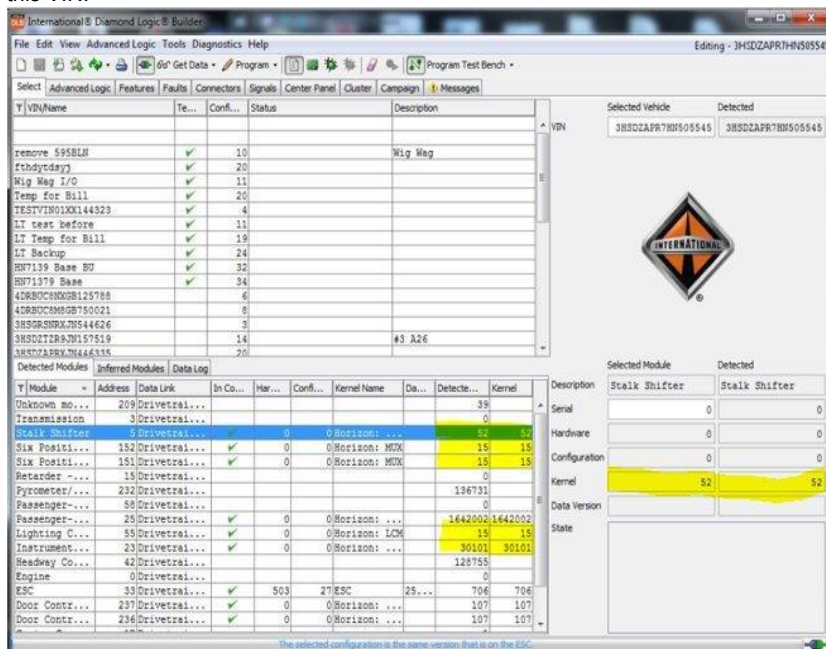
- Prior to connecting to the truck, with DLB, verify that the VIN has been deleted from the list in the Select Tab.
- Unless you are programming the stalk shifter, MUX switches, or door pods you can program the cluster and body controller with the key off. Connect to truck with DLB let it detect the modules, then click on the Detected Modules tab to see the Kernel information for this VIN.

- If the Detected Kernel and Kernel columns are not displayed, Right click on the column header, Red arrow in the graphic below, to select them.

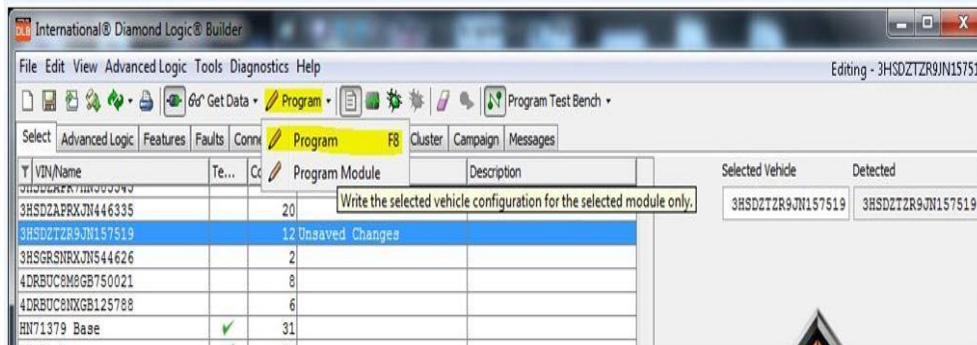
- If you only want to program the cluster, select it under the “detected modules” tab
- After the Kernels show up as being updated, Left click on the Program Icon.

If you only want to program one module than you must select “program module”.

The headlights will go “On” and “Off” during e programming and depending on the number of modules the programming could take as long as 40 minutes to complete. Connecting a battery charger and/or disconnecting the headlights is recommended.
