TECHNICAL INSTRUCTIONS

SPECIAL SERVICE CAMPAIGN H0E

FUEL CELL SYSTEM UPDATES

CERTAIN 2016 to 2017 MODEL YEAR MIRAI

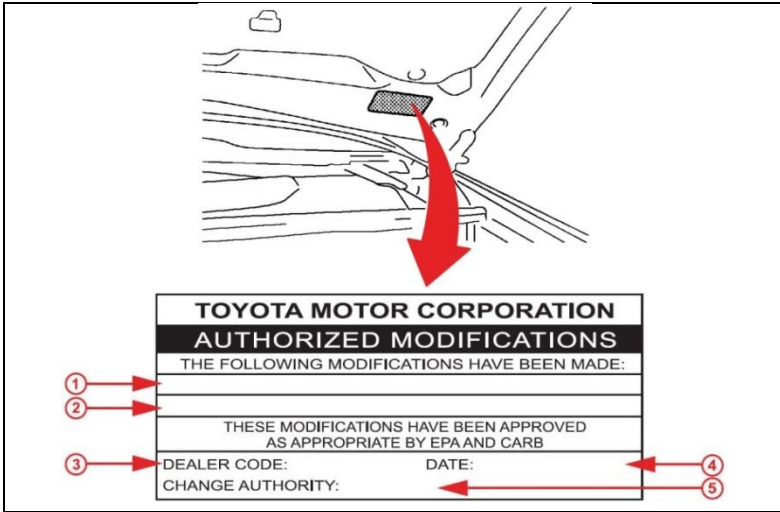
F. ATTACH THE AUTHORIZED VEHICLE MODIFICATION LABEL

- a) Fill out the label.
- b) Affix the label to the under-side of the hood.

1	ECM's P/N
2	New Calibration ID
3	Dealer Code
4	Date Completed
5	Campaign Code (H0E)
