# Entune Audio Head Unit Software Update (Panasonic)

**Service Category** Audio/Visual/Telematics

**Section** Navigation/Multi Info Display

## Introduction

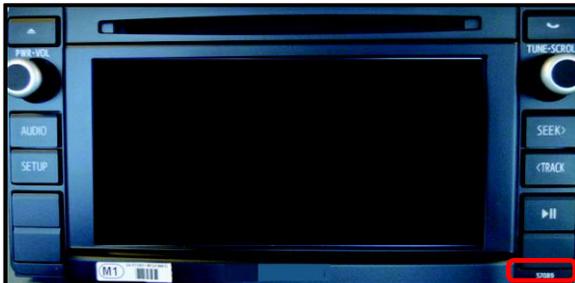
1. Confirm the audio system type by checking the Panel ID printed on the bottom-right or bottom-center of the machine.

**Figure 1. Avalon, Avalon HV, Highlander, Highlander HV, Prius V, Sienna, Sequoia, Tacoma & Tundra.**

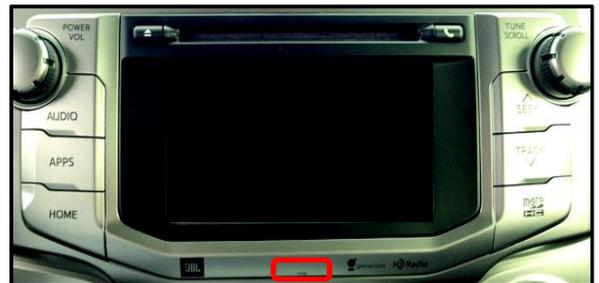
**Figure 2. 4Runner**

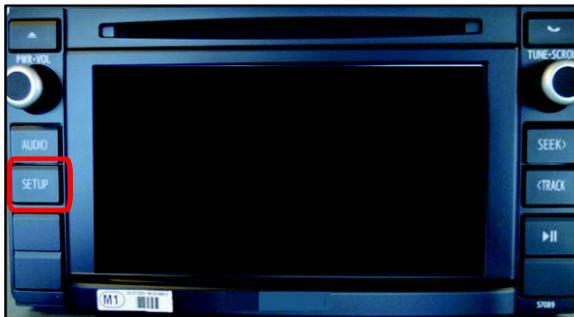
3. Go to the *Setup* screen.
  - A. **For Entune™ Audio:**  
Press the **SETUP** button on the panel.

**Figure 3. 4Runner, Highlander, Highlander HV, Sequoia, Tacoma & Tundra**

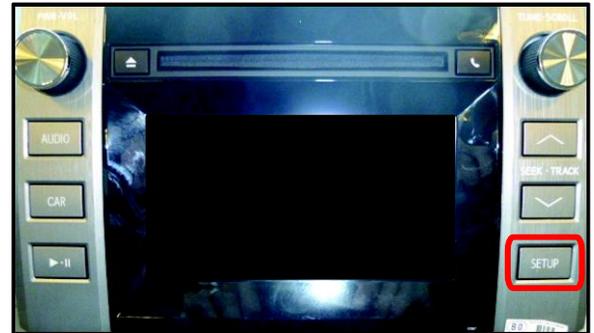
**Figure 4. 4Runner**

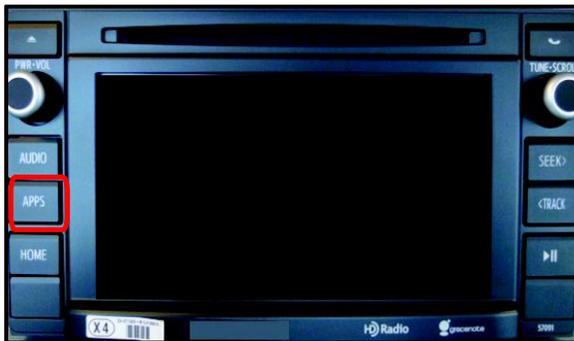
- B. **For Entune™ Audio Plus / Entune™ Premium Audio:**  
(1) Press the *APPS* button on the panel.

**Figure 5. 4Runner, Highlander, Highlander HV, Sequoia, Tacoma & Tundra**

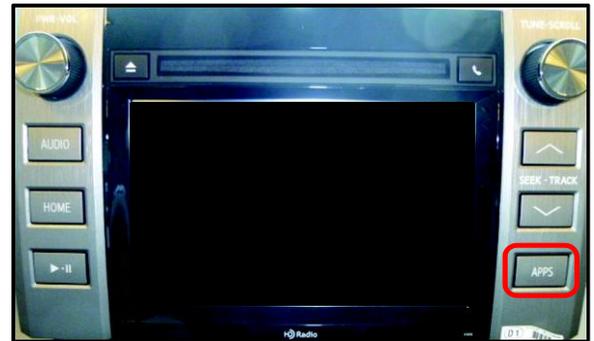
**Figure 6. Tundra**

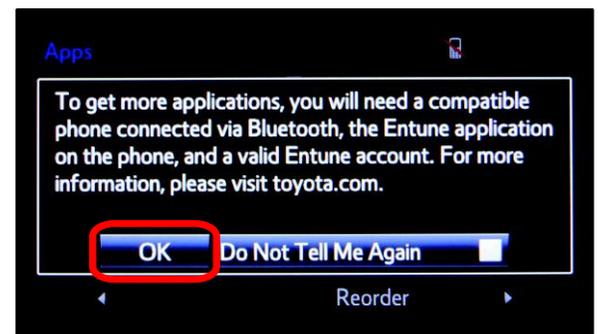
**Figure 7.**

If Entune™ pop-up displays, select **OK**.

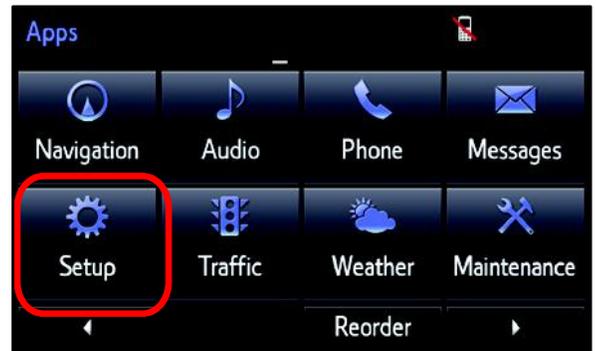
Figure 8.

- (2) Select *Setup* on the Apps screen.

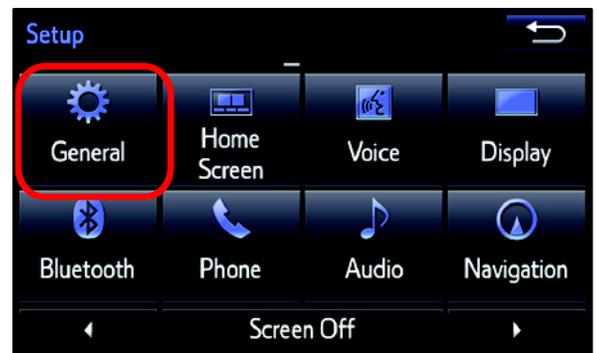
Figure 9.

4. Select *General* on the Setup screen.

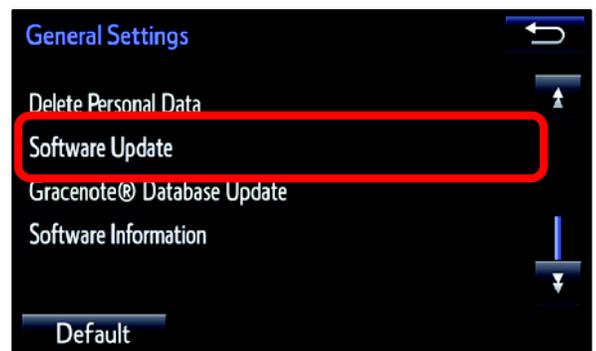
Figure 10.

5. Select *Software Update* from the list on the General Settings screen.

Scroll down the list until *Software Update* is displayed.

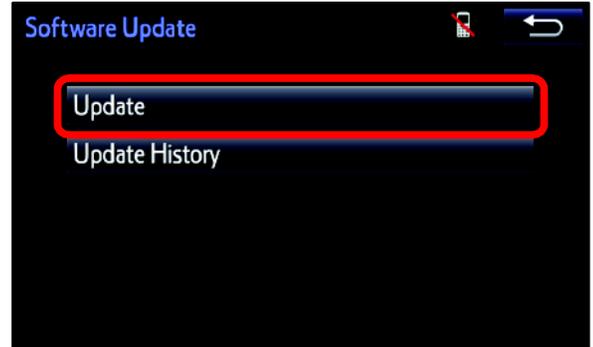
Figure 11.

6. Select *Update* on the Software Update screen.

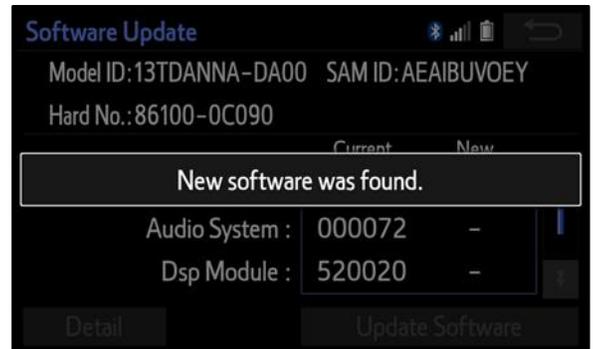
Figure 12.

7. Insert the USB Drive containing the NEW software into the vehicle USB port.

If software has been detected properly, a "New software was found." pop-up will be displayed.

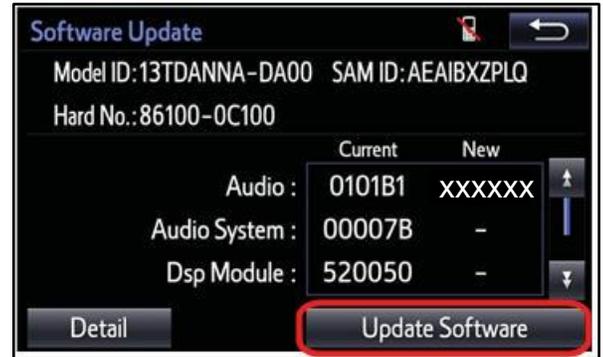
Figure 13.

- Verify that the NEW software is up-to-date on the Software Update screen.

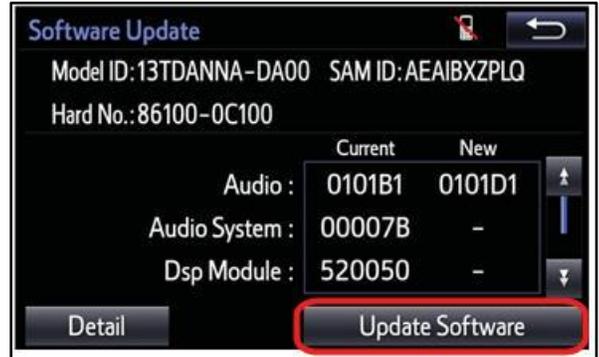
Figure 14.

9. Select *Update Software* on the Software Update screen.

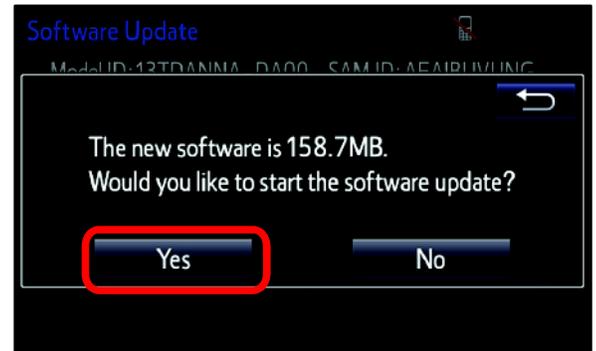
Figure 15.

10. Select Yes on the "Would you like to start the software update?" pop-up.

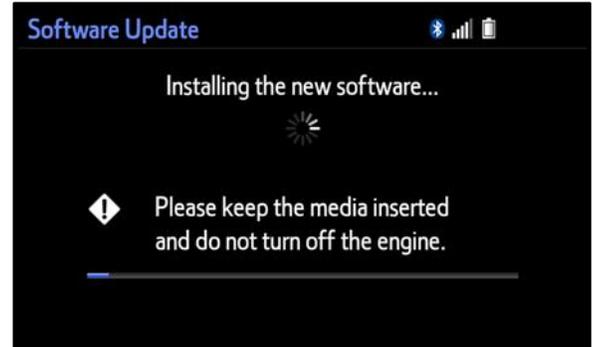
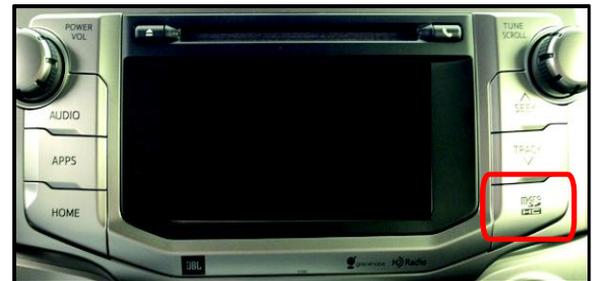
- The unit begins installation. The update will take about 10 minutes.

- When “The software is ready for updating.” displays, cycle the ignition OFF.

- Remove the USB Drive SST from the vehicle USB port.

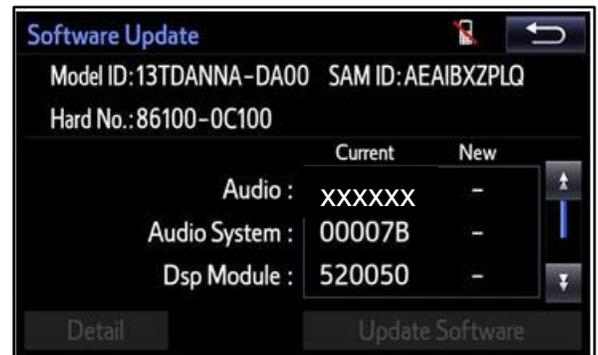
Figure 19.

1. Perform steps 3 – 7 of the Software Update procedure to re-enter the Software Update screen.
2. Verify that the software information is updated on the Software Update screen.
