TECHNICAL INSTRUCTIONS

WARRANTY EXTENSION PROGRAM ZH6, ZH7, ZH8 AND ZH9

FRAME INSPECTION ONLY

CERTAIN 2005-2010 TACOMA (ZH6)
CERTAIN 2007-2008 TUNDRA (ZH7)
CERTAIN 2005-2007 SEQUOIA (ZH8)
CERTAIN 2008 SEQUOIA (ZH9)

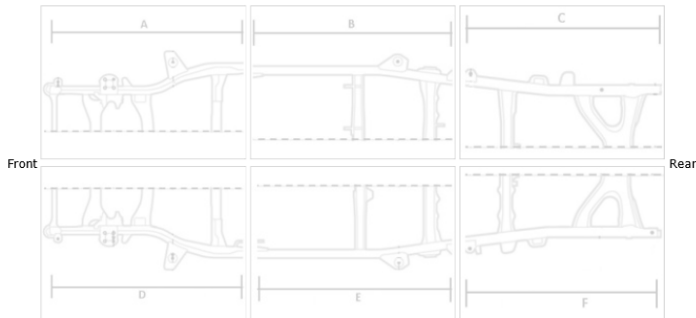
Frame Inspection - NO CRC Applied

Note: If perforation is found in both areas please identify both perforation locations below.

Front Rear
