# **Emissions Recall** Code: 23U3

Subject	2.0L TDI Engine (GEN 1) Emissions Modification – Customer Only (Retail Sold) USA ONLY				
Release Date	November 10, 2017				
<b>Revision Summary</b>	Updated work	Updated work procedure, 2010 Model Year pre-repair aftertreatment system inspection.			
Important Repair Information!	<b>CAMPAIGN 24CV MUST BE COMPLETED BEFORE BEGINNING THE 23U3 CAMPAIGN!</b> Over the next few weeks there will be updates made to ODIS and the campaign circular. Do not retain any hard copies of campaign circulars – only refer to the electronic copies posted to Elsa and ServiceNet.				
Affected Vehicles	U.S.A. ONLY:	2009-2014 MY Volkswagen 2.0L TE	DI (Gen 1), Customer Only (Retail Sold)		
	Country	Model Year	Vehicle Carline		
	USA	2009-2014	Jetta		
	USA	2009-2014	Jetta SportWagen		
	USA	2013-2014	Beetle		
	USA	2013-2014	Beetle Convertible		
	USA	2010-2014	Golf		
Problem Description	<ul> <li>Check Campaigns/Actions screen in Elsa on the day of repair to verify that a VIN qualifies for repair under this action. Elsa is the <u>only</u> valid campaign inquiry &amp; verification source.</li> <li>✓ Campaign status must show "open."</li> <li>✓ If Elsa shows other open acti

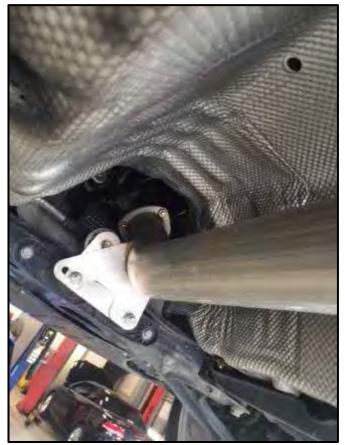
- Perform a visual inspection of the intake, • exhaust, and emissions systems.
  - o If the visual inspection of the intake, exhaust, or emissions equipment reveals damage or concerns, STOP, create a VTA ticket and contact the Volkswagen Technicians Helpline.
  - o If the visual inspection of the intake, exhaust, or emissions equipment reveals no damage or concerns, continue the work procedure.
- Check for vehicle modifications from original • equipment.
  - o If vehicle modifications from original equipment related to emissions components are found, STOP, create a VTA ticket and contact the Volkswagen Technicians Helpline.
  - o If vehicle modifications from original equipment related to emissions components are not found, continue the work procedure.

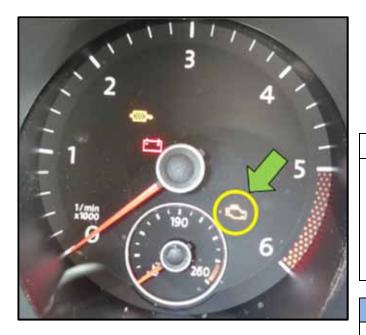
- Check for illumination of the MIL <arrow>.
  - o If MIL is illuminated, STOP, create a VTA ticket and contact the Volkswagen Technicians Helpline.
  - o If MIL is not illuminated, continue the work procedure.

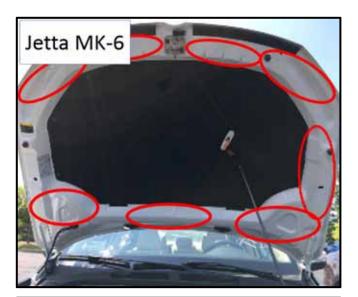
- The surface where the label is to be installed must be clean, dry, and free from oil residue prior to installing the label.
- Label must NOT cover any existing label(s).
- Label must be installed in locations shown.
- Photo documentation of label installed is required.

- Open the hood.
- Clean the surface where the label is to be installed <circled areas are examples>.
- Install the supplemental Vehicle Emissions Control Information label, 03L 010 005 G, according to the following guidelines:
  - o Painted surface
  - In a readily visible position on the underside of the hood
  - In as close proximity to the original VECI label as possible
  - In as close proximity (for picture purposes) of the Campaign Completion Label
