Emissions Recall

Code: 23V6

Subject	3.0L TDI Engine Emissions System Modification – TDI Vehicles <u>USA ONLY</u>
Release Date	November 30, 2017
Revision Summary	Updated resale information included.
Affected Vehicles	U.S.A.: 2013-2014 MY Volkswagen Touareg 3.0L TDI Generation 2.1 <i>Check Campaigns/Actions screen in Elsa on the day of repair to verify that a VIN qualifies for repair under this action. Elsa is the <u>only</u> valid campaign inquiry & verification source.</i> <ul style="list-style-type: none"> ✓ Campaign status must show “open.” ✓ If Elsa shows other open action(s), inform your customer so that the work can also be completed at the same time the vehicle is in the workshop for this campaign.
Problem Description	3.0L TDI vehicles were equipped with undisclosed Auxiliary Emission Control Devices which are not permitted by emissions regulations.
Corrective Action	Install updated engine control module (ECM) software, transmission control module (TCM) software and hardware to bring affected vehicles into regulatory compliance.

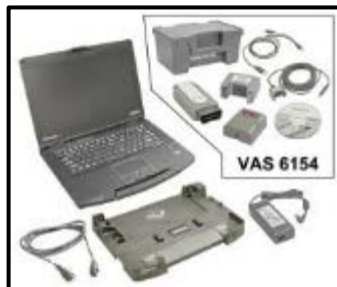
VAS6150X - Diagnostic Tester (or equivalent)
 VAS6154 - Vehicle Communication Interface (or equivalent)

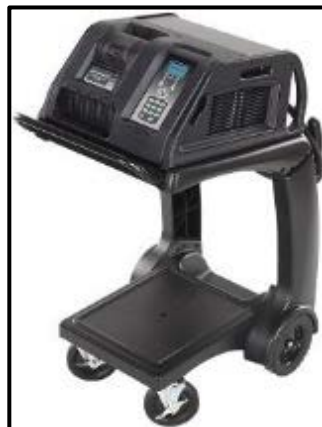
GRX3000VAS – Battery Tester/Charger (or equivalent)

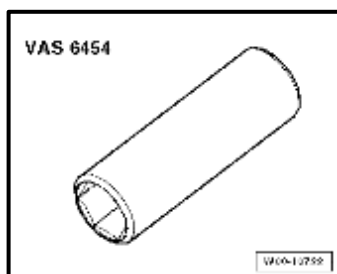
Glow Plug Socket – VAS6454 (or equivalent)

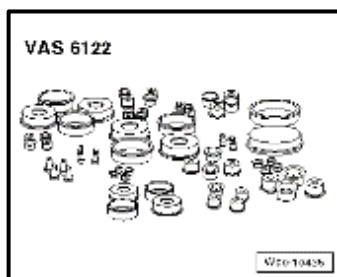
Engine Bung Set -VAS6122- (or equivalent)

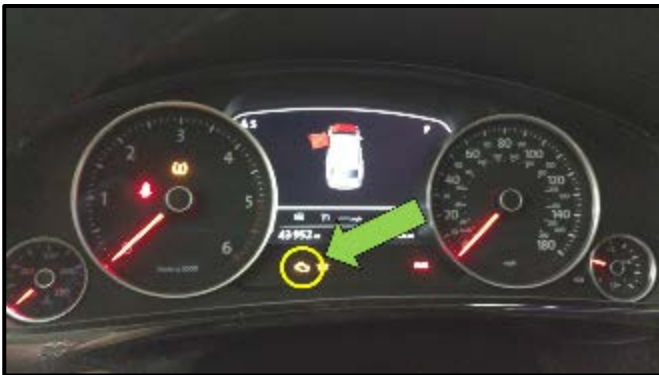
- If vehicle modifications from original equipment related to emissions components are not found, continue the work procedure.
- Check for illumination of the MIL <arrow>.

- If MIL is illuminated, **STOP**, create a VTA ticket and contact the Volkswagen Technicians Helpline.
 - If MIL is not illuminated, continue the work procedure.

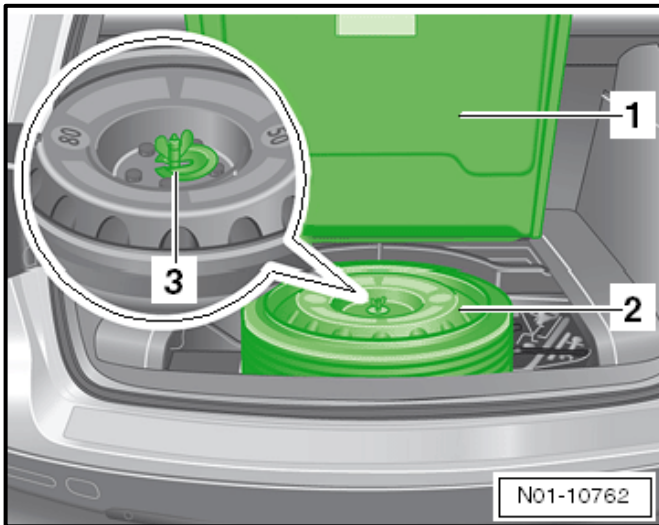
- Lift the rear compartment carpet <1> and slide it back.
- If equipped remove the spare tire <2> by removing the wing nut <3>.
- If equipped remove the foam piece <3>.

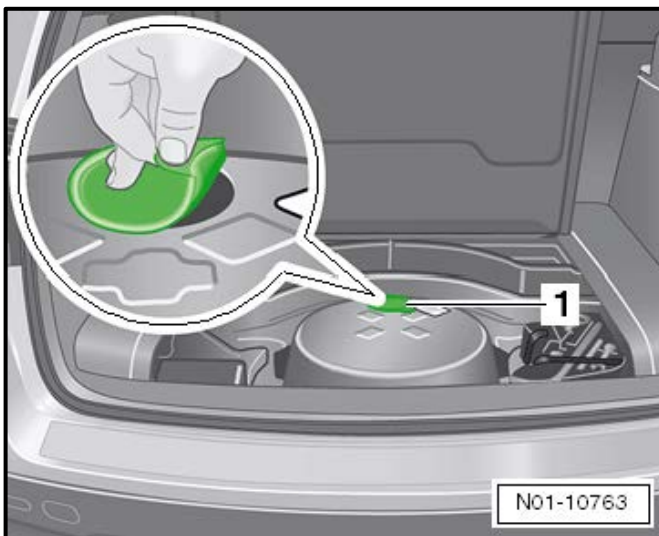
- Protect the hands when prying the plug out of the tank filler neck.
- Sharp-edged body components could cause injury.
- Remove the plug from the AdBlue tank filler neck <1>.

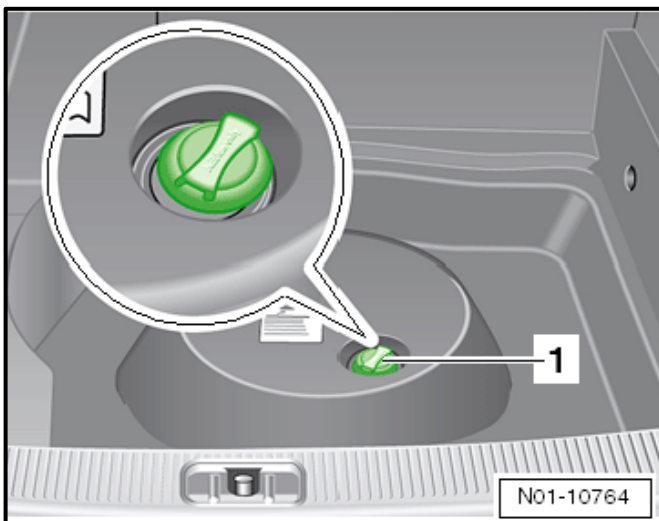
- Open the AdBlue filler cap <1> and fill the tank.

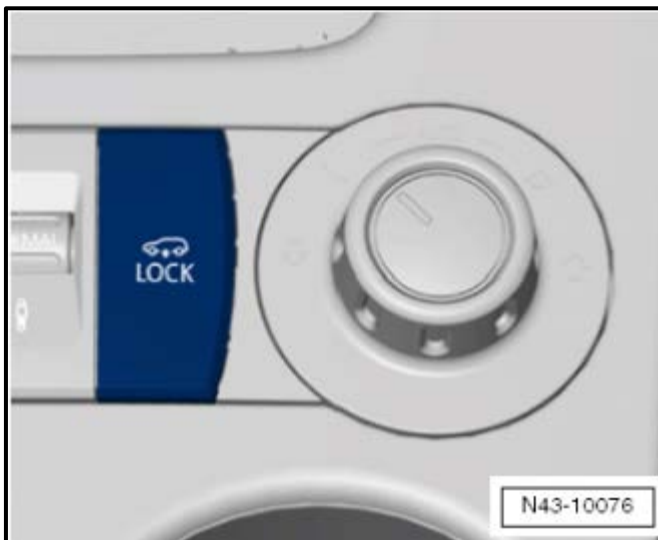
- Switch the ignition on.
 - Switch the electrical parking brake on.
 - Press the **LOCK** button in the center console for 5 seconds.
 - The Vehicle Lift Mode is displayed in the Instrument cluster and the indicator lamp in the **LOCK** button flashes when vehicle is ready to lift.
 - Turn off the ignition.
-
- Carefully pull the engine cover off the bolts one after the other in direction of <arrows>. Do not pull sharply on the engine cover or pull it to one side.

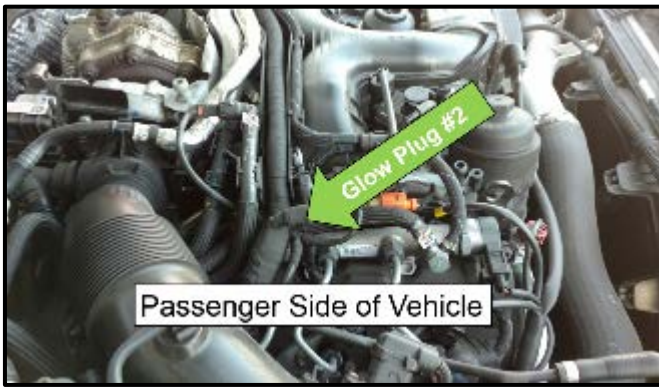
- From the passenger side of the vehicle, disconnect the glow plug connector <1> from Cylinder 2 Glow Plug with Combustion Chamber Pressure Sensor -G678- <2>.
- Clean the glow plug duct in the cylinder head (contaminants must not fall into the cylinder).

- Using Glow Plug Socket – VAS6454, tighten to 12 Nm.
- Reconnect the glow plug connector <1> from Cylinder 2 Glow Plug with Combustion Chamber Pressure Sensor -G678- <2> and make sure it is secure.

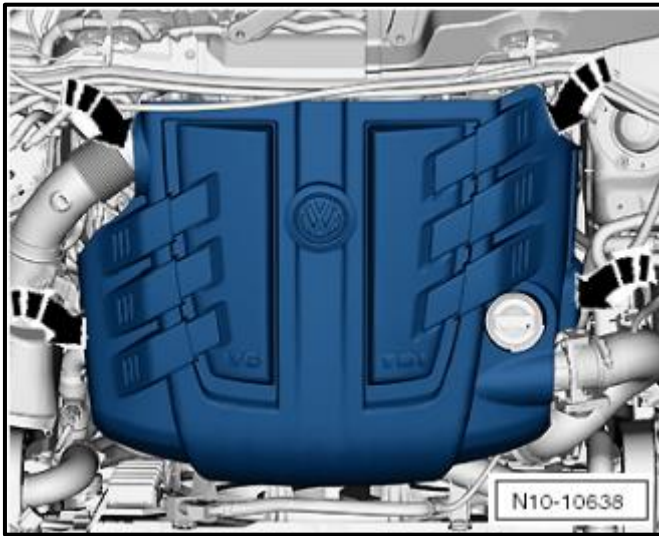
- Reinstall the engine cover by first pushing the cover with both hands into the rubber grommets in the rear and then into the rubber grommets in the front.

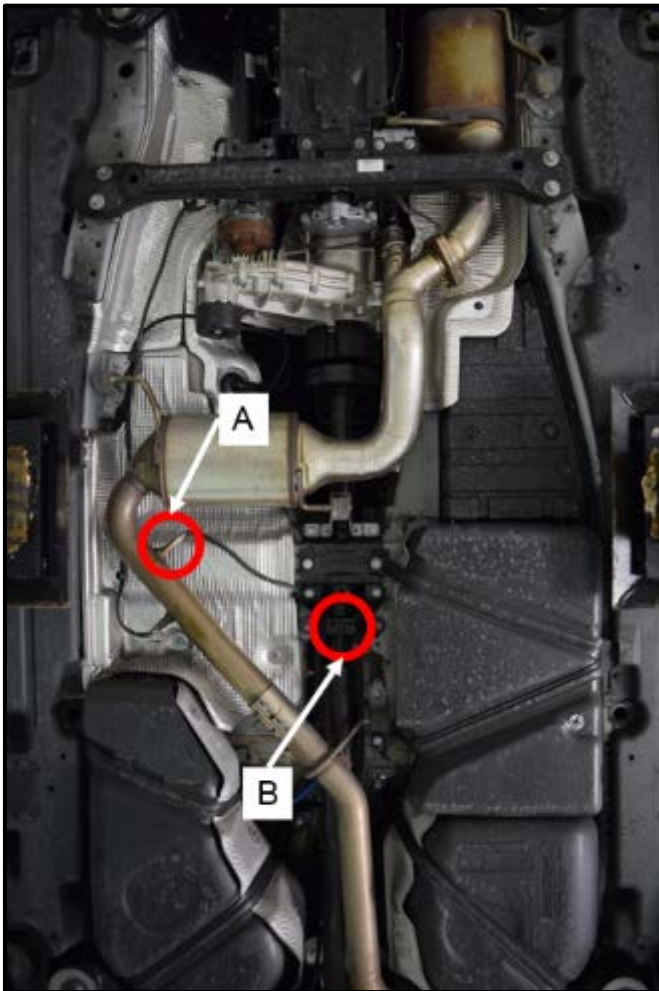
Figure <A>

Remove the NOx #2 sensor <1> from the catalyst pipe.

Cover the NOx #2 Sensor with a plastic bag (or equivalent) and secure it out of the way with a tie strap (or equivalent) attached through either one of two holes in the rear driveshaft mid-bearing bracket .

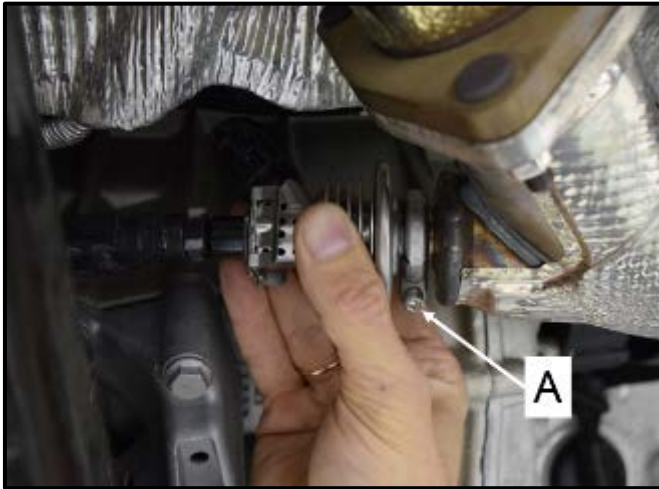
- Loosen the screw <A> and remove the clamp from the Reducing Agent Injector -N474-.
- Leave the electrical connector and the Reducing Agent Injector AdBlue feed line connected at this time. This will reduce the possibility of contaminating the electrical connection with AdBlue.
- Secure the Reducing Agent Injector out of the way with a tie strap (or equivalent).

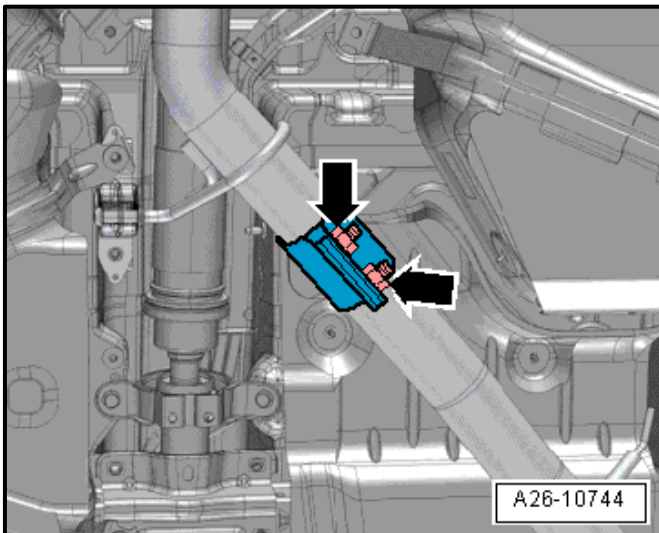
- Loosen the two nuts on the Dual Clamp <arrows> so the clamp can slide back and forth on the exhaust pipe.
- Leave the clamp in the installed position at this time. This will assist in holding the SCR Catalyst in place while removing the brackets in the next step.

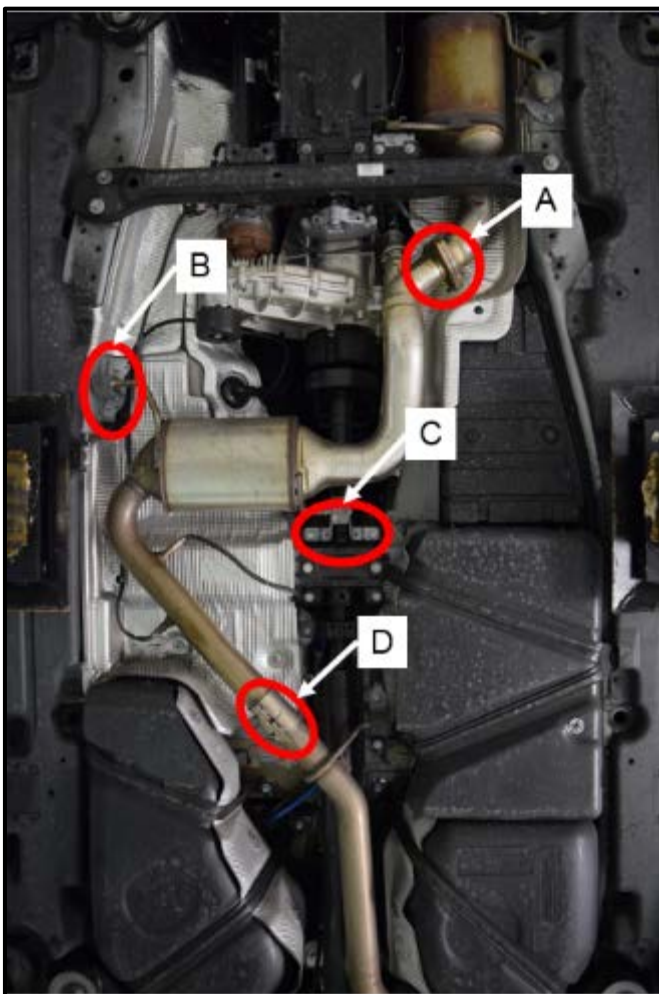
- With the assistance of a second technician, remove the three nuts <A> from the exhaust studs securing the SCR Catalyst to the Diesel Particulate Filter (DPF).
- Remove the bolts from SCR Catalyst brackets at locations <B and C> with assistance from second technician to support the SCR Catalyst while the brackets are removed.
- Slide the Dual Clamp <D> towards the rear of the vehicle, and with the assistance of a second technician, remove the SCR Catalyst from the vehicle.
- Remove the Dual Clamp <D> from the exhaust pipe and discard.

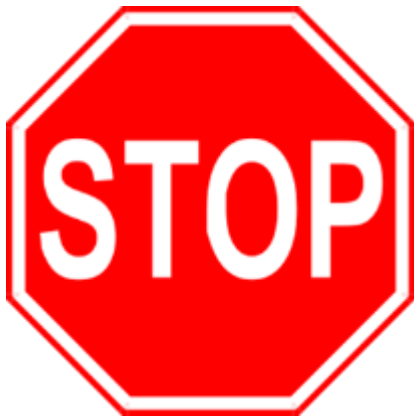
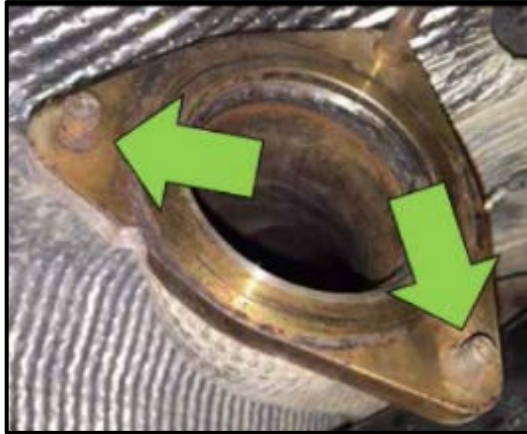
OTC 5057 Clevis Pin Press

- If stud replacement is necessary, **IT IS REQUIRED** to use a press tool such as the OTC 5057 clevis pin press (or equivalent), or other available screw or hydraulic type clevis/stud press tool to remove all necessary studs from the rear DPF flange.

- It is advised if one stud breaks that all three studs are pressed out and replaced with the bolts/nuts included in the parts kit.
 - Lubricate the OTC 5057 clevis/stud press tool threads and the press pin contact tip with hot bolt paste or anti-sieze lubricant before each use.

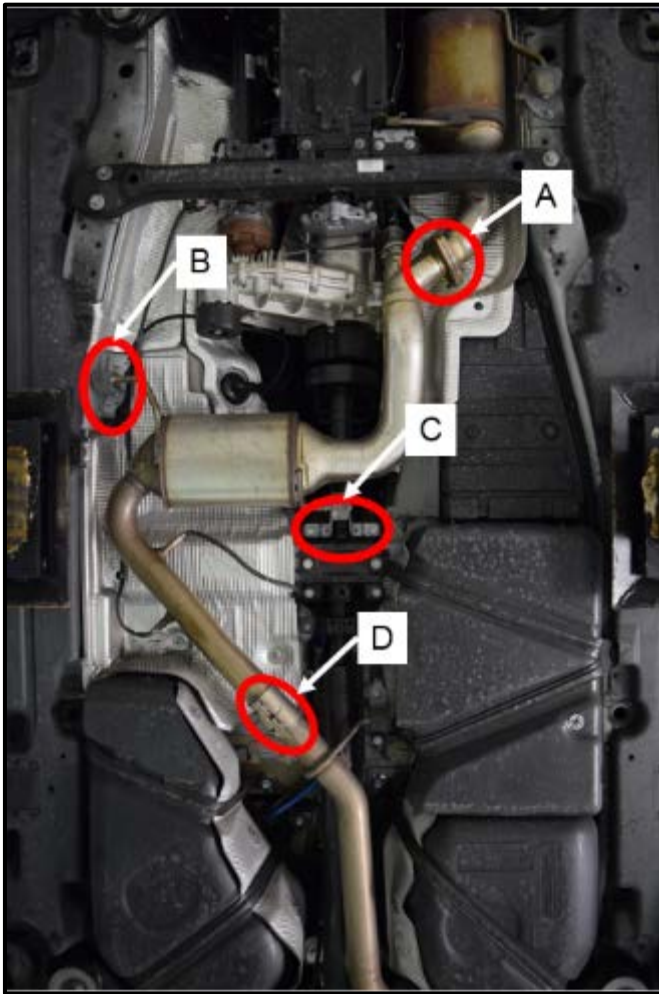
Coat the threads on the nuts and exhaust studs/bolts <A> with hot bolt paste prior to installation. Refer to the Parts Catalog.

- Install the new exhaust Dual Clamp onto the exhaust pipe at location <D> and slide the clamp to the rear of the vehicle, but do not tighten.
- With the assistance of a second technician, install the new SCR Catalyst with a new gasket between the SCR Catalyst and DPF <A>. Fit the SCR Catalyst onto the DPF flange studs/bolts and install new nuts and tighten to 23 Nm.
- Slide the Dual Clamp into the installed position on the SCR Catalyst, but do not tighten. This will assist in holding the SCR Catalyst in place while the exhaust system is properly tensioned.
- Install the bolts for the SCR Catalyst brackets <B and C> and tighten by hand.

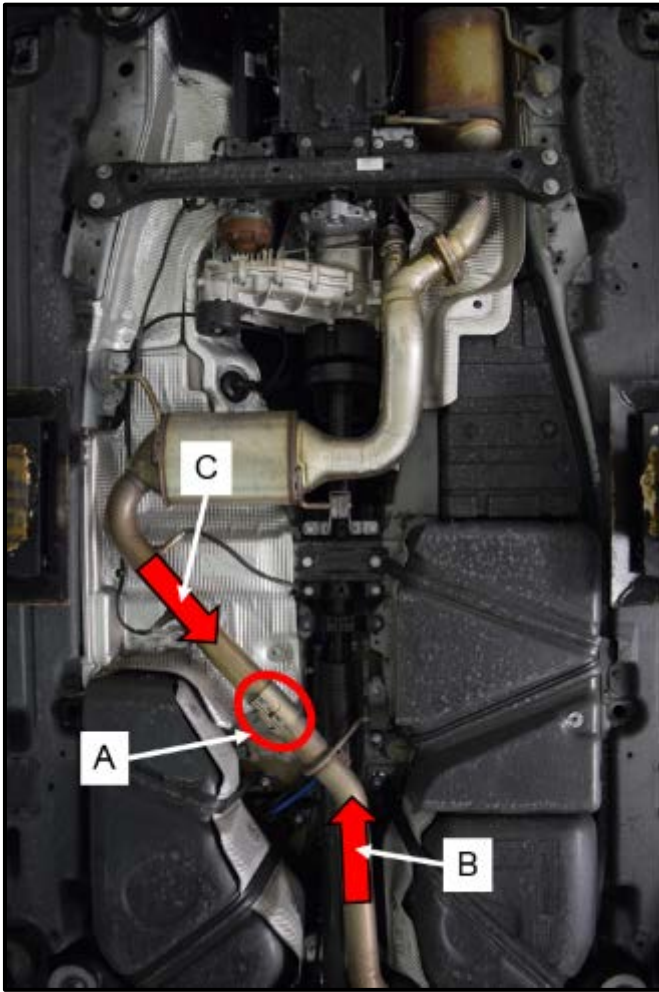
- Tighten the Dual Clamp <A> until there is a slight dragging resistance on both the SCR Catalyst pipe <arrow C> and the rear resonator/muffler pipe <arrow B>, but do not tighten so much that the pipes cannot slide in and out of the Dual Clamp <A>.
- Pretension the rear resonator/muffler hanging straps by pulling the rear resonator/muffler pipe towards the front of the vehicle <arrow B> and pulling the SCR Catalyst pipe towards the rear of the vehicle <arrow C>.

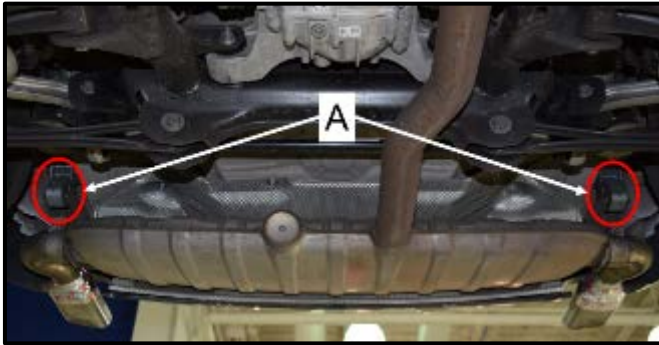
<A> = Rear Resonator Hanging Straps

In order to reduce harmonic vibration, the rear muffler/resonator straps <A> require 12 mm of forward tension, as shown in the sub-photo. Pull forward on the rear muffler/resonator pipe and insert the pipe deeper into the Dual Clamp until this dimension is achieved.

- Once the desired dimension of <a> = 12 mm is achieved, tighten the Dual Clamp nuts to 30 Nm.

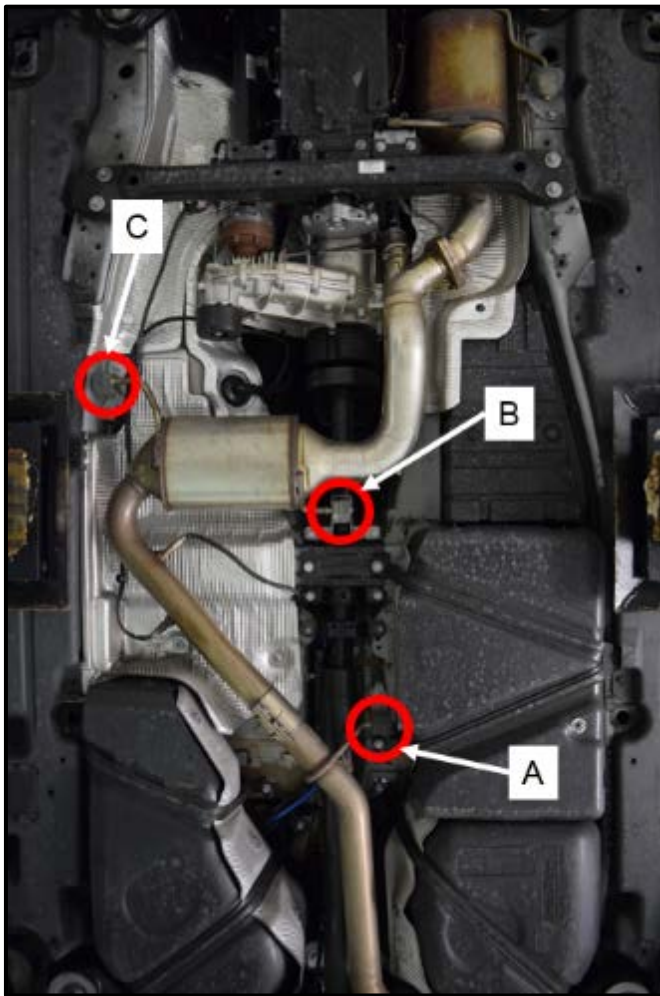
Figure <A>

If equipped, loosen the bolts at the forward resonator pipe hanging strap <A> and adjust the bracket until $\langle a \rangle = 4 \text{ mm}$ of forward tension.

- Tighten the two hanging strap bolts to 23 Nm.

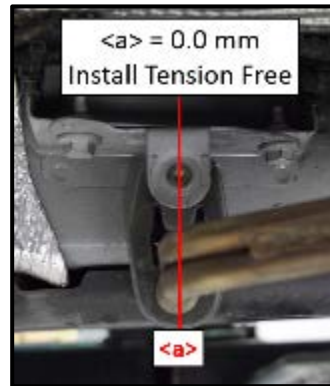
Figures <B and C>

Left and Right SCR hanging straps: $\langle a \rangle = 0.00 \text{ mm}$, install without tension.

If necessary, loosen the bolts at the left and right SCR Cat hanging straps <B and C> and adjust the brackets until $\langle a \rangle = 0.00 \text{ mm}$. The SCR Catalyst hanging straps are installed tension free.

- Tighten the two hanging strap bracket bolts to 60 Nm.
- Tighten the two hanging strap bracket bolts <C> to 23 Nm.

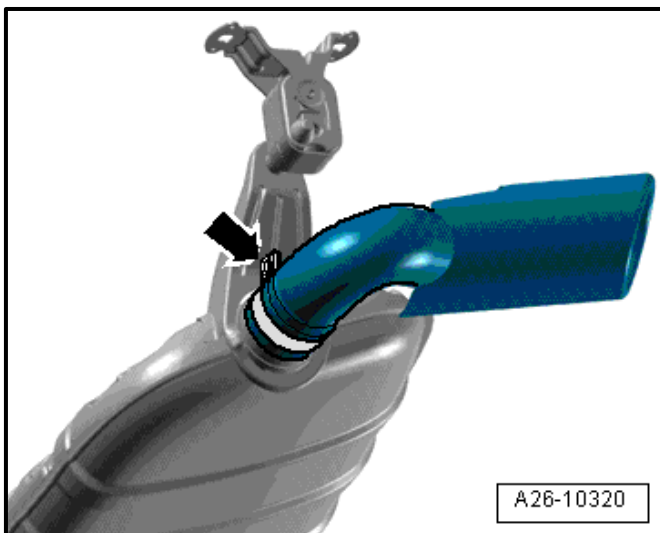
- If necessary, align the tailpipes by first loosening the screw-type clamp <arrow> on the tail pipes.

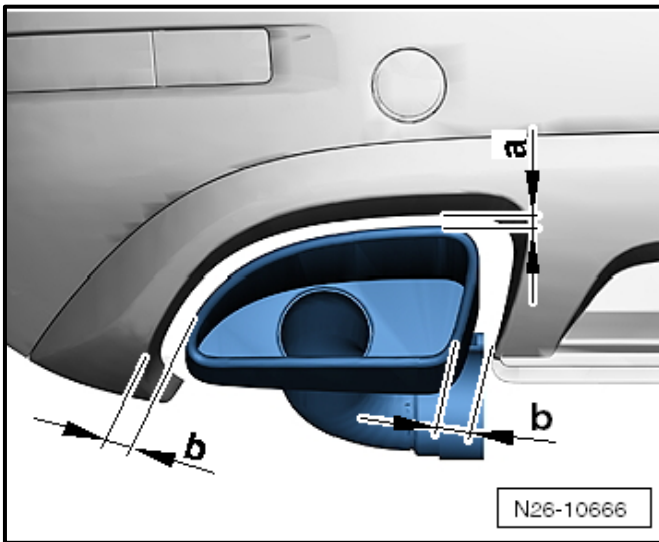
- Adjust the tailpipes to the specifications below.
 - Dimension -a- = 20 mm minimum.
 - Dimension -b- = align evenly.

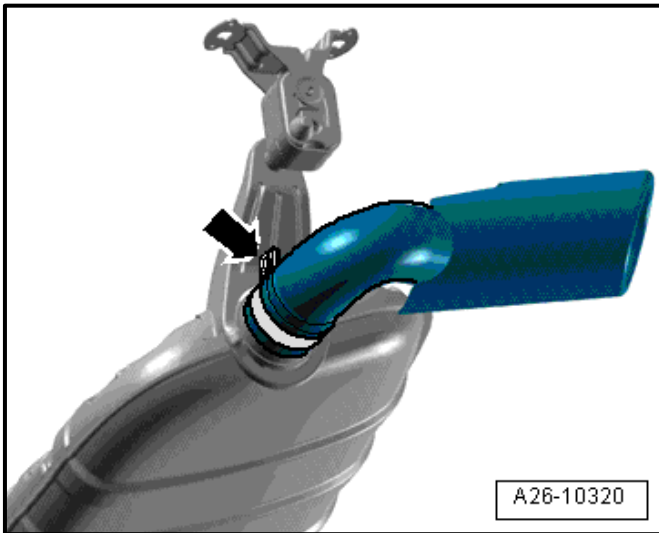
- Once the tail pipe is properly aligned to the bumper cover, tighten the screw-type clamps <arrow> to 60 Nm.

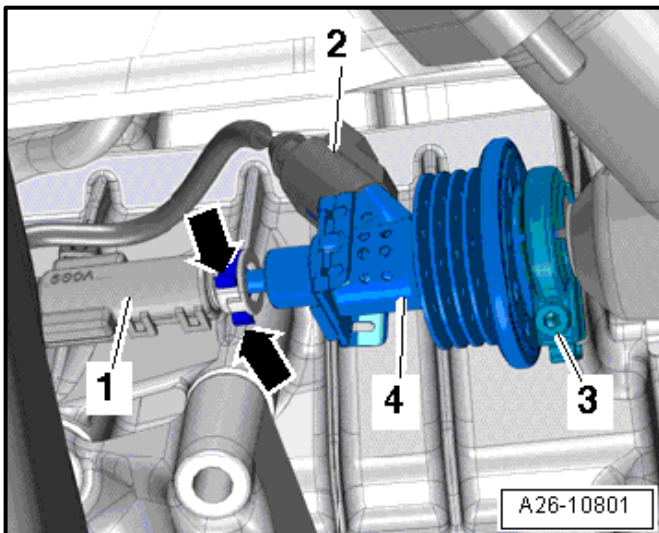
- Lay a cloth below to catch any escaping AdBlue reducing agent.
- Make certain the electrical connector is installed into the new Reducing Agent Injector -N474- before disconnecting the AdBlue reducing agent feed hose. This will reduce the possibility of contaminating the electrical connection with AdBlue.

- Disconnect the connector <2> from the existing Reducing Agent Injector -N474- <4>.
- Connect the connector <2> to the new Reducing Agent Injector -N474- <4> and set it aside.

- Make certain the electrical connector is installed into the new Reducing Agent Injector before disconnecting the AdBlue reducing agent feed hose. This will reduce the possibility of contaminating the electrical connection with AdBlue.
- Remove the AdBlue reducing agent feed hose <1> by pressing the release clasps <arrows> and remove the reducing agent hose <1>.
- Connect the AdBlue reducing agent hose <1> to the new Reducing Agent Injector -N474- <4>.
- Install the new Reducing Agent Injector -N474- into the SCR Catalyst pipe ensuring that the tabs in the Injector <arrows> fit into the corresponding mounts in the SCR catalytic converter.

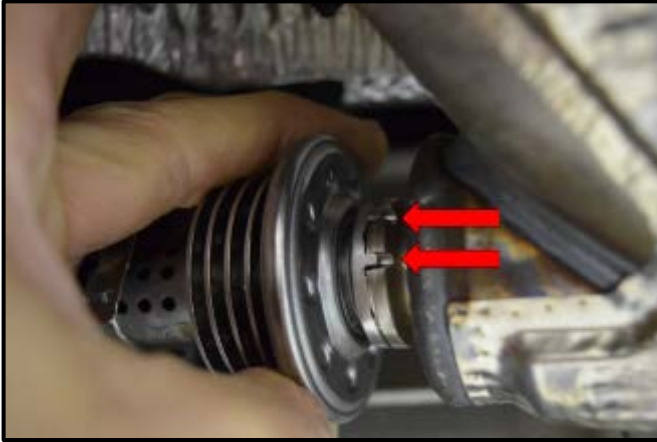
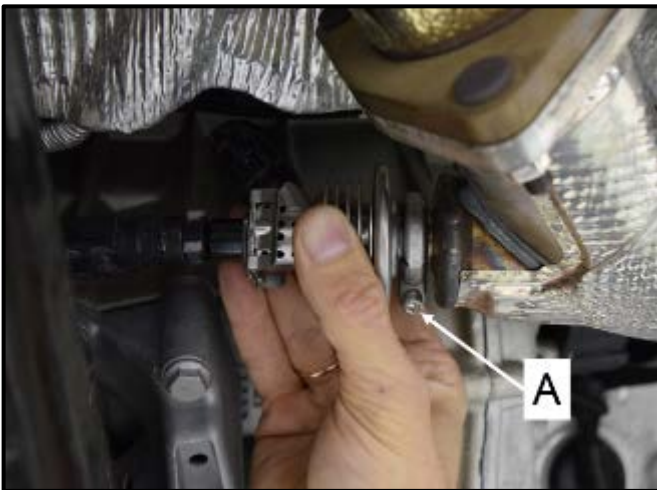
The gasket comes pre-installed on the new Injector. Verify the new gasket is present and seated properly before installation.

- Install a new retaining clamp <A> and tighten the bolt to 5 Nm.

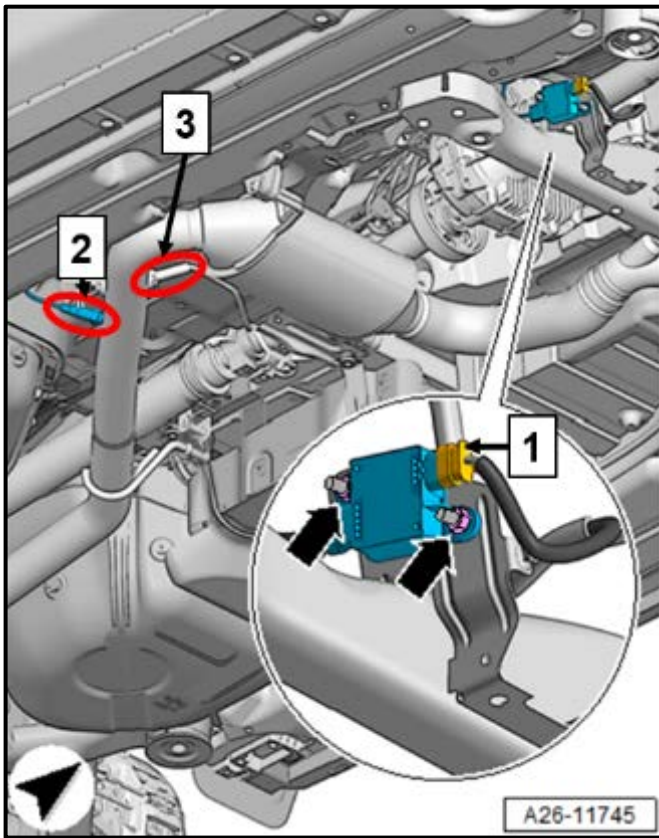
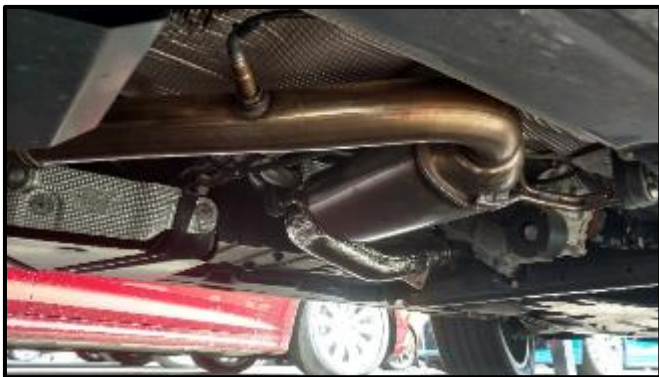
- Coat new PM Sensor and the existing NOx #2 Sensor threads with hot bolt paste. Paste must not get on to slits of sensor body. Refer to the Parts Catalog.
- The sensor wires must always be attached at the same location as removed when installing. Do not let the sensor wires come in contact with the exhaust pipe.

- Recover all retention clips from the removed PM Sensor and NOx #2 Sensor harnesses and install them into the appropriate locations on the chassis. A new tie strap may be required for some of the retention clips (shop supply).
- Install the PM Sensor control module -G784- and the nuts <arrows>. Tighten to 6 Nm.
- Reconnect the PM Sensor connector <1>.
- Capture a single photo showing both the new SCR Catalyst and the new PM Sensor and upload the photo to the TDI IN-FORM Tool.
- See the example photo for proper orientation and preferred photo angle. This photo can be captured in the air during the repair, or on the ground after the repair as shown.

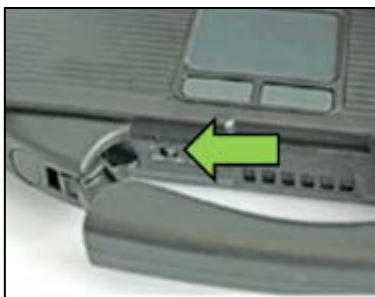
VAS 6150 & VAS 6150A
(Front panel behind handle)

- Performing a software update using a Bluetooth connection increases the risk of losing connection during the update, which could result in damage to the control module. It also greatly increases the time required to perform the update. Requests for additional time or parts will be denied if the GFF log shows the update was performed using Bluetooth.
- ✓ **The Bluetooth function of the scan tool is physically switched off <see pictures below>.**

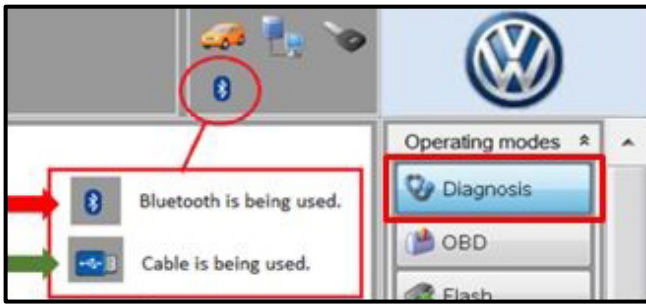
- Confirm that scan tool is communicating with the diagnostic head by USB <Green Arrow>.
 - If the Bluetooth symbol is shown <Red Arrow> then disconnect the diagnostic head from the vehicle and reconnect the USB cable to the diagnostic head and then reattach to the vehicle.
- Upon ODIS startup, verify the "Diagnosis" operating mode is selected <as shown>.

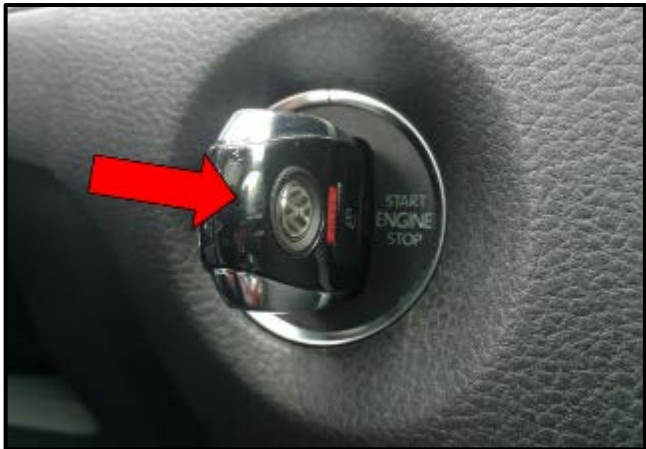
It is **REQUIRED** to insert the key into the reader coil <arrow>, or place the key in the closest proximity possible to the reader coil throughout the flash process.

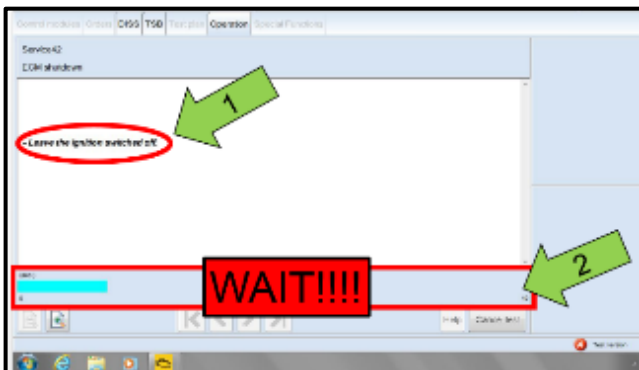
- It is **IMPERATIVE** that **ALL** of the ignition cycle on/off delay requests are fulfilled in their entirety during this flash process <arrow 1>.
- Failing to wait for the ignition on/off timing cycle to complete (progress bar and countdown timer <arrow 2>) before cycling the ignition on/off **MAY** damage a control module.
- Damage to control modules as a result of failing to wait the specified time displayed by the progress bar and countdown timer <arrow 2> are **NOT** covered under this action.

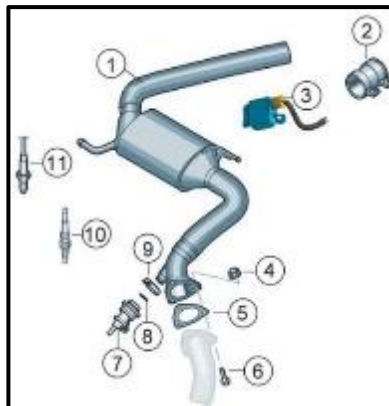
Appendix C – 3.0L Gen 2.1 Parts Kit

Kit	Part Number	Part Description	Quantity	Diagram Location
7P0 298 099 X Gen 2.1 Kit	7P0 254 400 BX	Exhaust Pipe With Catalyst And Adapters	1	1
	7L5 253 115 C	Gasket	1	5
	1K0 253 141 AF	Dual Clamp	1	2
	N 91130802	Shouldered Hex Nut	3	4
	N 01024713	Replacement Stud/Bolt	3	6
	4H0 131 113 A	Injector For Reduction Agent	1	7
	3C0 253 725	Retaining Clamp	1	9
	059 906 261	PM Sensor	1	3 / 11
