Emissions Recall

Code: 23V7

Subject	3.0L TDI Engine Emissions System Modification – Customer Only (Retail Sold) TDI Vehicles <u>USA ONLY</u>
Release Date	November 6, 2017
Affected Vehicles	U.S.A.: 2015-2016 MY Volkswagen Touareg 3.0L TDI Generation 2.2 <i>Check Campaigns/Actions screen in Elsa on the day of repair to verify that a VIN qualifies for repair under this action. Elsa is the <u>only</u> valid campaign inquiry & verification source.</i> <ul style="list-style-type: none">✓ Campaign status must show “open.”✓ If Elsa shows other open action(s), inform your customer so that the work can also be completed at the same time the vehicle is in the workshop for this campaign.
Problem Description	3.0L TDI vehicles were equipped with undisclosed Auxiliary Emission Control Devices which are not permitted by emissions regulations.
Corrective Action	Install updated engine control module (ECM) software and transmission control module (TCM) software to bring affected vehicles into regulatory compliance.

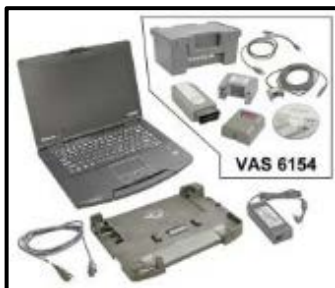
VAS6150X - Diagnostic Tester (or equivalent)

VAS6154 - Vehicle Communication Interface (or equivalent)

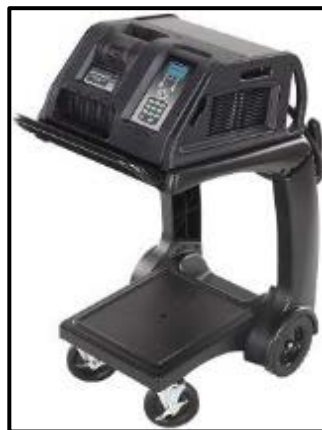
GRX3000VAS – Battery Tester/Charger (or equivalent)

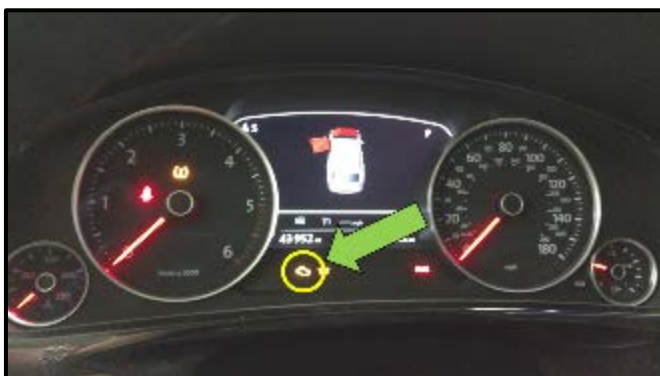
- If vehicle modifications from original equipment related to emissions components are not found, continue the work procedure.
- Check for illumination of the MIL <arrow>.

- If MIL is illuminated, **STOP**, create a VTA ticket and contact the Volkswagen Technicians Helpline.
 - If MIL is not illuminated, continue the work procedure.

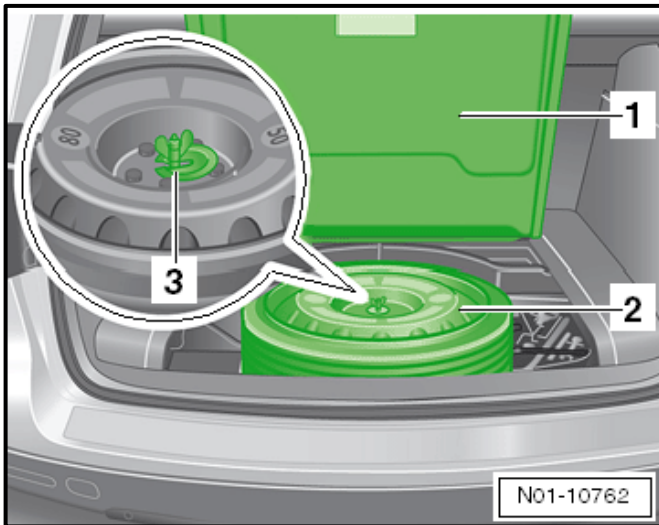
- Lift the rear compartment carpet <1> and slide it back.
- If equipped remove the spare tire <2> by removing the wing nut <3>.
- If equipped remove the foam piece <3>.

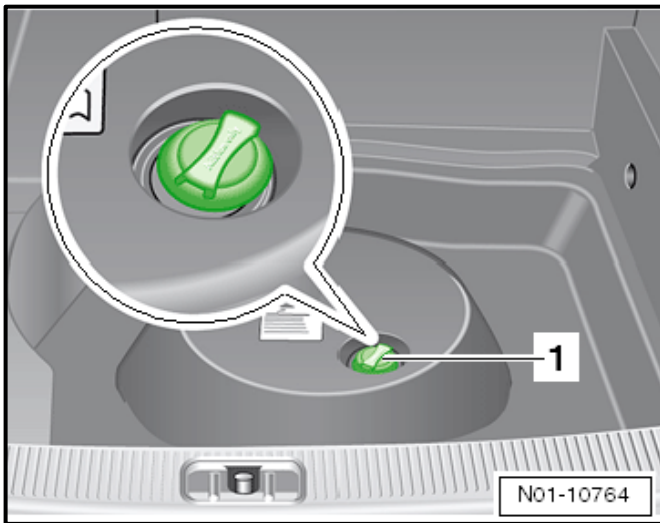
- Open the AdBlue filler cap <1> and fill the tank.

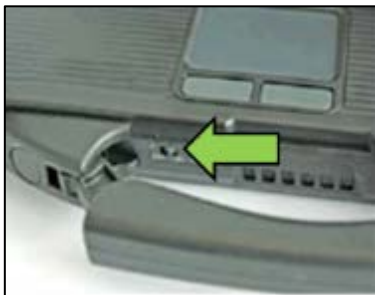
VAS 6150 & VAS 6150A
(Front panel behind handle)

- Performing a software update using a Bluetooth connection increases the risk of losing connection during the update, which could result in damage to the control module. It also greatly increases the time required to perform the update. Requests for additional time or parts will be denied if the GFF log shows the update was performed using Bluetooth.
- ✓ **The Bluetooth function of the scan tool is physically switched off <see pictures below>.**

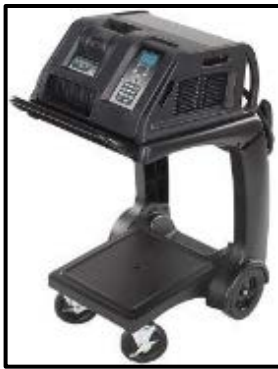
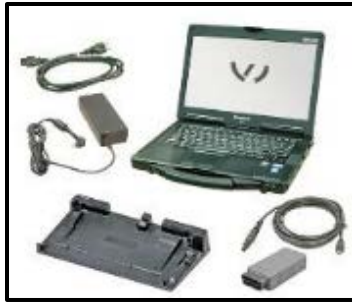
- Open the hood.
- Open the battery jump point cover.
- Attach the GRX3000VAS Tester/Charger (or equivalent) to the vehicle battery jump point and ground jump point.
- Switch the ignition on.
- Apply the parking brake.
- Switch the headlights off.
- Connect the VAS6150X Diagnostic Tester (or equivalent) to the vehicle.
- Start the ODIS program.

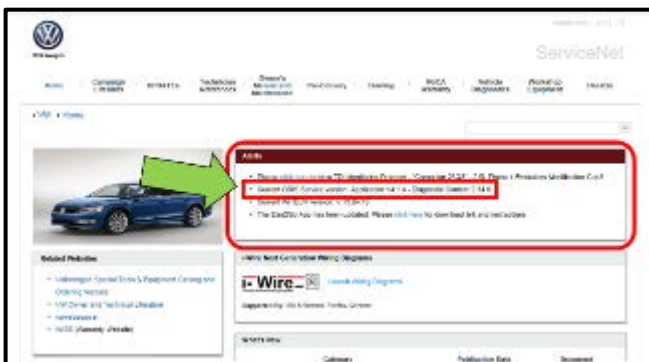
- At this time, refer to the “Alerts” section of ServiceNet <arrow> to verify that the most recent version of ODIS Software is loaded to the VAS6150X Diagnostic Tester (or equivalent). Failure to flash the vehicle using the most recent version of ODIS Diagnostic Software will cause faults in certain features of the flash operation.
- Failure to validate the ODIS Diagnostic version before flashing the vehicle may result in flash failure, and may delay if not negate the payment of the emissions modification.

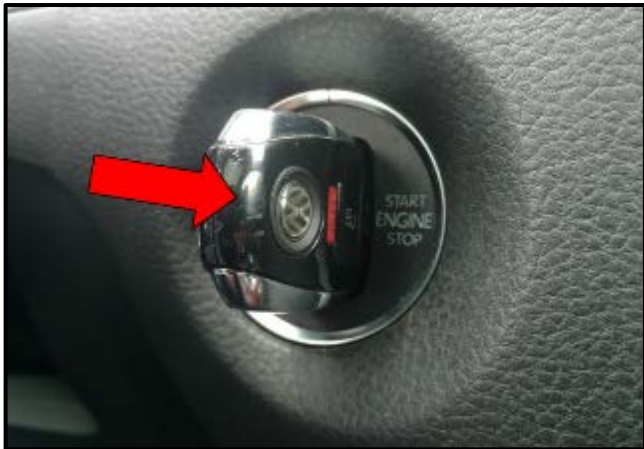
It is **REQUIRED** to insert the key into the reader coil <arrow>, or place the key in the closest proximity possible to the reader coil throughout the flash process.

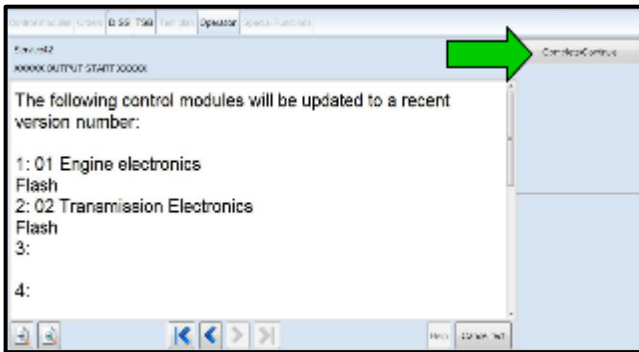
- Select “Complete/Continue” <arrow> to begin the software update process.

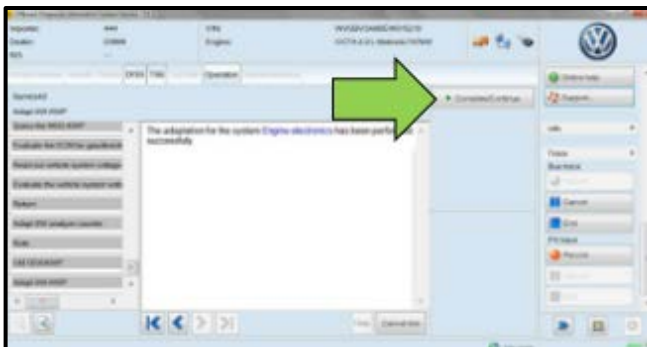
- When the SVM update is complete a confirmation message is displayed <as shown>.
- Select “Complete/Continue” <arrow>.

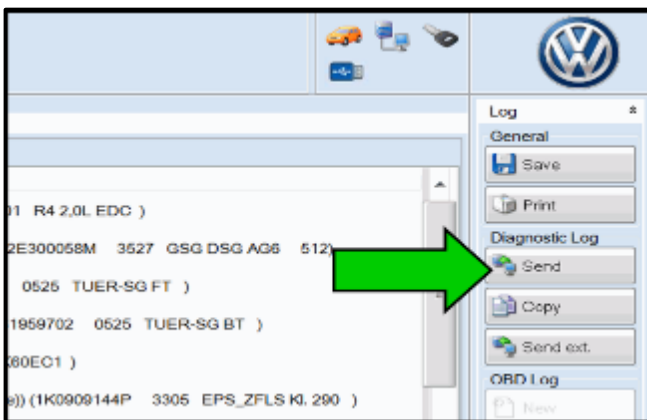
- At the end of the diagnostic session, Select “Send” <arrow> and follow the prompt for sending the log on-line.

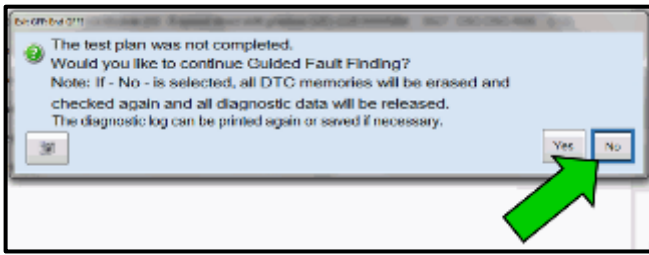
When exiting GFF, it is important to select "No" <arrow>.

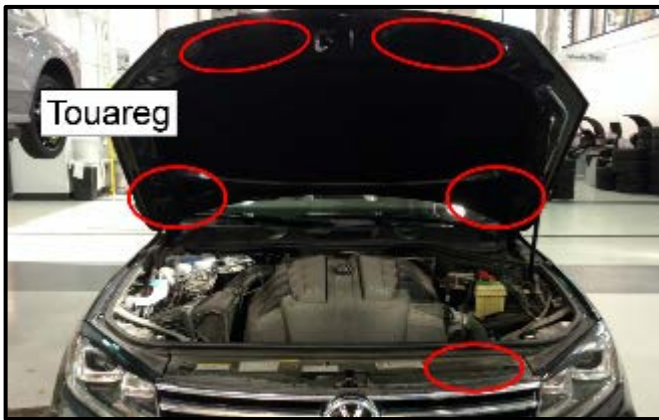
Install TDI Emissions Modification Proof of Completion label

- Clean the surface where the Vehicle Emission Control Information Label where the TDI Recall Proof of Completion label is to be installed.
- Fill out completely the Recall Code, Dealer Code, and Repair Date.
- Affix the TDI Recall Proof of Completion label and verify that the correct part number is being installed according to chart below onto the underside of the hood or onto the core support. The TDI Recall Proof of Completion label and Supplemental Vehicle Emissions Control Information (VECI) label should be placed next to each other so that a single photograph can capture both labels.

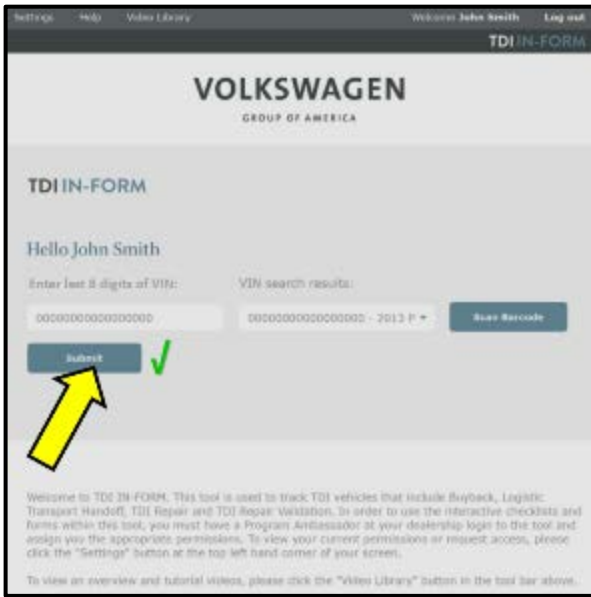
The VIN can be manually typed in or using an iPad or iPhone running iOS 9+, the camera can be used to scan the VIN Barcode.

After the VIN has been entered, the system will automatically validate that it is a TDI VIN. This will be indicated by a green check mark that will appear next to the VIN.

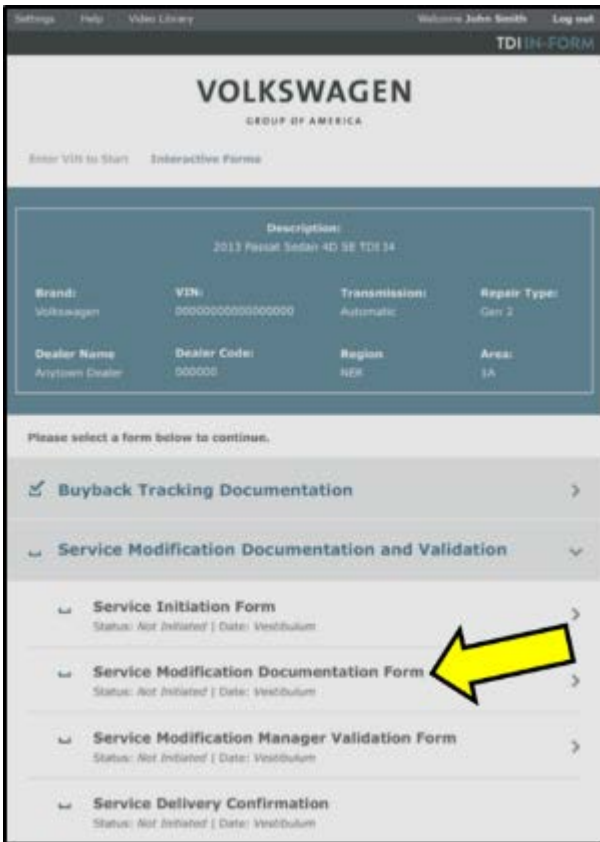
- Select “Service Modification Documentation Form” <arrow>.
- Follow the on-screen prompts completely.
