Emissions Recall

Code: 23V7

Subject	3.0L TDI Engine Emissions System Modification
Release Date	November 29, 2017
Revision Summary	Updated resale information included.
Affected Vehicles	<p>U.S.A.: 2015-2016 MY Volkswagen Touareg 3.0L TDI Generation 2.2</p> <p><i>Check Campaigns/Actions screen in Elsa on the day of repair to verify that a VIN qualifies for repair under this action. Elsa is the <u>only</u> valid campaign inquiry & verification source.</i></p> <ul style="list-style-type: none"> ✓ Campaign status must show "open." ✓ If Elsa shows other open action(s), inform your customer so that the work can also be completed at the same time the vehicle is in the workshop for this campaign.
Problem Description	3.0L TDI vehicles were equipped with undisclosed Auxiliary Emission Control Devices which are not permitted by emissions regulations.
Corrective Action	Install updated engine control module (ECM) software and transmission control module (TCM) software to bring affected vehicles into regulatory compliance.

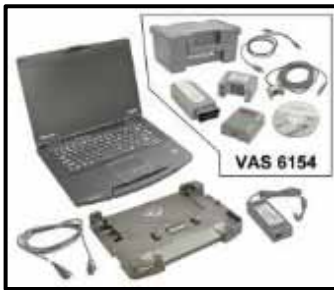
VAS6150X - Diagnostic Tester (or equivalent)
VAS6154 - Vehicle Communication Interface (or equivalent)

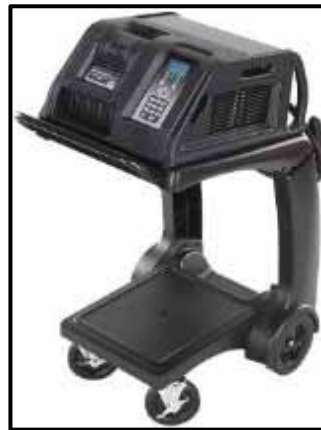
GRX3000VAS – Battery Tester/Charger (or equivalent)

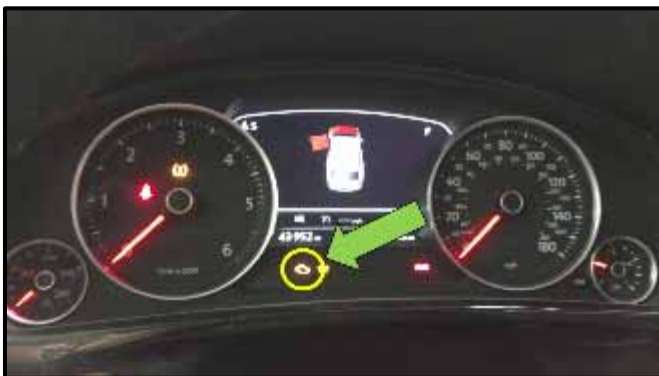
- If vehicle modifications from original equipment related to emissions components are not found, continue the work procedure.
- Check for illumination of the MIL <arrow>.

- If MIL is illuminated, **STOP**, create a VTA ticket and contact the Volkswagen Technicians Helpline.
 - If MIL is not illuminated, continue the work procedure.

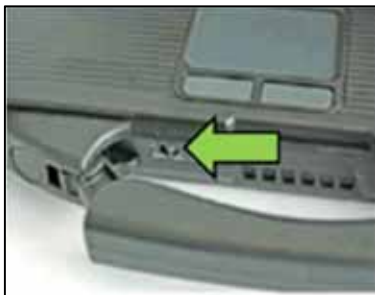
VAS 6150 & VAS 6150A
(Front panel behind handle)

- Performing a software update using a Bluetooth connection increases the risk of losing connection during the update, which could result in damage to the control module. It also greatly increases the time required to perform the update. Requests for additional time or parts will be denied if the GFF log shows the update was performed using Bluetooth.
- ✓ **The Bluetooth function of the scan tool is physically switched off <see pictures below>.**

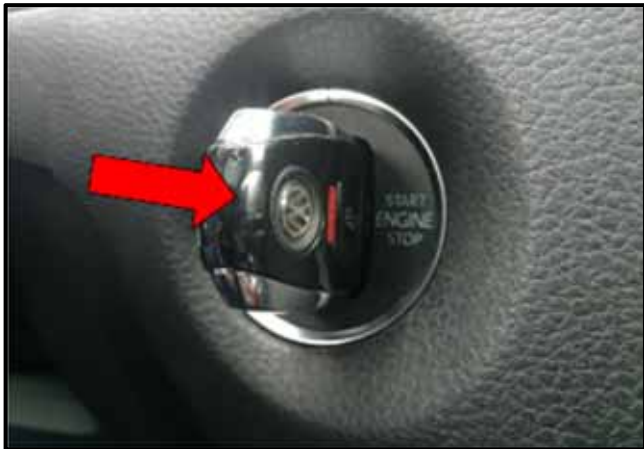
It is **REQUIRED** to insert the key into the reader coil <arrow>, or place the key in the closest proximity possible to the reader coil throughout the flash process.

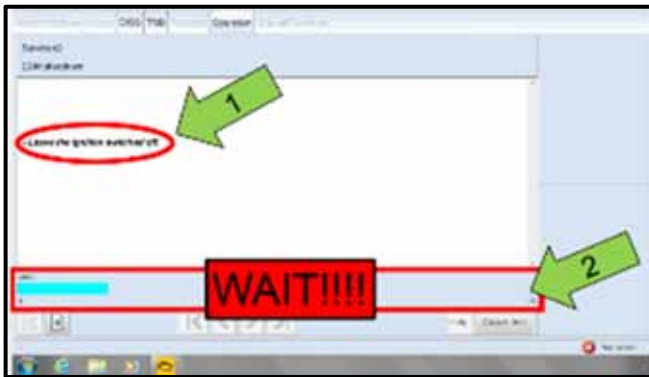
- It is **IMPERATIVE** that **ALL** of the ignition cycle on/off delay requests are fulfilled in their entirety during this flash process <arrow 1>.
- Failing to wait for the ignition on/off timing cycle to complete (progress bar and countdown timer <arrow 2>) before cycling the ignition on/off **MAY** damage a control module.
- Damage to control modules as a result of failing to wait the specified time displayed by the progress bar and countdown timer <arrow 2> are **NOT** covered under this action.

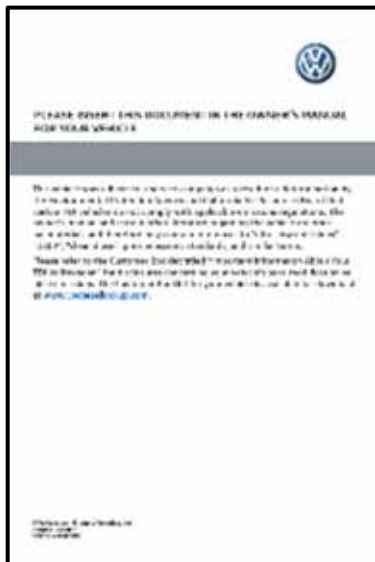
- Insert the appropriate Owner's Manual Supplement into the Owner's Manual that corresponds to the vehicle model.

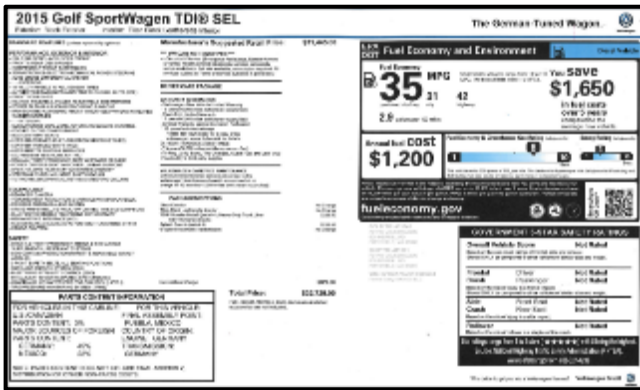
- Remove original Monroney Label and discard.
- Install new Monroney Label that corresponds to the vehicle VIN on the rear passenger side window.

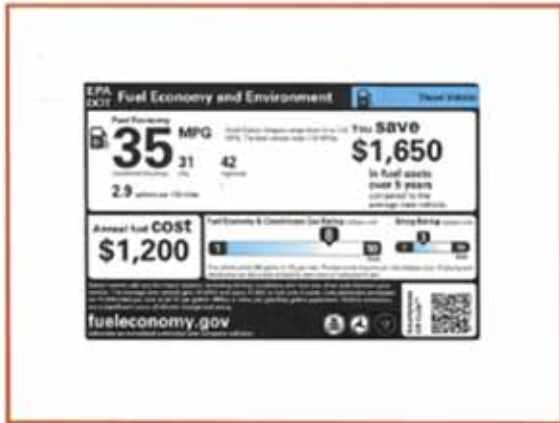
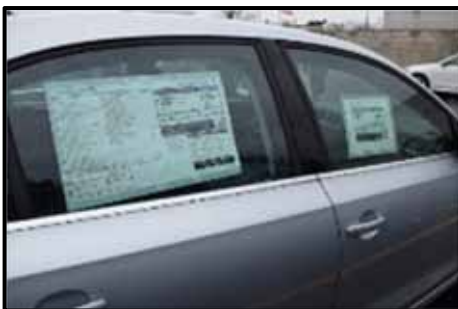
- Install new Fuel Economy Label <example pictured left> to the right of the new Monroney Label. If necessary, use the passenger front window <examples pictured below>.

- See Examples of properly installed labels:
- Install Monroney and fuel economy labels as shown:

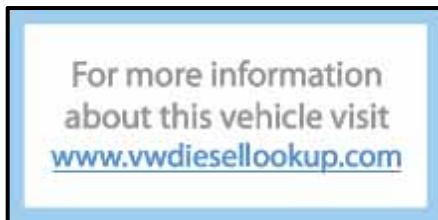
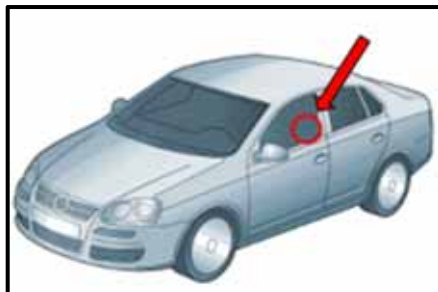
- Place the “more information” permanent window sticker <pictured left> on the front driver-side window in the lower right corner of the window <arrow>. Install the sticker from the inside of the window.
 - Affix the “more information” sticker to the front driver-side window as necessary either above, beside, or under any other required State and/or Local Labels (example, California Prop 65).
