February 2017  
FL721A-E  
NHTSA #16V-656  
Transport Canada #16-441  
SECOND REVISED NOTICE

## Subject: CNG Fuel Tank and CPDM Mounting Location

**Models Affected:** Specific Freightliner Cascadia vehicles manufactured September 24, 2012, through May 27, 2015, built with CNG fuel tanks

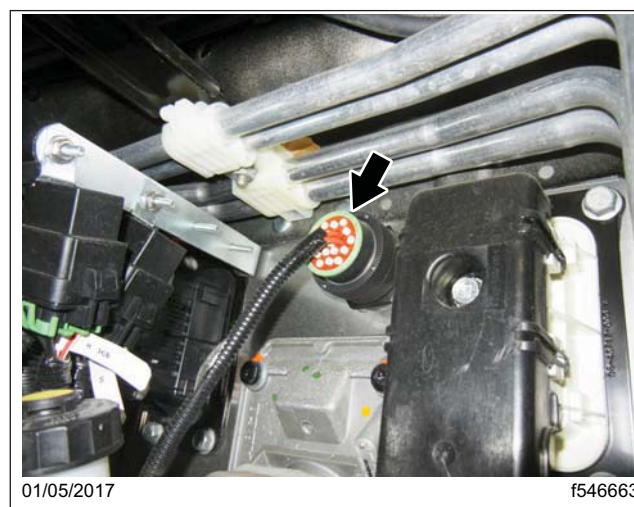
**Fig. 1, Bulkhead Connector**

1. Shut off the gas valve and disconnect the batteries.
2. Remove the driver-side kick panel, the center lower dash cover, and the instrumentation control unit (ICU).
3. Raise the hood and disconnect the bulkhead connector 1A. See [Fig. 1](#). Remove the nut that secures the dash side 1A bulkhead connector to the front wall.

1. Shut off the gas valve and disconnect the batteries.
2. Remove the driver-side kick panel, the center lower dash cover, and the instrumentation control unit (ICU).
3. Raise hood and disconnect bulkhead connector 1A. See [Fig. 1](#) . Remove the nut that secures the dash side 1A bulkhead connector to the front wall.

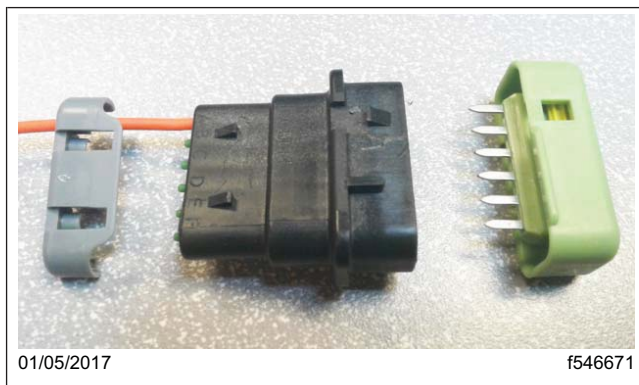
**Fig. 11, Splice Pack Cover and Lock (removed)**

17. Remove the green cover and the grey terminal lock from the ABS ignition PLC filtered splice pack on harness A06-93209-000. See [Fig. 11](#).
18. Insert the GT150S terminal end of the single wire harness A06-93668-000 into any available cavity in the splice pack. See [Fig. 12](#). Install the terminal lock and cover.

17. Plug the 4-wire connector on harness A06-93000-000 into slot x55 on the SAM Chassis. See [Fig. 10](#).
  18. Remove the green cover and grey terminal lock from the ABS ignition PLC filtered splice pack on harness A06-93209-003. See [Fig. 11](#).

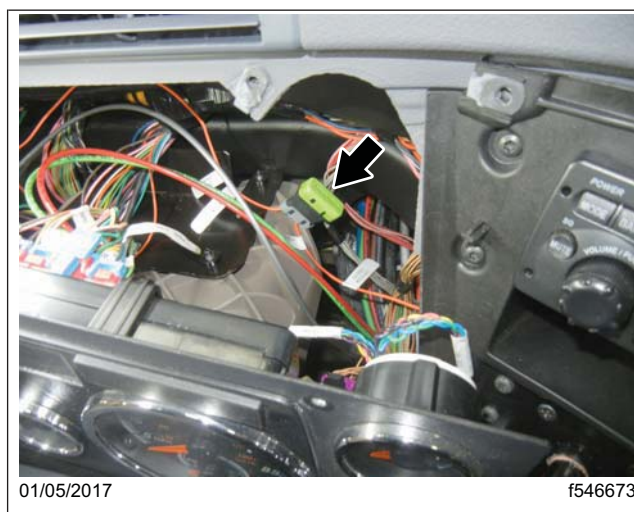
**Fig. 13, Splice Pack Routing**

19. Route the splice pack behind the ICU near the radio. See [Fig. 13](#)

20. Route the splice pack behind the ICU, near the radio. See [Fig. 13](#).
  21. Disconnect connector 2A from the back of the ICU, and remove the terminal locks. See [Fig. 14](#).

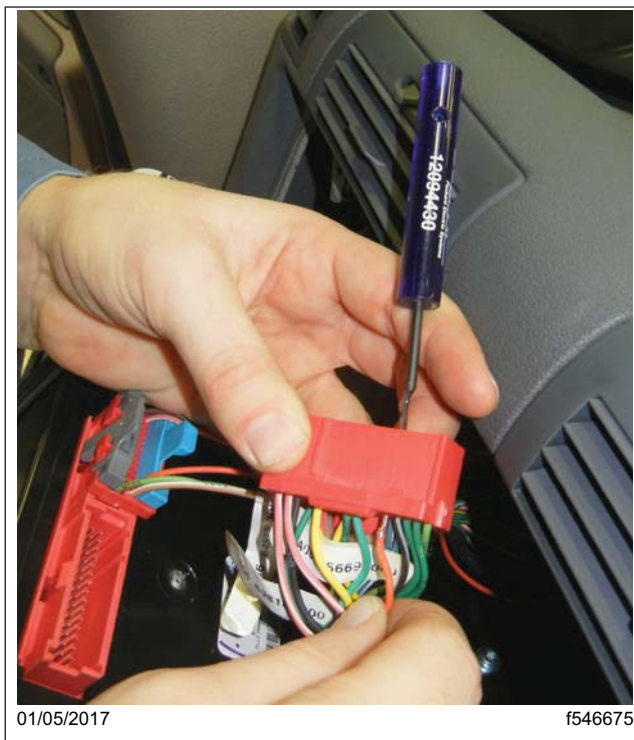
**Fig. 15, Wire Removal from Cavity D12 of ICU  
Connector 2A**

21. Remove the existing wire from cavity D12 of ICU connector 2A. See [Fig. 15](#).

22. Remove the existing wire from cavity D12 on ICU connector 2A. See [Fig. 15](#).
  23. Fold the removed wire back against itself, and cover the terminal with heat shrink tubing. See [Fig. 16](#).

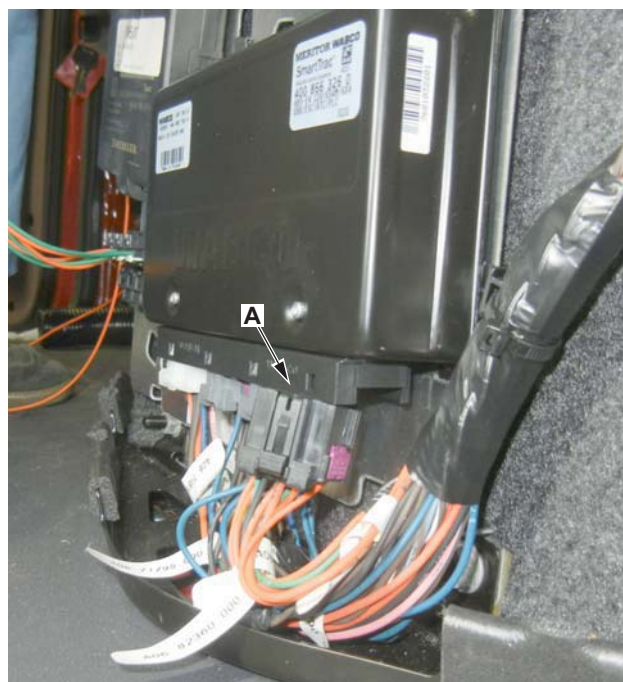
**Fig. 19, Connector X1A on the ABS Module**

27. Disconnect connector X1A from the ABS module and remove the terminal lock. See [Fig. 19](#) and [Fig. 20](#)

A. Connector A is located on the right-hand side of the ABS module.

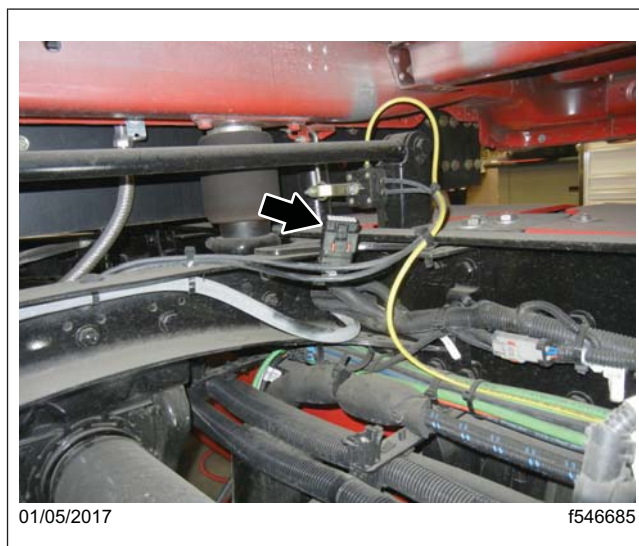
**Fig. 25, CPDM Harness Capped**

34. Outside the cab, disconnect the CPDM harness and cap it with part number 23-13153-011. Plug each cavity with a cavity plug (23 13218 300). See [Fig. 25](#), [Fig. 26](#), and [Fig. 27](#).

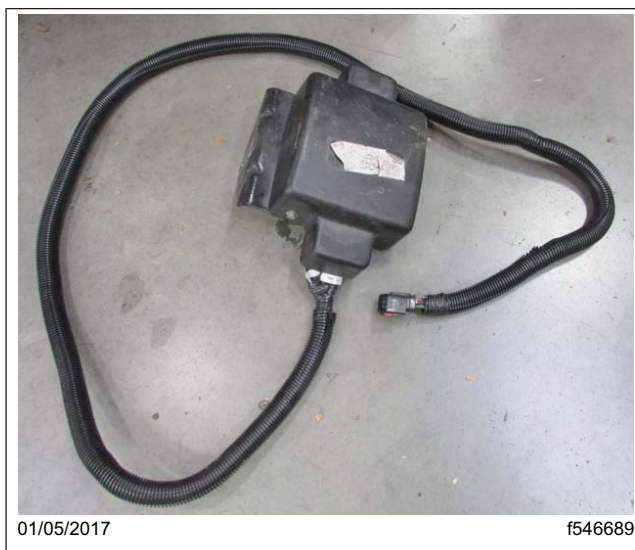
**Fig. 29, CPDM Removed from the Vehicle**

NOTE: The CPDM should be discarded after it is removed from the vehicle. It will not be used again.

36. Remove the CPDM from the vehicle. See [Fig. 29](#).

26. Install the terminal lock in connector X1A and plug the connector back into the ABS module.
  27. Use cable ties to secure the bundle to the HVAC ducting behind the ICU. See [Fig. 24](#).
  28. Outside the cab, disconnect the chassis PDM (CPDM) harness and cap it with 23-13153-011. Plug each cavity with a cavity plug (23-13218-300). See [Fig. 25](#), [Fig. 26](#), and [Fig. 27](#).
- NOTE: Remove MEGA fuses from the PNDB if there are no other cables populated on the studs.
29. Disconnect the CPDM power cable from the PNDB and remove it from the vehicle. See [Fig. 28](#). Replace any cable ties that were removed, which are still needed to secure other hoses and wiring.
- NOTE: The CPDM should be discarded after it is removed from the vehicle. It will not be used again.
30. Remove the CPDM from the vehicle. See [Fig. 29](#).

- NOTE: The CPDM should be discarded after it is removed from the vehicle. It will not be used again.
42. Remove the CPDM from the vehicle. See [Fig. 29](#).

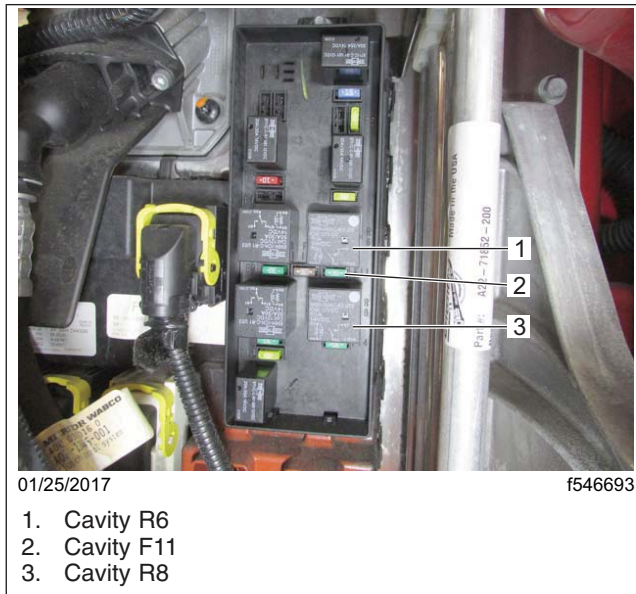
**Fig. 33, Relays and Fuses on the SAM Chassis  
(FL721-B installation shown)**

46. Install relay 23-11276-020 (vendor p/n 896-1AH-C-R1-U03-12VDC) into cavity R8, and verify there is a 30 amp fuse in cavity F14 on the SAM Chassis. See **Fig. 33**
