Entune Audio Head Unit Software Update (Panasonic)

Service Category Audio/Visual/Telematics

Section Navigation/Multi Info Display

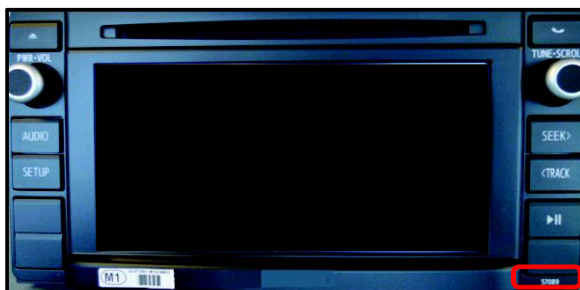
1. Confirm the audio system type by checking the Panel ID printed on the bottom-right or bottom-center of the machine.

Figure 1. Avalon, Avalon HV, Highlander, Highlander HV, Prius, Prius V, Sienna, Sequoia, Tacoma & Tundra

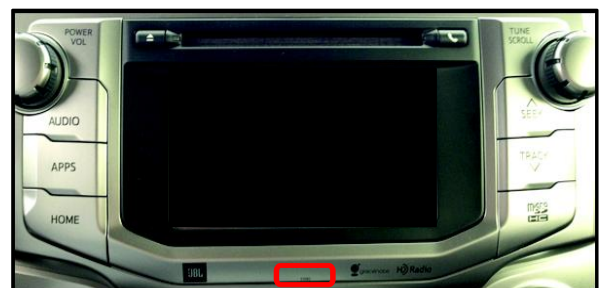
Figure 2. 4Runner

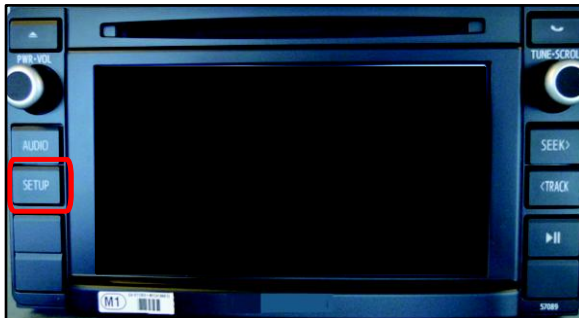
A. For Entune™ Audio: Press the SETUP button on the panel.

Figure 3. Tacoma, Prius, Prius V

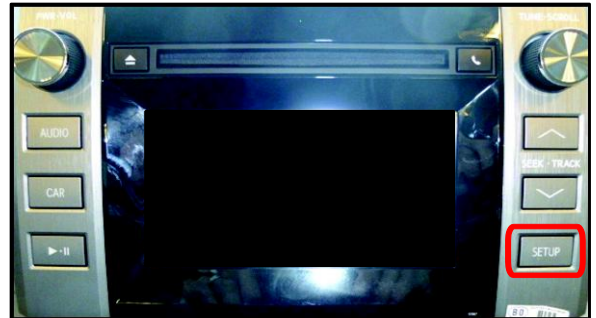
Figure 4. Tundra

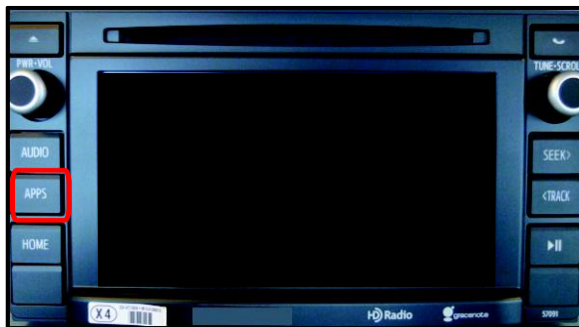
B. For Entune™ Audio Plus/Entune™ Premium Audio: Press the APPS button on the panel.

Figure 5. 4Runner, Avalon, Avalon HV, Highlander, Highlander HV, Prius, Prius V, Sienna, Sequoia, Tacoma & Tundra

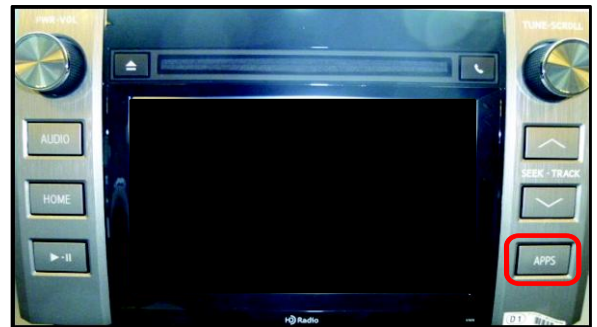
Figure 6. Tundra

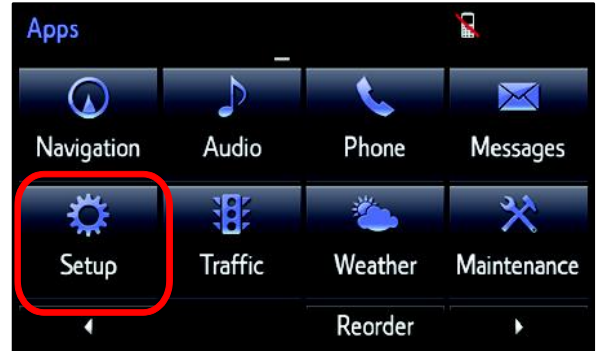
Figure 8.

Select *Setup* on the Apps screen.

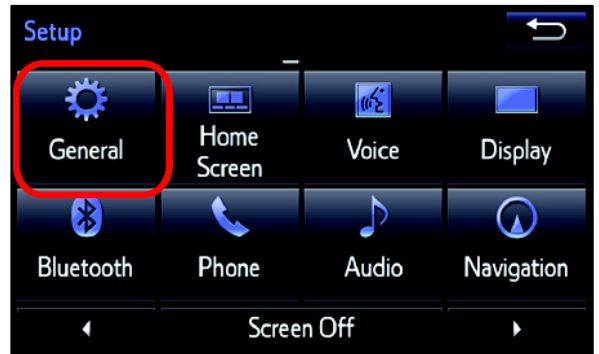
Figure 9.

5. Select *General* on the Setup screen.

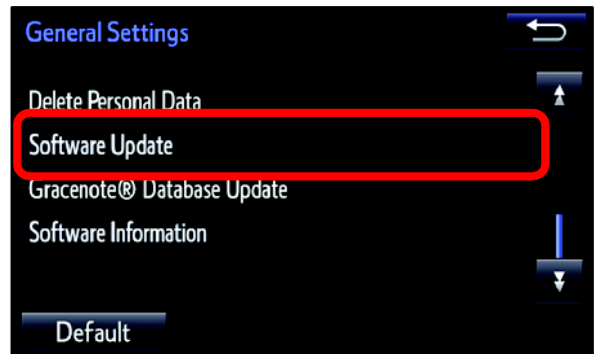
Figure 10.

6. Select *Software Update* from the list on the General Settings screen.

Scroll down the list until *Software Update* is displayed.

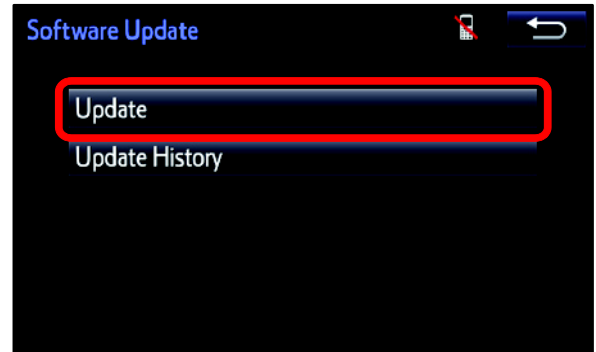
Figure 11.

7. Select *Update* on the Software Update screen.

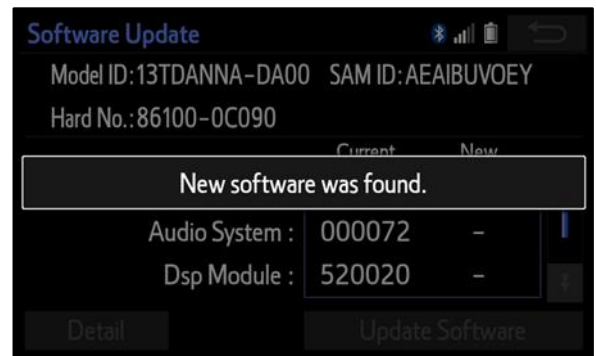
Figure 12.

If software has been detected properly, a "New software was found." pop-up will be displayed.

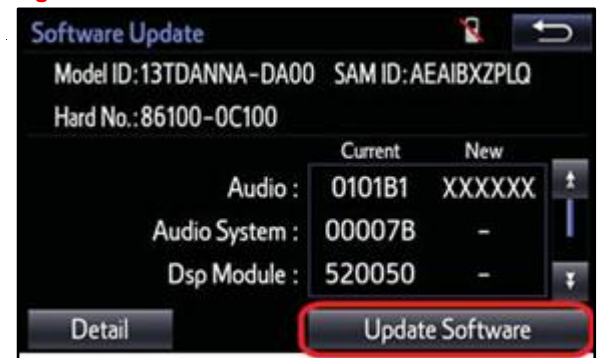
Figure 13.

8. Verify that the NEW software is up-to-date on the Software Update screen.

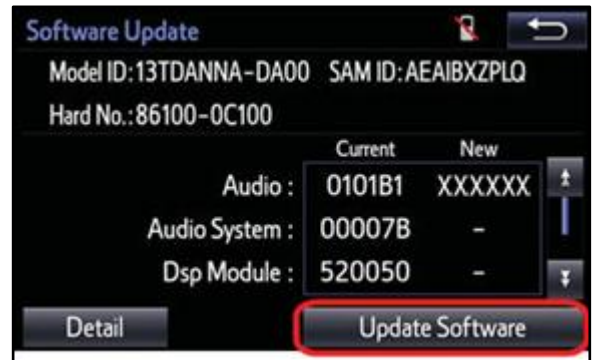
Figure 14.

9. Select *Update Software* on the Software Update screen.

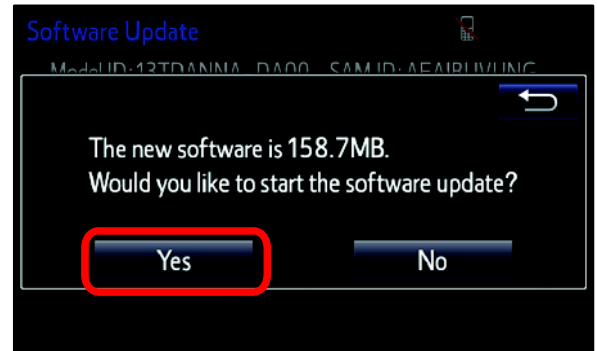
Figure 15.

10. Select *Yes* on the "Would you like to start the software update?" pop-up.

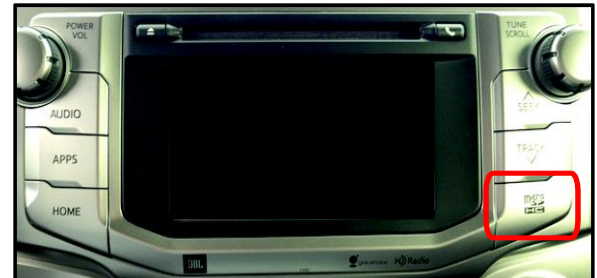
Figure 17.

If update fails and the error message “New software is not compatible with the system.” displays, cycle the ignition OFF, remove the Map Micro SD Card from the head unit, and repeat steps 3 – 11.

1	Map Micro SD Card
----------	--------------------------

Once update is complete, reinsert the Map Micro SD card into the head unit, cycle the ignition OFF, and proceed to step 12.

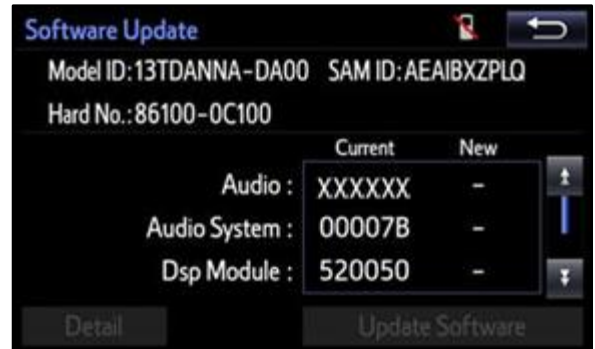
Figure 19.

1. Perform steps 3 – 6 of the Software Update procedure to re-enter the Software Update screen.
2. Verify that the software information is updated on the Software Update screen.
