ECM Calibration: Transmission Software Enhancements

Section Automatic Transmission/Transaxle

YEAR(S)	MODEL(S)	ADDITIONAL INFORMATION
2016	Land Cruiser

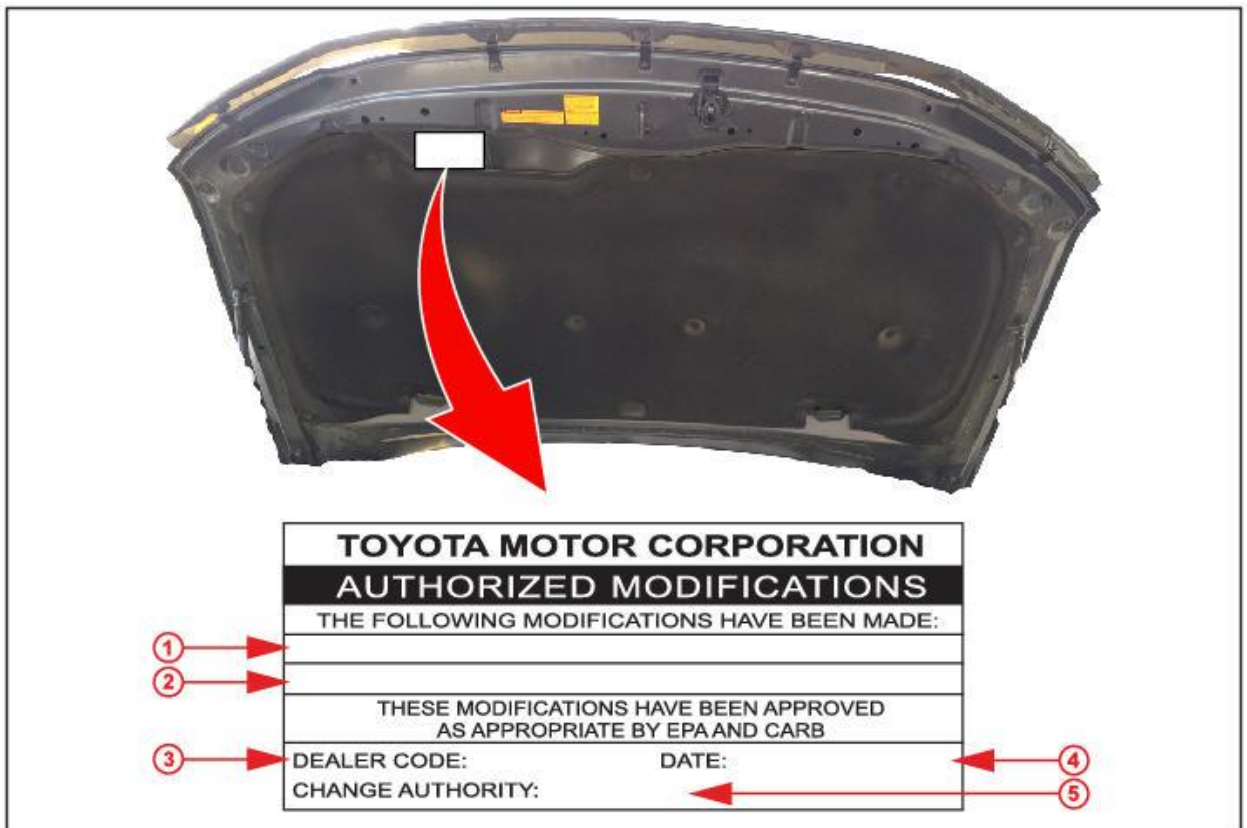
Figure 1. Location of Authorized Modification Label for 2016 Land Cruiser

1	Replacement ECM (PCM) Part Number (i.e., 89530-60512)
2	New Calibration ID (i.e., 895366011200)
3	Dealer Code

4	Date Completed
5	This SB Number

4. Install the Authorized Modifications Label.
 - A. Using a permanent marker, enter the following information on the label:
 - ECM part number [*Refer to the **Parts Information** section for the **NEW PART NUMBER***]
 - Calibration ID(s) [*Refer to the **Calibration Information** section for the **NEW CALIBRATION ID***]
 - Dealer Code
 - Repair Date
 - Change Authority [**This bulletin number**]
 - B. Affix the Authorized Modifications Label to the vehicle at the location shown in Figure 1. The Authorized Modifications Label is available through the MDC, P/N 00451-00001-LBL.
5. Perform transmission initialization.
