TECHNICAL INSTRUCTIONS

LIMITED SERVICE CAMPAIGN E03

U760 ATM ECM SOFTWARE UPDATE

CERTAIN 2012-2014 MY CAMRY

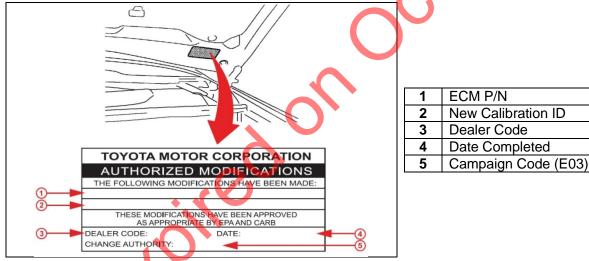
C. ATTACH THE AUTHORIZED VEHICLE MODIFICATION LABEL

- a) Fill out the label.
- b) Affix the label to the under-side of the hood.
