SI B11 17 16  
Engine

## VOLUNTARY EMISSIONS RECALL CAMPAIGN 16E-A05 - N26 ENGINE: REPLACE TURBOCHARGER OIL SUPPLY LINE

F30 (328i Sedan and 328i xDrive Sedan)

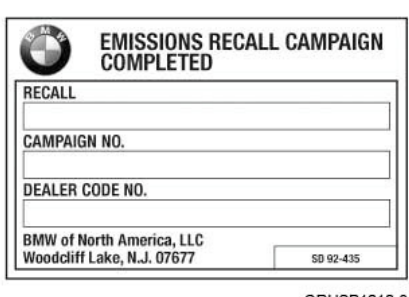
<p><b>EMISSIONS RECALL CAMPAIGN COMPLETED</b></p> <p>RECALL CAMPAIGN NO. DEALER CODE NO.</p> <p>BMW of North America, LLC Woodcliff Lake, N.J. 07677</p> <p>SD 92-435</p> <p>GRUSB1212-01</p>	<p>After the vehicle has been checked and corrected, obtain a label (SD 92-435) and with the indelible marker provided, legibly print the Recall name, Recall number, and dealer code (5 digits) on the "Emissions Recall Campaign Completed Label" (see illustration). <b>Note:</b> Additional labels can be ordered online at BMW TIS.</p>
---	--

First check if a Recall Completion Label, SD 92-435 for this campaign is already attached to the underside of the hood on the right (passenger) rear close to the windshield.
