September 2017  
SF543A

## Subject: Stoneridge Light Bar Control Unit Software Update

**Models Affected:** Specific Freightliner Custom Chassis X-line motorhome and shuttle bus chassis equipped with Stoneridge light bar control units, manufactured April 20, 2015, through March 22, 2017.

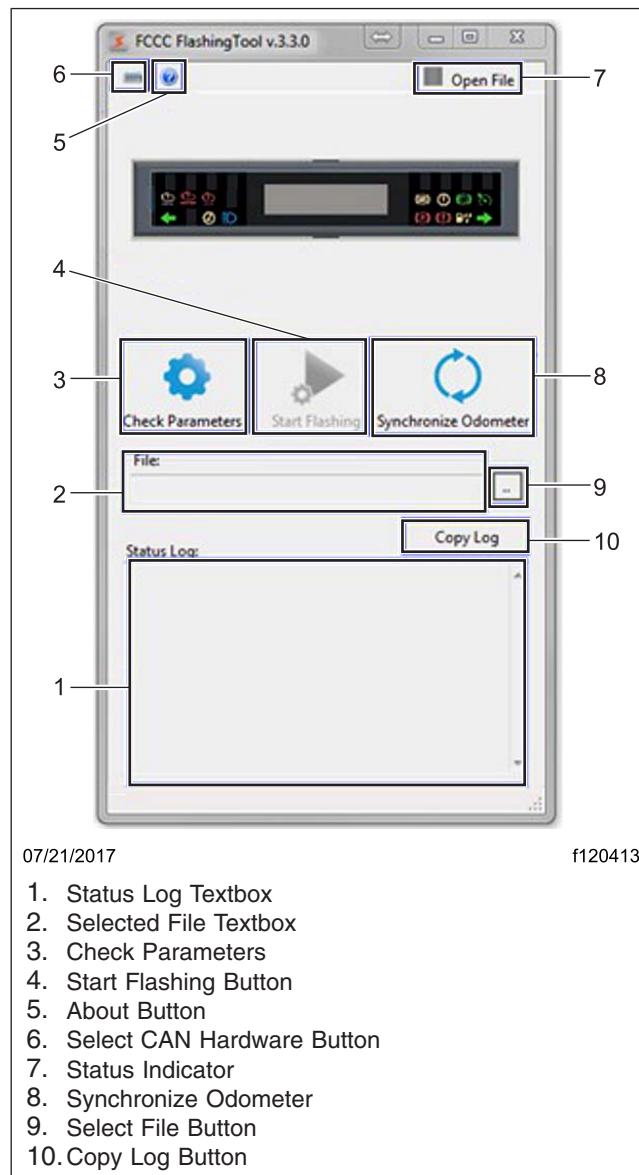
**Fig. 1, Reflash Tool, Main Screen**

3. Select the "Select CAN Hardware" button, shown in [Fig. 1](#), then select the "Check" button in the "Select Hardware Interface" window to display which hardware devices are available on the laptop.

17. Select the "Select CAN Hardware" button, shown in **Fig. 1**, then select the "Check" button in the "Select Hardware Interface" window to display which hardware devices are available on the laptop.

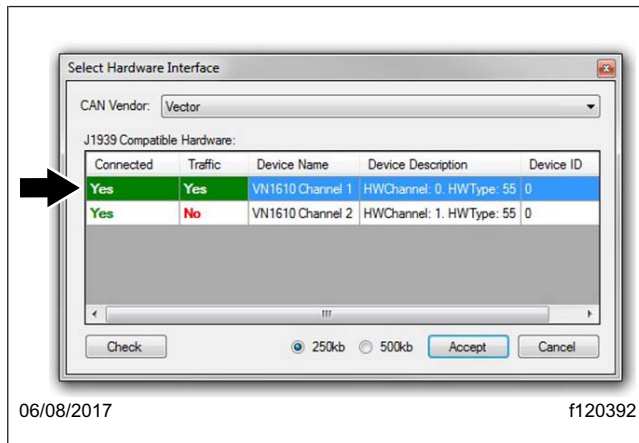
**Fig. 2, Select Hardware Interface Screen, Vector Hardware**

4. Select the "Check" button in the "Select Hardware Interface" window to determine which hardware devices are available on the laptop. **Fig. 2** shows Vector hardware options, and **Fig. 3** shows Nexiq USB Link options.

- If the device list is empty, it means that either the proper drivers are not installed, or there is no hardware interface physically connect to the laptop.
  - This setting can be changed at any time when the reflash process is idle.
5. Select the proper device, making certain the entire line is highlighted, then select the "Check" button. If "Yes" appears green in the "Traffic" column, CAN messages are detected and the speed rate, either 250kb or 500kb, was correctly selected.

If "Yes" appears red in the "Traffic" column, the speed rate must be changed. Select the other speed rate option, either 250kb or 500kb, then select the "Check" button.
  6. Once "Yes" appears green in both the "Connected" and "Traffic" columns, highlight that hardware option and select the "Accept" button. See [Fig. 2](#) and [Fig. 3](#).
  7. Select the "Check Parameters" button shown in [Fig. 4](#).

18. Select the "Check" button in the "Select Hardware Interface" window to determine which hardware devices are available on the laptop. **Fig. 2** shows Vector hardware options, and **Fig. 3** shows Nexiq USB Link options.
  - If the device list is empty, it means that either the proper drivers are not installed, or there is no hardware interface physically connect to the laptop.
  - This setting can be changed at any time when the reflash process is idle.

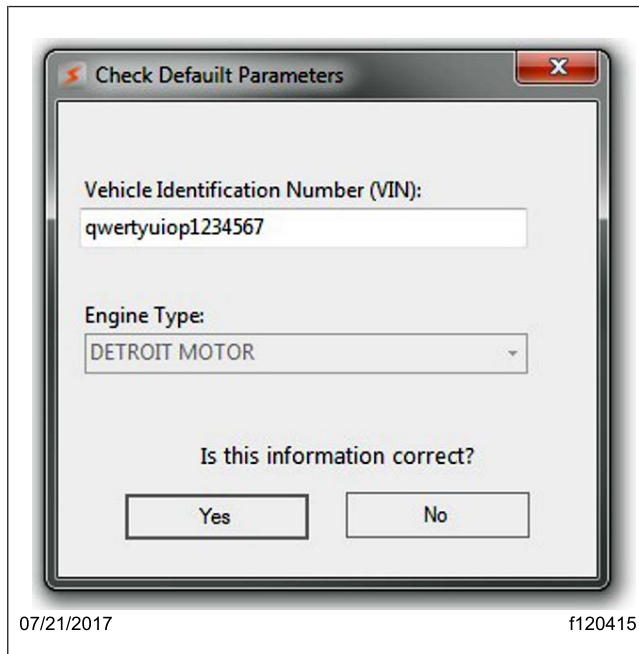
Fig. 5, Check Default Parameters Window

8. Once the process is complete, the parameter's values appear in the "Check Default Parameters" window. See [Fig. 5](#).

If the VIN and engine type parameters shown in the window are correct, select the "Yes" button.

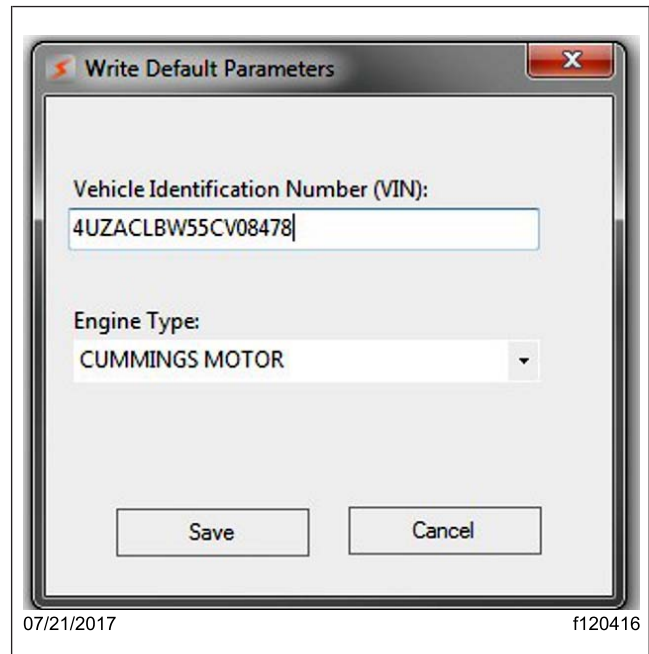
Fig. 6, Write Default Parameters Window

If the parameters are not correct, select the "No" button. The VIN and engine fields are now enabled for the user to enter the correct information. Once the correct information appears in the VIN and engine fields, select "Save." See [Fig. 6](#).

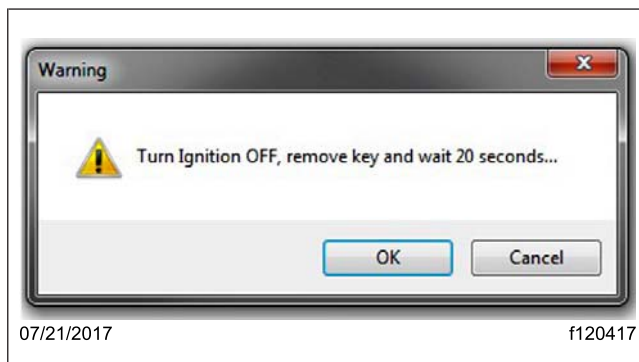
Fig. 7, Turn Ignition OFF Message

9. A warning message appears as shown in Fig. 7. Turn the ignition to the "OFF" position, remove the key and select "OK."
10. After 20 seconds, a window opens. See Fig. 8. Insert the key in the ignition and turn it to the "ON" position, then select "OK."

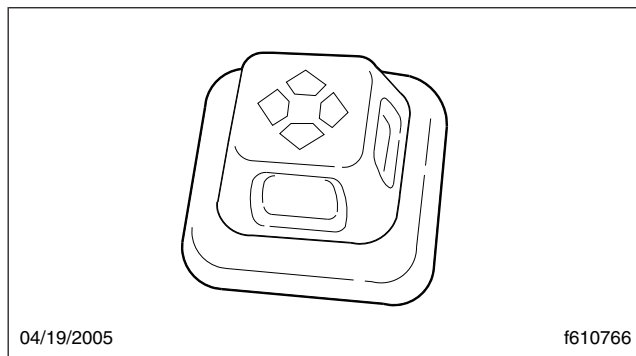
**Fig. 9, Toggle Switch**

13. Using the LBCU toggle switch, shown in **Fig. 9**, navigate through the menus as follows to the "Hardware/Software Version" screen.

- 13.1 Move the toggle switch to the left one time, then move the toggle switch to the right and hold for approximately five seconds. The setup/maintenance/diagnostic screen appears.

- 13.2 Scroll down to "Diagnostics" and move the toggle switch right one time.
- 13.3 Scroll down to "Hardware/Software Version" and move the toggle switch right one time.

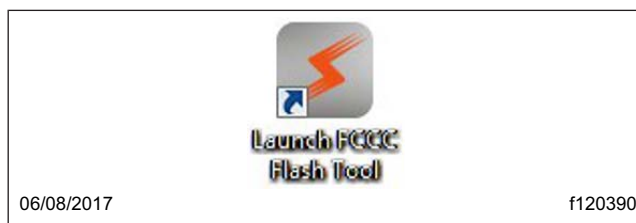
**Fig. 10, Flash Tool Icon**

15. Connect an RP1210B compliant vehicle diagnostic adaptor into the laptop and the vehicle diagnostic port.
16. From the laptop, go to the "Start" menu and select the flash tool or use the desktop shortcut if available. See **Fig. 10**.

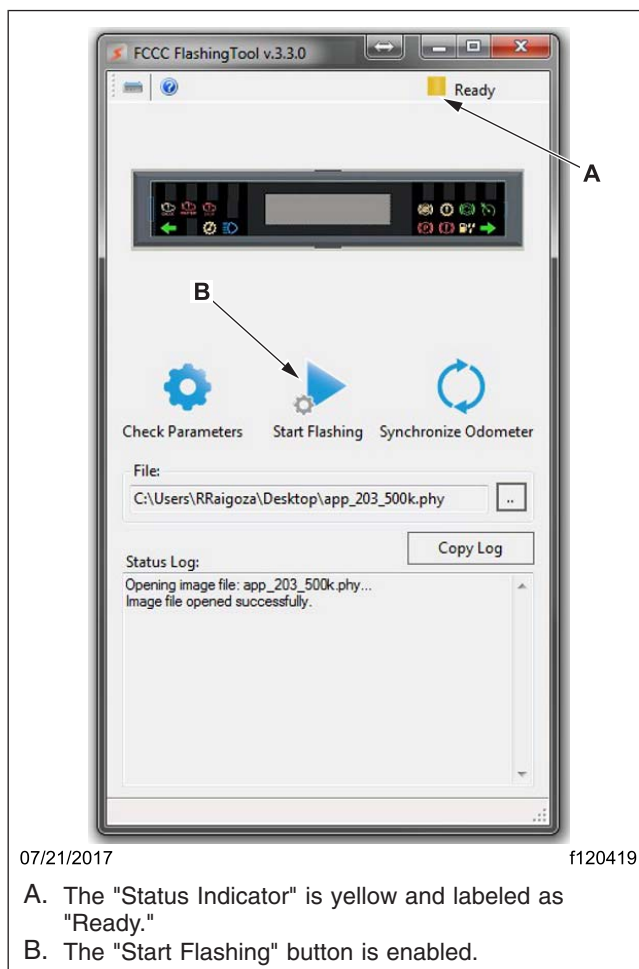
**Fig. 12, Select File Screen, Start Flashing Button is Enabled**

If "Yes" appears red in the "Traffic" column, the speed rate must be changed. Select the other speed rate option, either 250kb or 500kb, then select the "Check" button.
20. Once "Yes" appears green in both the "Connected" and "Traffic" columns, highlight that hardware option and select the "Accept" button. See **Fig. 2** and **Fig. 3**.
21. Using the "Select File" button, select the file to download (i.e. the \*.phy file). Once the file is selected, a warning message will appear as shown in **Fig. 11**. Select "OK." The status indicator at the top-right of the window will be yellow and labeled as "Ready," and the "Start Flashing" button will be enabled. See **Fig. 12**.

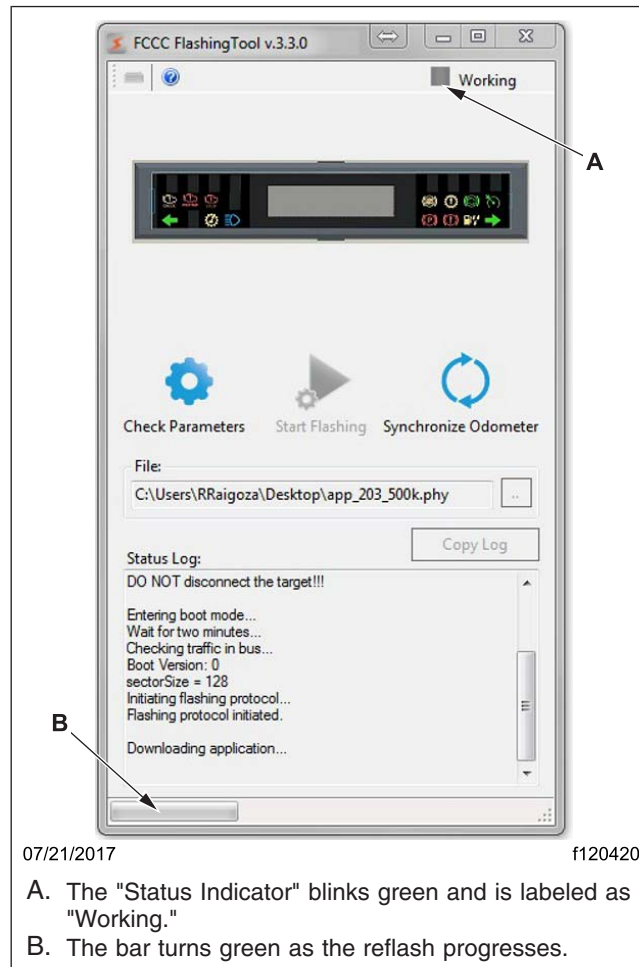
**Fig. 13, Reflash Tool is Working**

22. Select the "Start Flashing" button to begin the reflash process. The "Status Indicator" will blink green and be labeled as "Working" and the bar at the bottom of the screen will slowly turn green. See [Fig. 13](#). When the flash tool is working, the application buttons are disabled with the exception of the "About" button. The application can not be closed until the reflash process is finished.

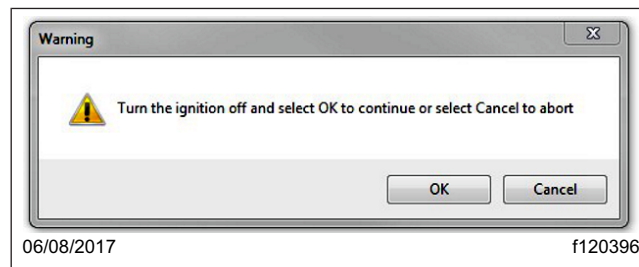
**Fig. 14, Warning Message, Turn Ignition Off**

23. A message will appear stating to turn the ignition off and ask for permission to continue. Turn the ignition to the "OFF" position, then select "OK." See [Fig. 14](#).

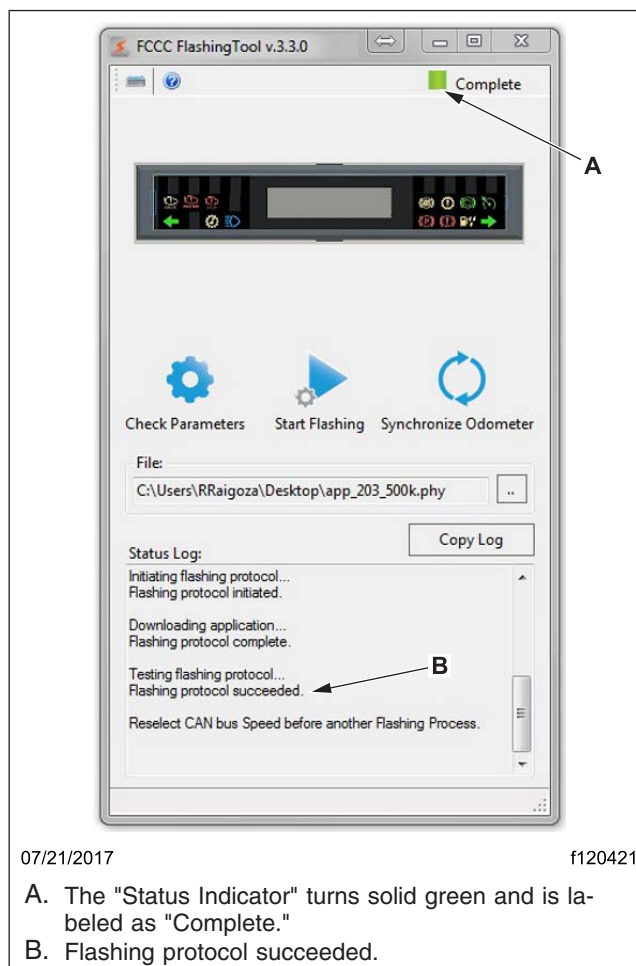
**Fig. 15, Process Complete Screen**

24. If there are not any CAN messages, the reflash process will start. The process of checking load in the CAN bus is made once the "Start Flashing" button is selected and the unit goes to boot mode.
25. Once the reflash is finished, the LBCU shuts down. The "Status Indicator" turns solid green and is labeled as "Complete." See [Fig. 15](#).

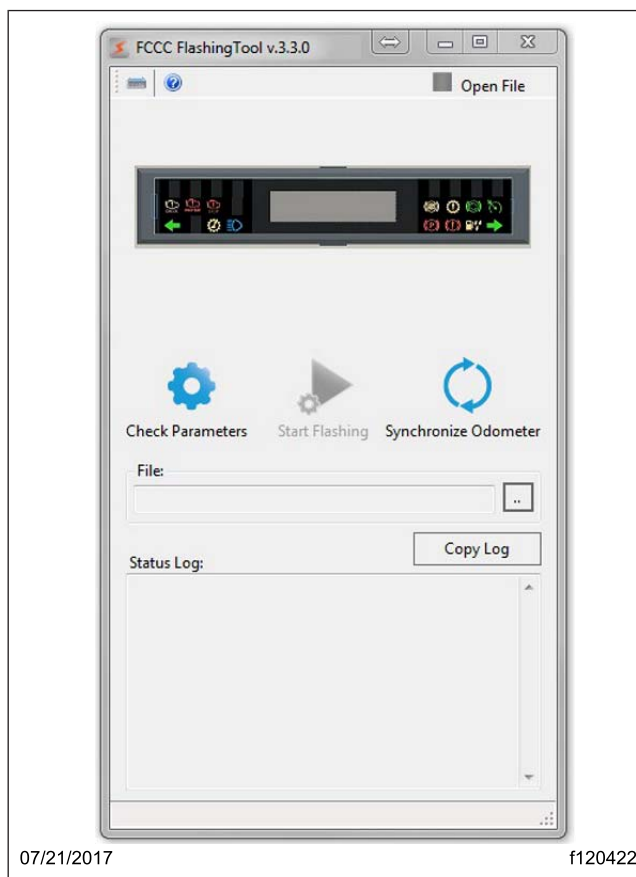
**Fig. 16, Selecting the Synchronize Button**

1. With the ignition switch in the ON position, select the CAN bus speed (if not already selected) and the proper hardware. Select the "Synchronize Odometer" button to start the process. See [Fig. 16](#).

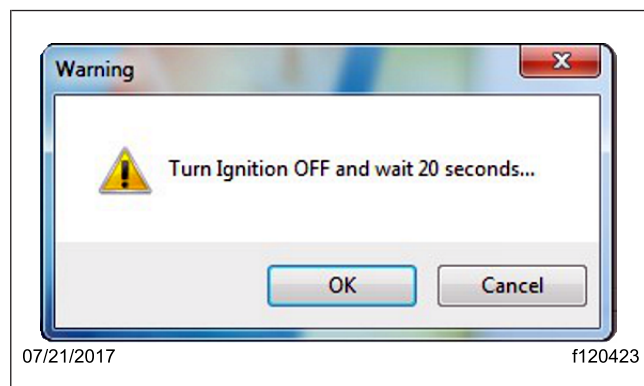
**Fig. 17, Turn Ignition OFF and Wait 20 Seconds**

2. When the LBCU receives the odometer information, an exclamation (!) symbol appears in the display screen. To save the odometer information, the ignition switch must be turned to the "OFF" position and remain there for 20 seconds after the exclamation (!) symbol appears in the display screen. See [Fig. 17](#) and [Fig. 18](#).

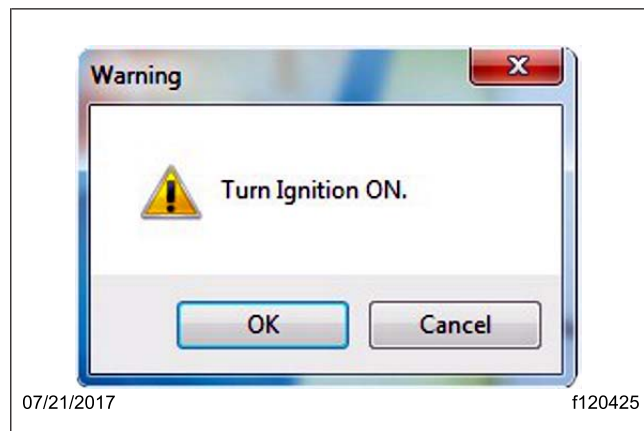
**Fig. 19, Turn Ignition ON Message**

3. After the 20 second time elapses, the tool will request that the ignition be placed in the "ON" position. See [Fig. 19](#).
4. With the ignition in the "ON" position, the LBCU displays the new odometer value and the exclamation (!) symbol no longer appears. See [Fig. 20](#).

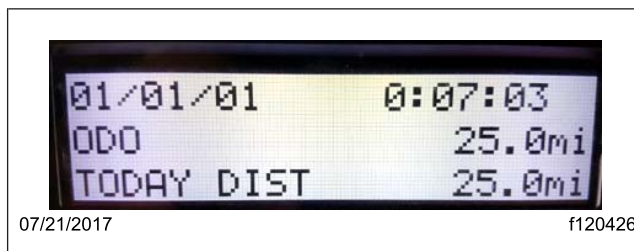
**Fig. 20, Odometer Screen**

NOTE: The odometer value will change only if the new value is greater than the previous value. Otherwise the odometer will display the current value.
