June 2017
FL714A
NHTSA #16V-418
Transport Canada #16-284
REVISED NOTICE

Subject: Takata Passenger Side Airbags

Models Affected: Specific model year 2008-2009 Sterling Bullet vehicles built with Takata (frontal) passenger side airbags manufactured October 15, 2007, through November 10, 2008.

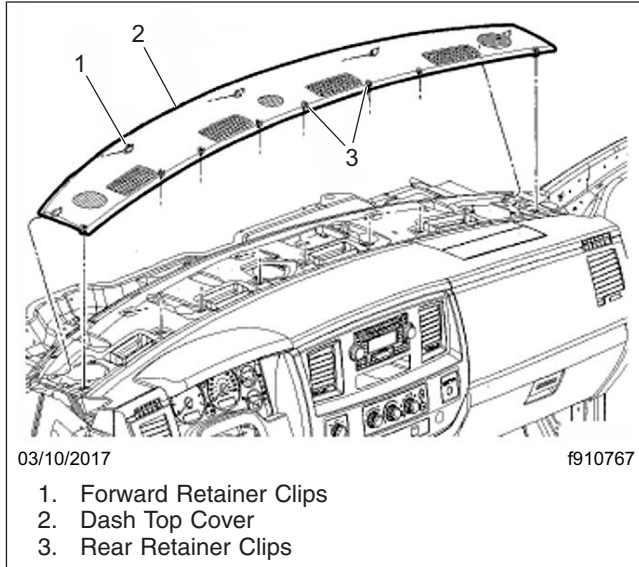
Fig. 1, Dash Top Cover Installation

3. Disable the SRS, as follows:
 - 3.1 Disconnect and isolate the negative battery cable.
 - 3.2 Wait two minutes for the system capacitor to discharge before further service.
4. Remove the dash top cover, as follows:
 - 4.1 Using a trim stick, pry the rearward side of the cover up to disengage the eight retainer clips. See [Fig. 1](#).
 - 4.2 Pull the cover rearward to release the five retainer clips that secure the forward side of the cover to the top of the dash. Remove the cover.
5. Remove the glove box, as follows:
 - 5.1 Open the glove box.
 - 5.2 Push in the sides of the glove box to release the stops and lower the glove box past the stops. See [Fig. 2](#).
 - 5.3 Disengage the globe box hinges from the dash. Remove the glove box.

- 23.3 Close the glove box.
24. Install the dash top cover, as follows:
 - 24.1 Position the cover in place and engage the five retainer clips that secure the front of the cover to the top of the dash. See [Fig. 1](#).

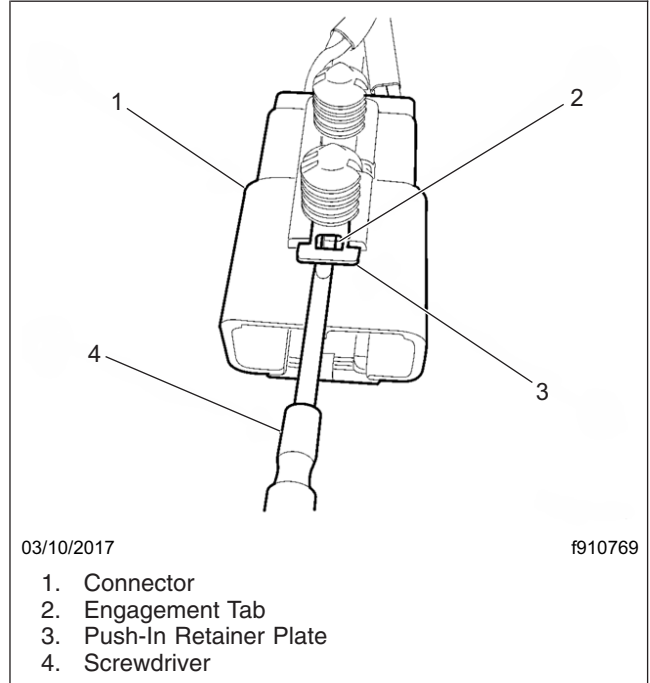
Fig. 4, Disengaging the Connector From the Push-In Retainer Plate

7. Remove the two screws that secure the airbag lower bracket to the support bracket.
8. Using a small screwdriver, carefully pry the leading edge of the push-in retainer plate from the airbag inflator pigtail wire connector enough to clear the engagement tab. then slide the connector and retainer plate apart. See [Fig. 4](#).

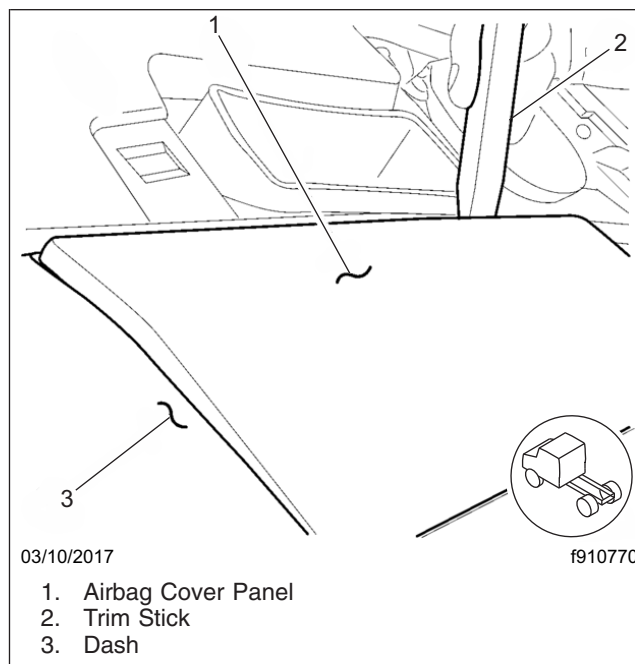
Fig. 5, Airbag Cover Panel

9. Using a trim stick or another suitable wide flat-bladed tool, pry the forward edge, then the outboard edge of the airbag cover panel from dash far enough to disengage the panel from the dash. See [Fig. 5](#). Remove the airbag and the airbag cover panel as a unit. See [Fig. 6](#).

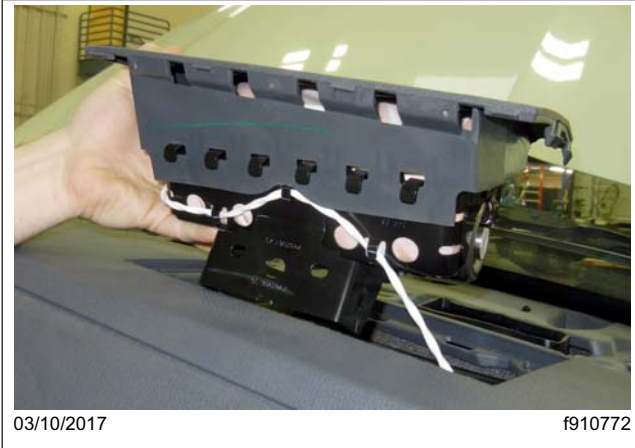
f910772

Fig. 6, Removing the Airbag

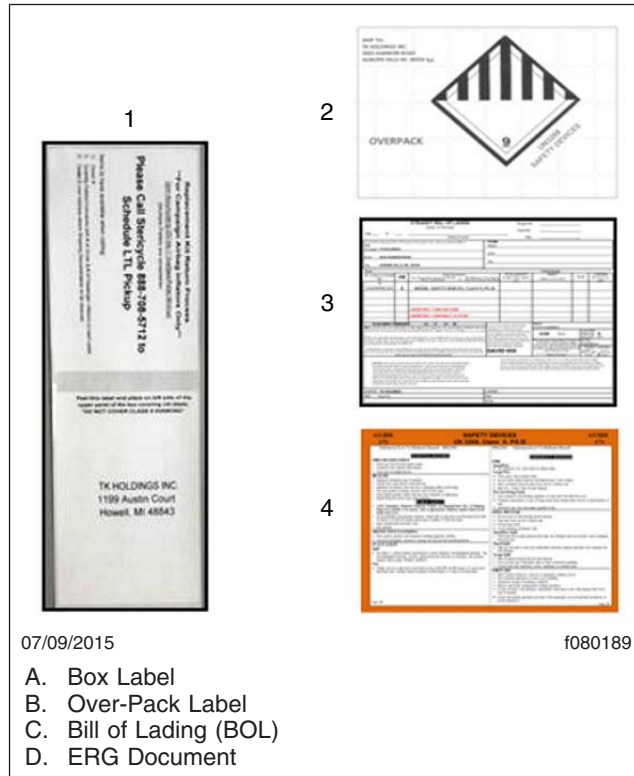
Fig. 10, Shipping Documents

Shipping documents (**Fig. 10**) needed are:

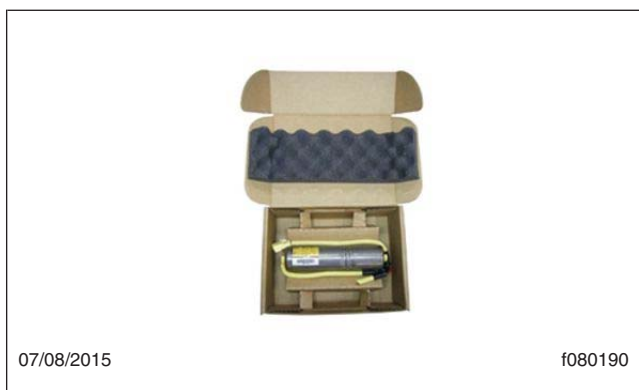
Fig. 11, Packing the Inflator

1. Package the un-deployed airbag inflator for return, using the replacement kit box.
 - 1.1 Confirm that the box is in acceptable condition. If a new box is needed, follow the procedure in "Requesting a New Box / Shipping Labels" at the end of these work instructions.
 - 1.2 Place the airbag inflator in the "cradle" of the box insert. See **Fig. 11**.
2. Close the box top flap, per box closure instructions located on the front panel of the box. See **Fig. 12**.

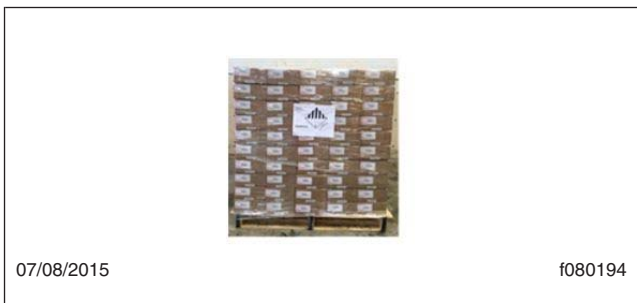
Fig. 15, Preparing the Pallet

5. **Larger Quantity Returns (10 or more airbag inflators)**—Pack airbag inflators on one or more pallets (**Fig. 15**), depending on the number of inflators to be returned. Shrink-wrap the pallet(s) and affix the over-pack label to one side of the pallet (not on top).

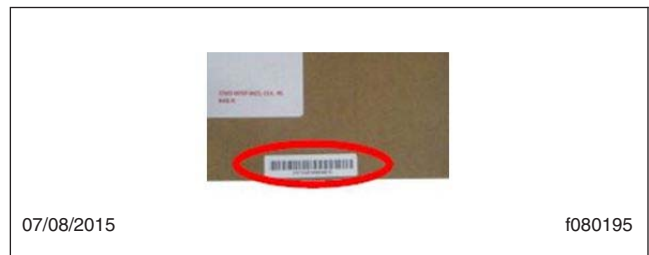
Fig. 16, Box Serial Number

- serial number on the original box (**Fig. 16**)
- type of shipping material needed
