Customer Satisfaction Campaign

Code: 91Q1

Subject	Modular Infotainment System Software Update
Release Date	September 06, 2017
Revision Summary	<ul style="list-style-type: none">• Canada added.• Software version updated.• Software download instructions in Appendix A updated.
Affected Vehicles	<p>U.S.A. & Canada : Certain 2017 MY Golf, GTI, Golf SportWagen and Golf Alltrack</p> <p><i>Check Campaigns/Actions screen in Elsa on the day of repair to verify that a VIN qualifies for repair under this action. Elsa is the <u>only</u> valid campaign inquiry & verification source.</i></p> <ul style="list-style-type: none">✓ Campaign status must show "open."✓ If Elsa shows other open action(s), inform your customer so that the work can also be completed at the same time the vehicle is in the workshop for this campaign.
Corrective Action	Install software to bring the infotainment system up to current production standards.
Parts Information	Software update only; no parts needed.

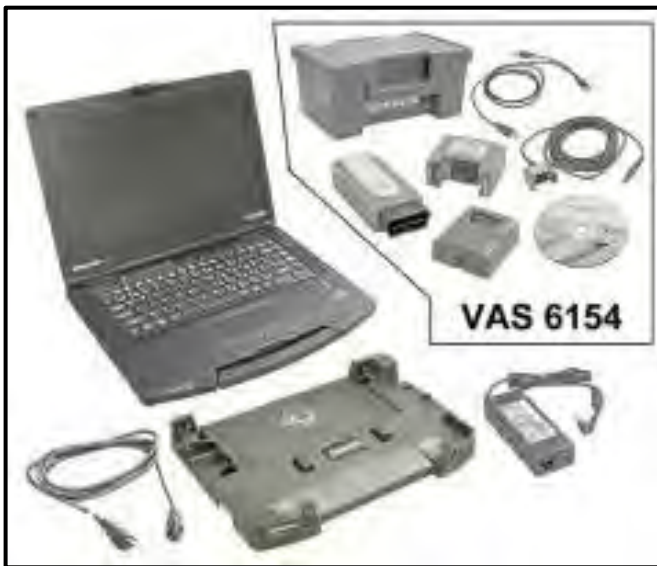
- VAS6150D - Diagnostic Tester (or equivalent)
- VAS6154 - Vehicle Communication Interface (or equivalent)

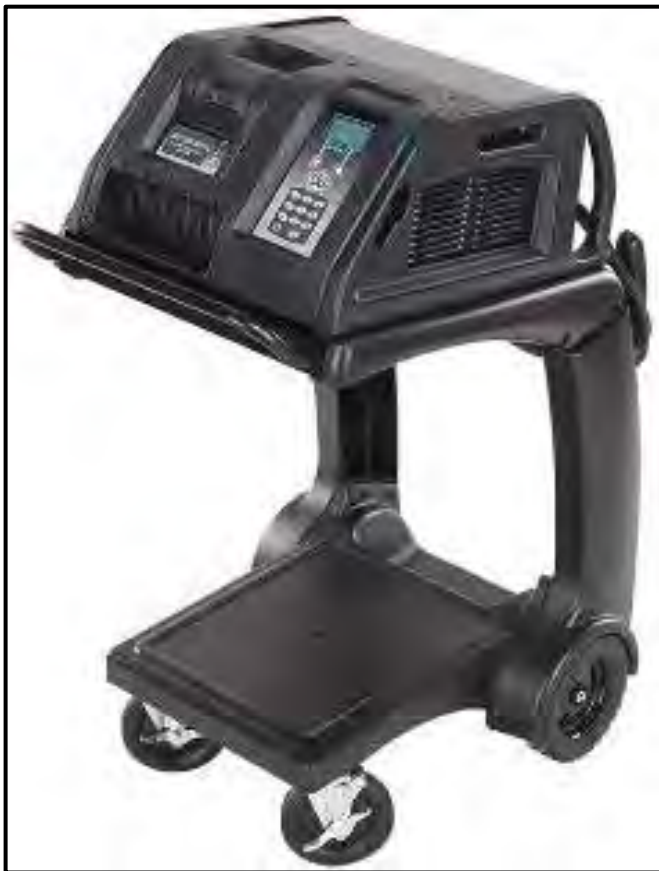
- GRX3000VAS – Battery Tester/Charger (or equivalent)

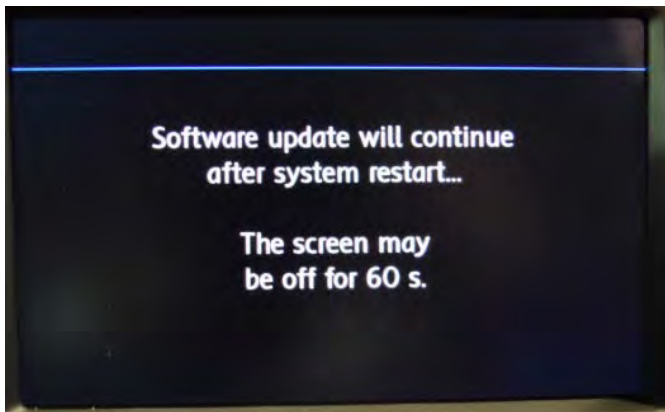
- This screen will be displayed during the software update.

The infotainment system may reboot several times during the update.

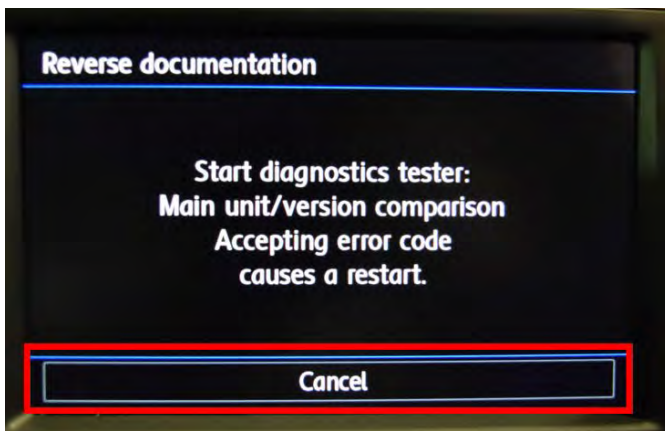
- This screen will be displayed during the software update.

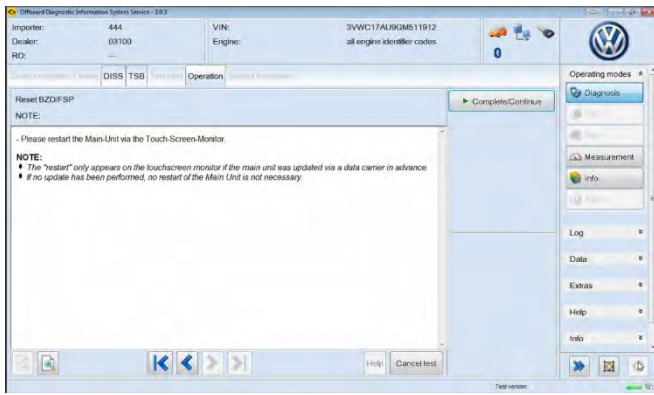
- Under the Special Functions tab, run the “005F-Design status check/reset DTC memory” test plan.

- When the test plan reaches the step to “restart the Main-Unit via the Touch-Screen-Monitor”, hold the radio’s power button down for 10 seconds to reboot the J794. Once the radio turns back on, select Complete/Continue.
- Once the test plan ends, the B201A fault should clear.
- Exit the scan tool.
- Send the Diagnostic log online to GFF Paperless.
- Remove the battery charger.
- Close the battery cover.
