February 2017  
FL721A-E  
NHTSA #16V-656  
Transport Canada #16-441  
FIFTH REVISED NOTICE

## Subject: CNG Fuel Tank and CPDM Mounting Location

**Models Affected:** Specific Freightliner Cascadia vehicles manufactured September 24, 2012, through May 27, 2015, built with CNG fuel tanks

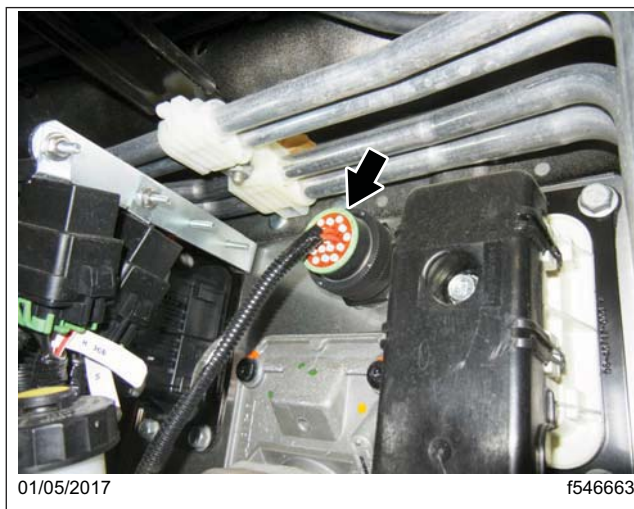
1. Shut off the gas valve and disconnect the batteries.
2. Remove the driver-side kick panel, the center lower dash cover, and the instrumentation control unit (ICU).
3. Raise the hood and disconnect the bulkhead connector 1A. See [Fig. 1](#). Remove the nut that secures the dash side 1A bulkhead connector to the front wall.

**Fig. 1, Bulkhead Connector**

1. Shut off the gas valve and disconnect the batteries.
2. Remove the driver-side kick panel, the center lower dash cover, and the instrumentation control unit (ICU).
3. Raise the hood and disconnect the bulkhead connector 1A. See [Fig. 1](#). Remove the nut that secures the dash side 1A bulkhead connector to the front wall.

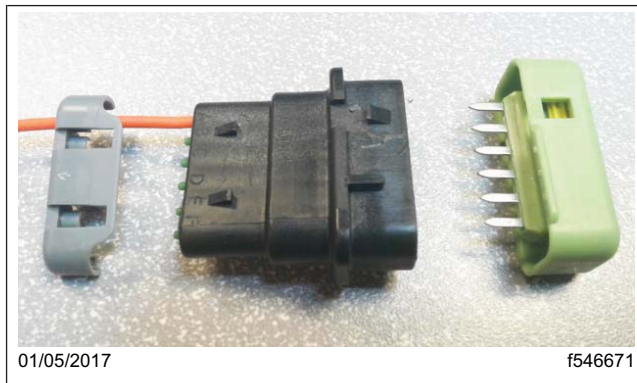
17. Remove the green cover and the grey terminal lock from the ABS ignition PLC filtered splice pack on harness A06-93209-000. See [Fig. 11](#).
18. Insert the terminal end of the single wire harness A06-93668-000 into any available cavity in the splice pack as shown. See [Fig. 12](#). Install the terminal lock and cover.

**Fig. 11, Splice Pack Cover and Lock (removed)**

28. Plug the 4-wire connector on harness A06-93208-000 into slot x55 on the SAM Chassis. See [Fig. 10](#).
  29. Remove the green cover and grey terminal lock from the ABS ignition PLC filtered splice pack on harness A06-93209-004. See [Fig. 11](#).

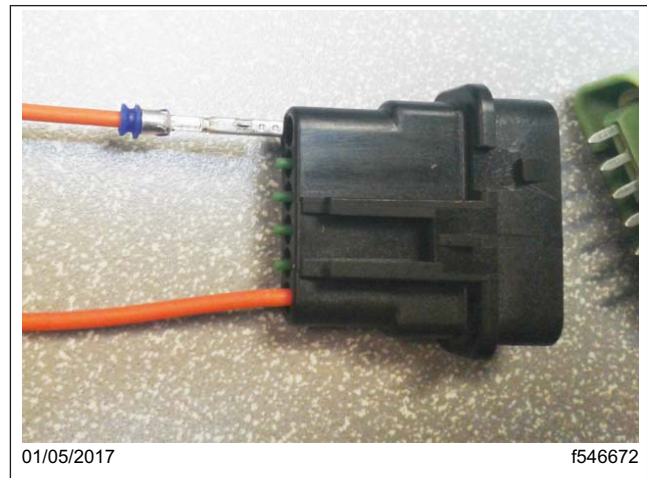
**Fig. 12, Splice Pack Terminal Insertion**

30. Insert the terminal end of the single wire harness A06-93668-000 into any available cavity in the splice pack as shown. See [Fig. 12](#). Install the terminal lock and cover.

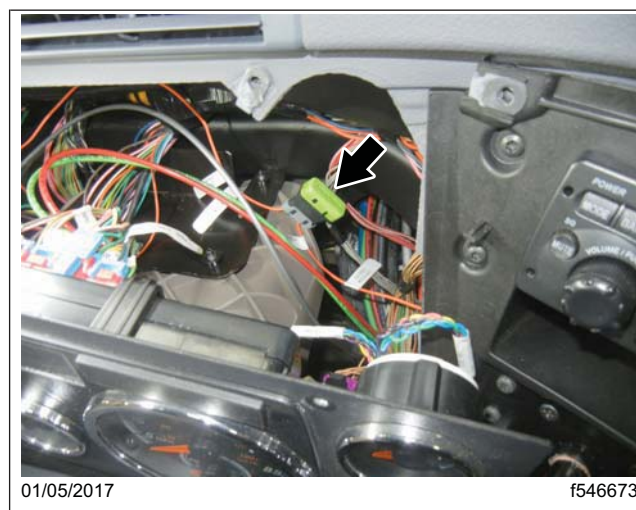
19. Route the splice pack behind the ICU near the radio. See [Fig. 13](#)

**Fig. 13, Splice Pack Routing**

31. Route the splice pack behind the ICU, near the radio. See [Fig. 13](#).
  32. Route wire behind the dash down to the ABS module. See [Fig. 18](#).

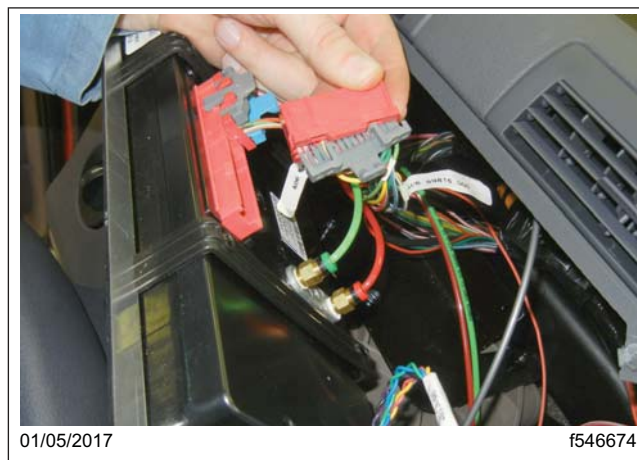
20. Disconnect the 2A connector from the back of the ICU, then remove the terminal locks. See [Fig. 14](#).

**Fig. 14, ICU 2A connector Terminal Locks**

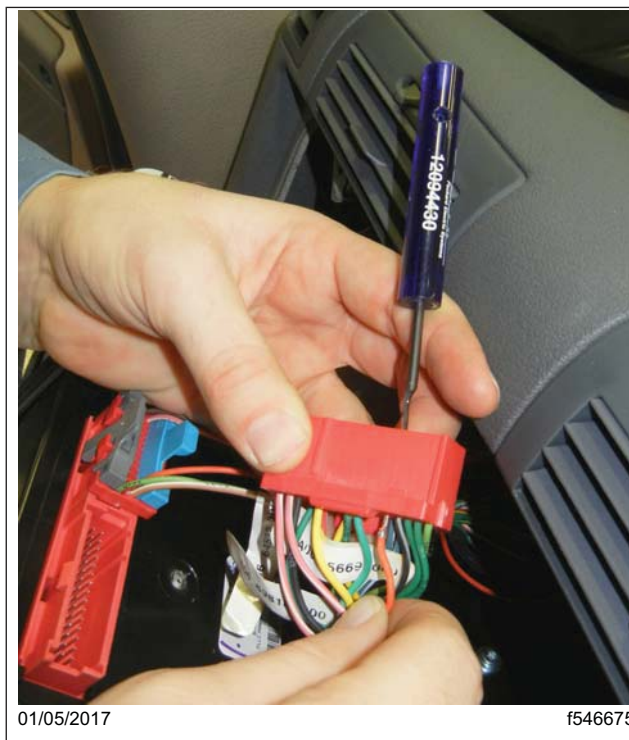
21. Remove the existing wire from cavity D12 of ICU connector 2A. See [Fig. 15](#).

**Fig. 15, Wire Removal from Cavity D12 of ICU  
Connector 2A**

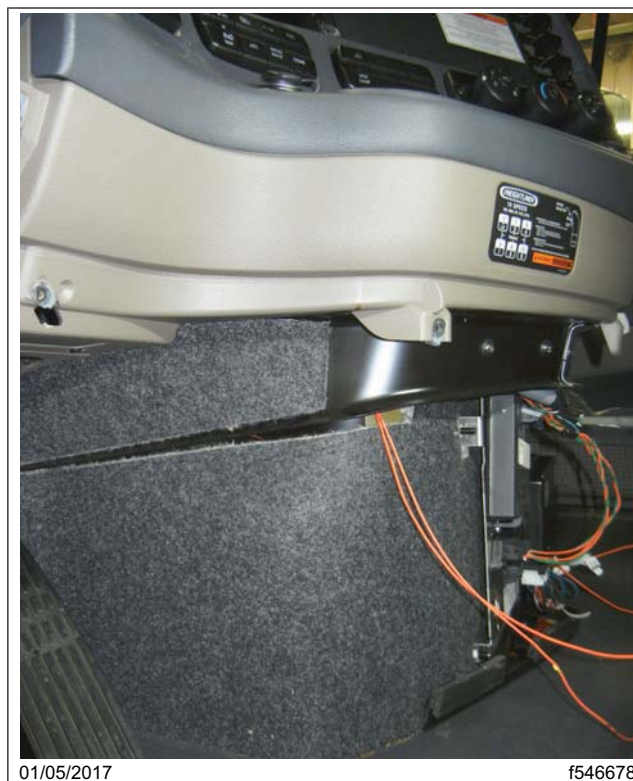
23. Label the wire with tape with the description "Removed for FL721."
24. Insert the metri-pac 100 terminal end from single wire harness A06-82360-000 into ICU connector 2A, cavity D12. See [Fig. 17](#).
25. Install the terminal lock and plug connector 2A into the ICU.
26. Route wires A06-93668-000 and A06-82360-000 behind the dash and down to the ABS module. See [Fig. 18](#).

**Fig. 18, Routing the Wires to the ABS Module  
(FL721-A installation shown)**

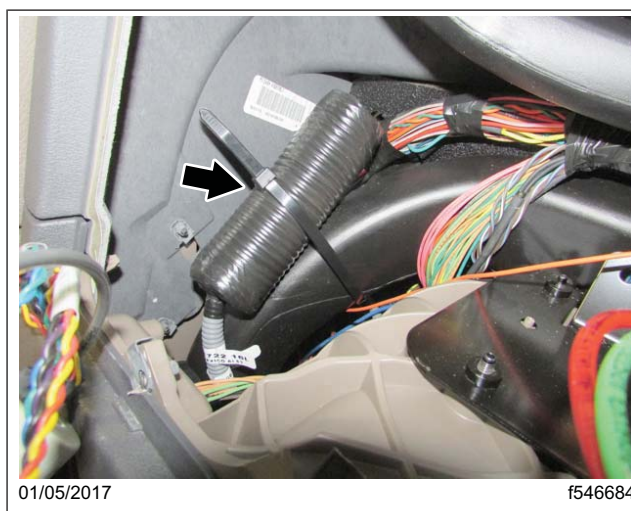
29. Fold the removed wires back against themselves, and cover the exposed terminal ends with heat shrink tubing.
30. Label the wire with tape with the description "Removed for FL721."
31. Insert the free ends of single-wire harnesses A06-93668-000 and A06-82360-000 into ABS module connector X1A. Connect A06-93668-000 into cavity 7, and A06-82360-000 into cavity 2. See [Fig. 23](#).
32. Install the terminal lock in connector X1A and plug the connector back into the ABS module.
33. Use cable ties to secure the bundle to the HVAC ducting behind the ICU. See [Fig. 24](#).

**Fig. 24, PLC Bundle Mounting**

26. Install the terminal lock in connector X1A and plug the connector back into the ABS module.
27. Use cable ties to secure the bundle to the HVAC ducting behind the ICU. See [Fig. 24](#).
28. Find the CPDM harness connector inside the frame rail a few feet forward of the CPDM. See [Fig. 25](#). Disconnect and cap it with part number 23-13153-011. Plug each cavity with a cavity plug (23-13218-300). See [Fig. 26](#) and [Fig. 27](#).

38. Install the terminal lock in connector X1A and plug connector back into the ABS module.
  39. Use cable ties to secure the bundle to the HVAC ducting behind the ICU. See [Fig. 24](#).

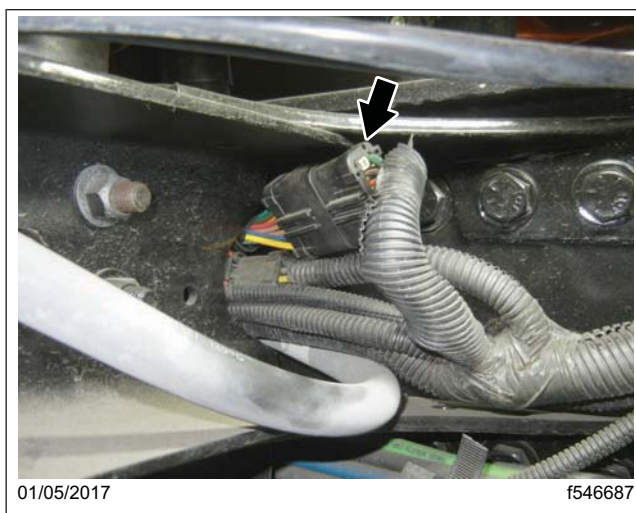
34. Find the CPDM harness connector inside the frame rail a few feet forward of the CPDM. See [Fig. 25](#). Disconnect and cap it with part number 23-13153-011. Plug each cavity with a cavity plug (23-13218-300). See [Fig. 26](#) and [Fig. 27](#).

**Fig. 25, CPDM Harness Connector**

40. Find the CPDM harness connector inside the frame rail a few feet forward of the CPDM. See [Fig. 25](#). Disconnect and cap it with part number 23-13153-011. Plug each cavity with a cavity plug (23-13218-300). See [Fig. 26](#) and [Fig. 27](#).

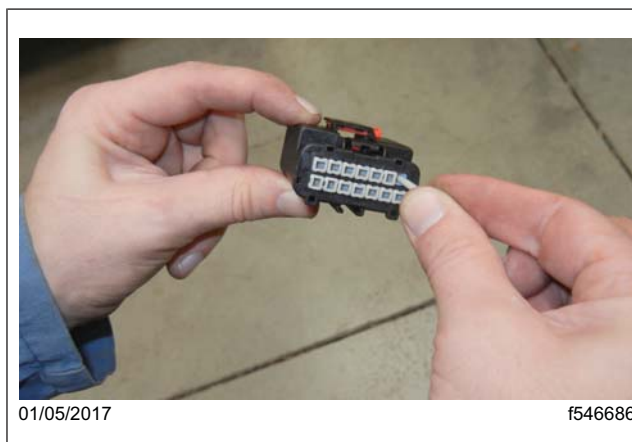
**Fig. 26, 23-13153-011 Populated with 23-13218-300 Plugs**

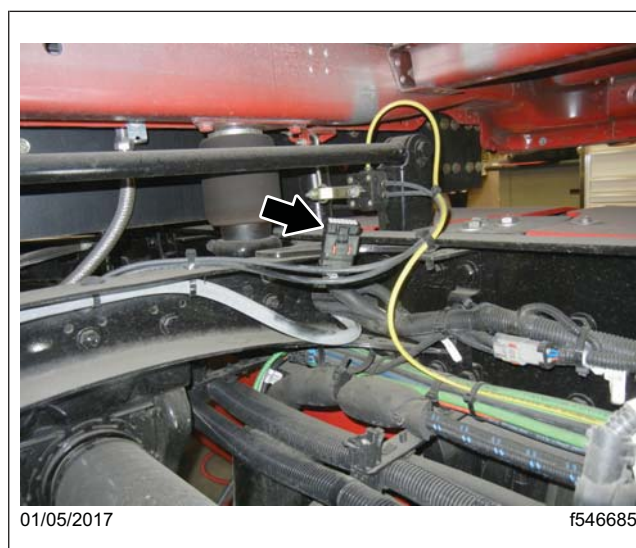
**Fig. 27, CPDM Harness Capped**

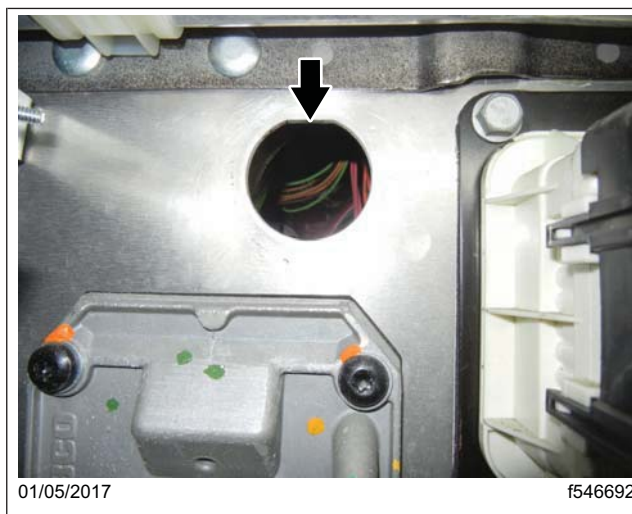
NOTE: The bulkhead connector is keyed with one flat side to be aligned with the D-shape in the frontwall hole.

40. Insert the cab side 1A bulkhead connector into the D-shaped hole and connect the engine side 1A bulkhead connector to it. See [Fig. 32](#).

**Fig. 32, Bulkhead Connector 1A Cavity on the Frontwall**
