# Vehicle does not start, battery discharged.

Topic number	LI54.10-P-066342
Version	4
Function group	54.10 Battery, power supply, voltage converter
Date	10-26-2017
Validity	MFA (BR117/ BR156/ BR176/ BR242/ BR246)
Reason for change	Remedy for Cause 1 available
Reason for block

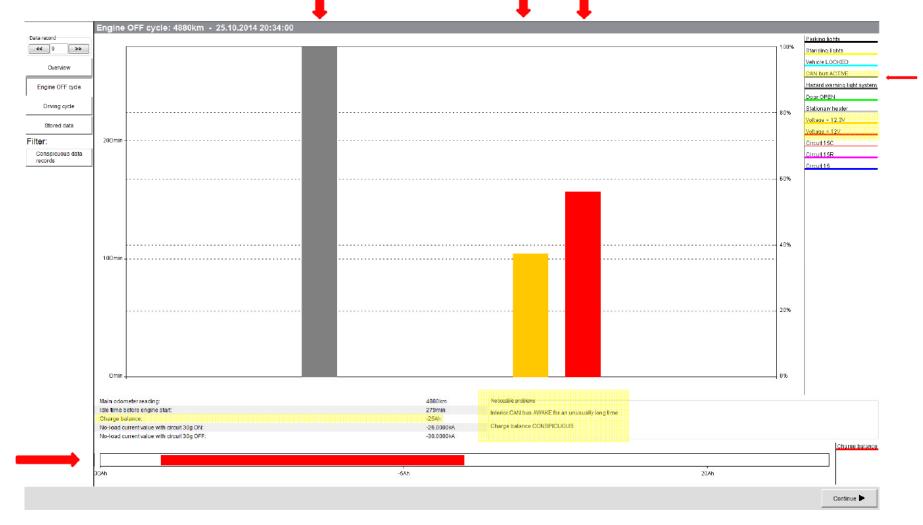
# BODY-CAN keeps awake – technical issue

To be able to assess whether a bus keepawake event caused the battery discharge, it is necessary to examine the stationary cycles. A constantly active CAN is identified by the text "Interior CAN awake unusually long" (see attachment). If this text is not displayed, the battery discharge has a different cause.
