Emissions Recall

Code: 23U4

Subject	2.0L TDI Engine (GEN 2 – Automatic Transmission) Emissions Modification – Customer Only (Retail Sold) <u>USA ONLY</u>
Release Date	June 26, 2017
Revision Summary	Updated work instructions.
Repair Applicability	The ONLY Vehicles eligible for repair under this action are: <ul style="list-style-type: none">• Customer owned automatic transmission vehicles only
Affected Vehicles	U.S.A. ONLY: 2012-2014 MY Volkswagen Passat 2.0L TDI (Automatic Transmission only) <i>Check Campaigns/Actions screen in Elsa on the day of repair to verify that a VIN qualifies for repair under this action. Elsa is the <u>only</u> valid campaign inquiry & verification source.</i> <ul style="list-style-type: none">✓ Campaign status must show “open.”✓ If Elsa shows other open action(s), inform your customer so that the work can also be completed at the same time the vehicle is in the workshop for this campaign.
Problem Description	The Environmental Protection Agency and California Air Resources Board have determined that Volkswagen vehicles equipped with a 2.0L 4-cylinder TDI engine do not comply with applicable emissions regulations. The emissions control systems on the vehic

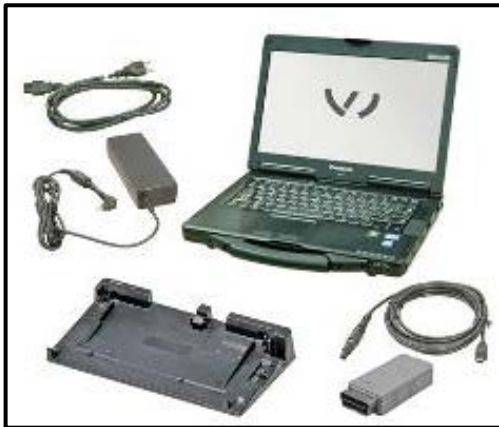
- VAS6150X – Diagnostic Tester (or equivalent)
- VAS5054X – Remote Diagnosis Head (or equivalent)

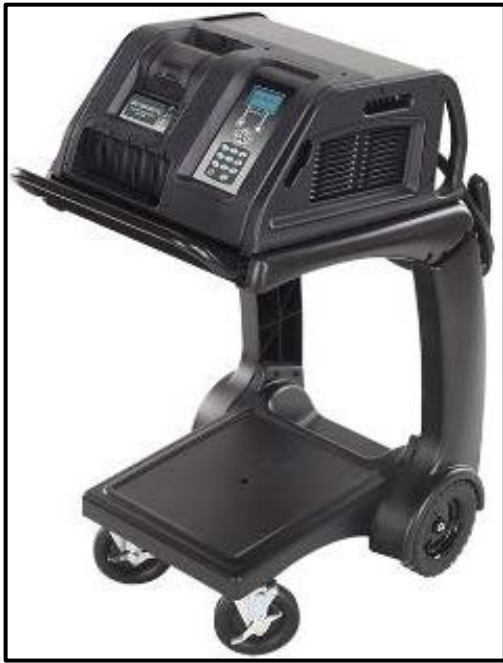
- GRX3000VAS – Battery Tester/Charger (or equivalent)

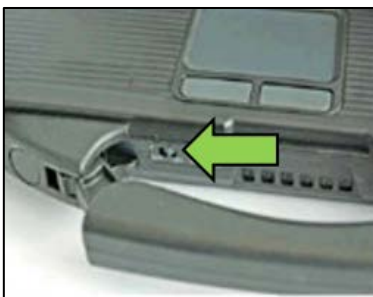
VAS 6150 & VAS 6150A
(Front panel behind handle)

- Performing a software update using a Bluetooth connection increases the risk of losing connection during the update, which could result in damage to the control module. It also greatly increases the time required to perform the update. Requests for additional time or parts will be denied if the GFF log shows the update was performed using Bluetooth.
- ✓ **The Bluetooth function of the scan tool is physically switched off <see pictures below>.**
