**MODEL:** Karma Revero

**TITLE:** Baseline BL1021 Release

**PURPOSE:** This document will be used as a reference guide for technicians to update a vehicle to Baseline 1021

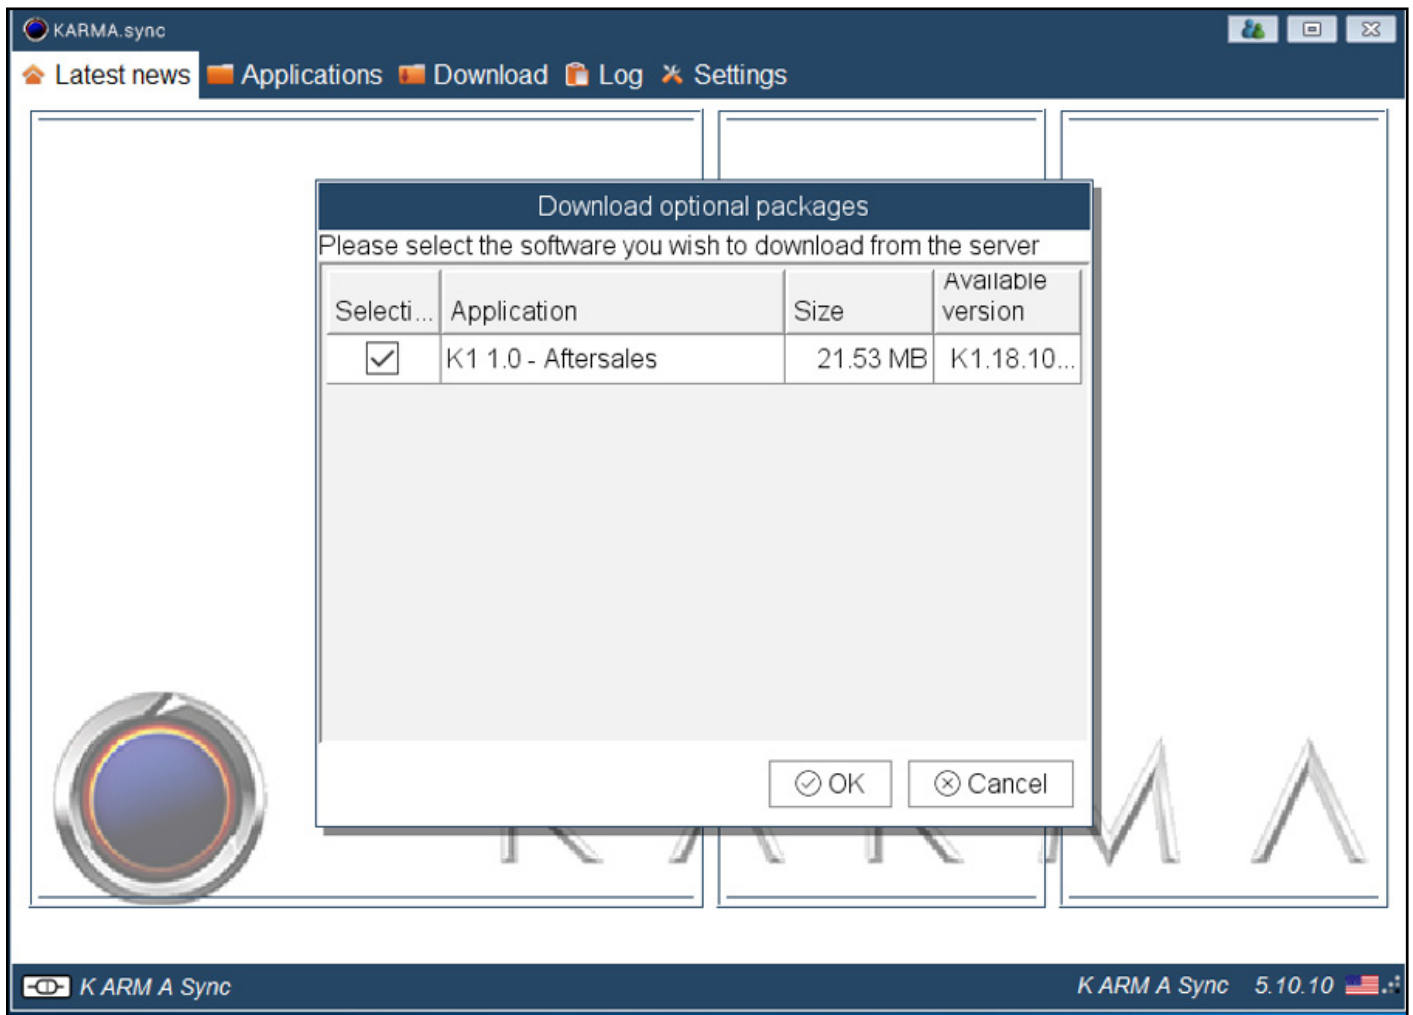
fig.1

1. Launch the Karma Sync application or close and relaunch if already open
2. Upon launch of the scan tool you may be prompted to enter user credentials
3. When a software update is available an update dialog box should appear with the new software package (fig.1).

4. Click "Ok" to install. (fig. 1)

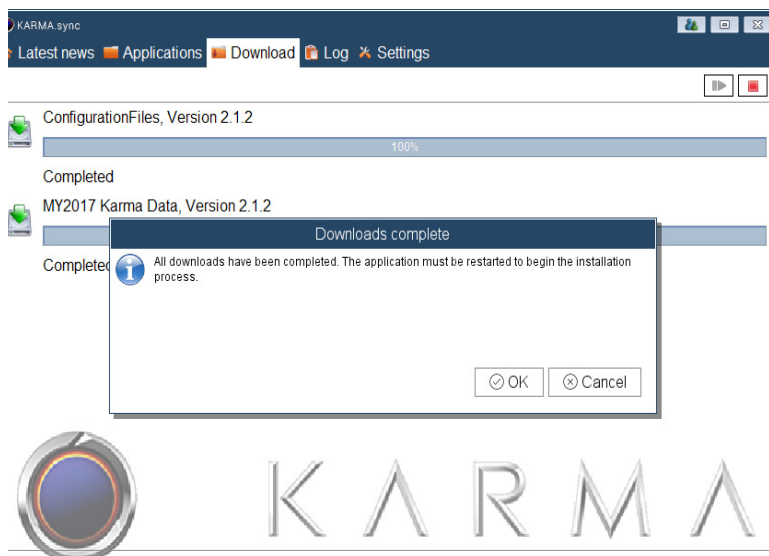
fig.2b

5. When download is complete, follow the on screen prompt, to allow the Software to update on the next restart (fig.2b). Doing this restart is a complete closing of Karma SYNC and relaunching as the to restart the program.

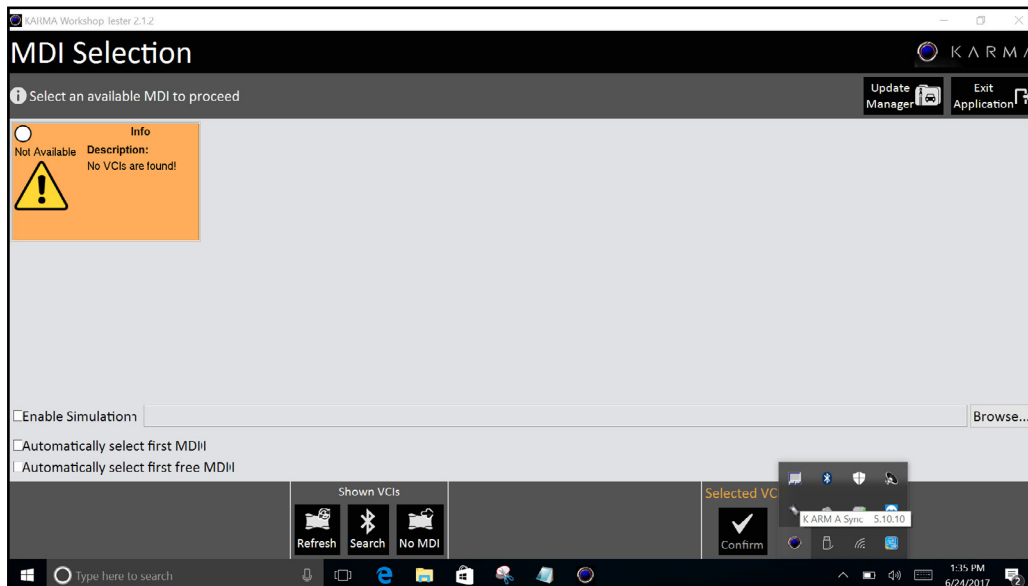
fig.3a

**If the dialog box does not open automatically** to download the new software proceed to add software as shown The tool bar will have a Karma Sync icon, hover over it (fig. 3a), right-click, proceed to “add software” as in (fig. 3b). Once complete proceed with the remainder of this bulletin.

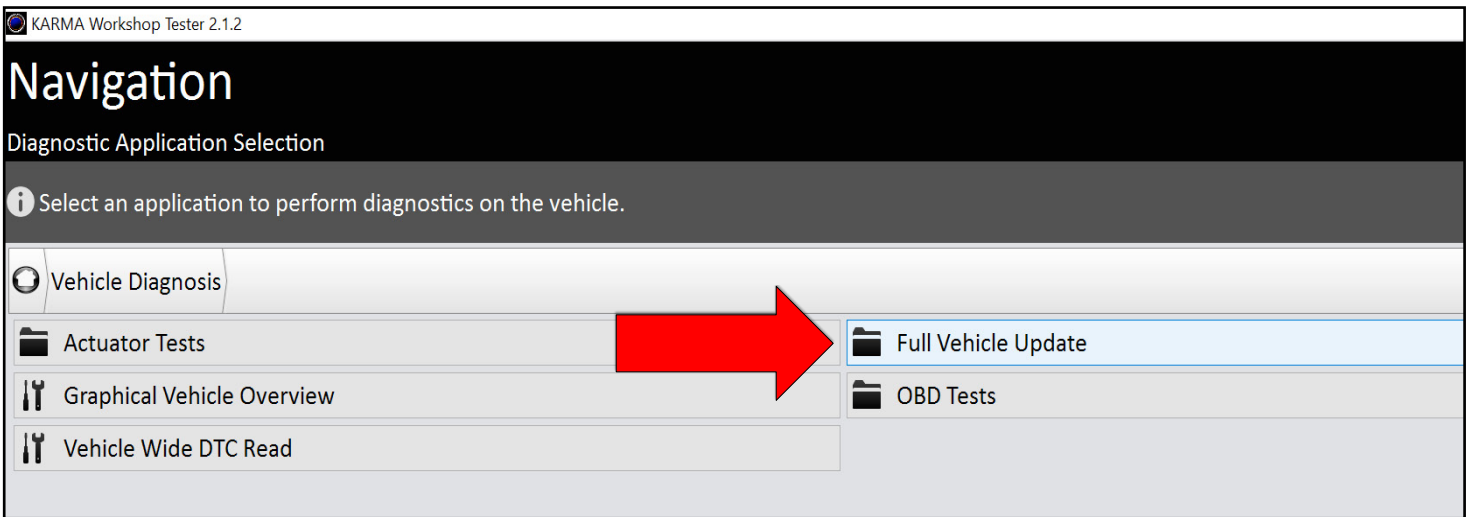
fig.6a

- Place vehicle in Ready Mode
- 1. Enter the Vehicle Diagnosis menu (fig.6a)

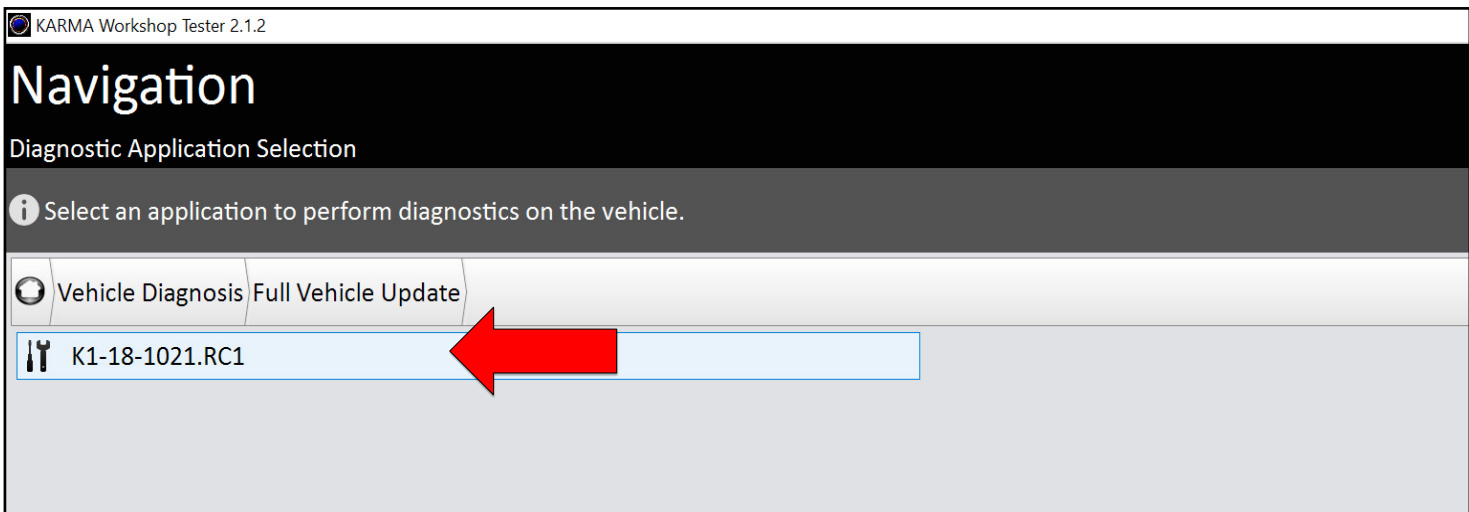
fig.6b

- 2. Proceed to Full Vehicle Update
- Click on "K1-18-1021.RC1" (fig. 6b)

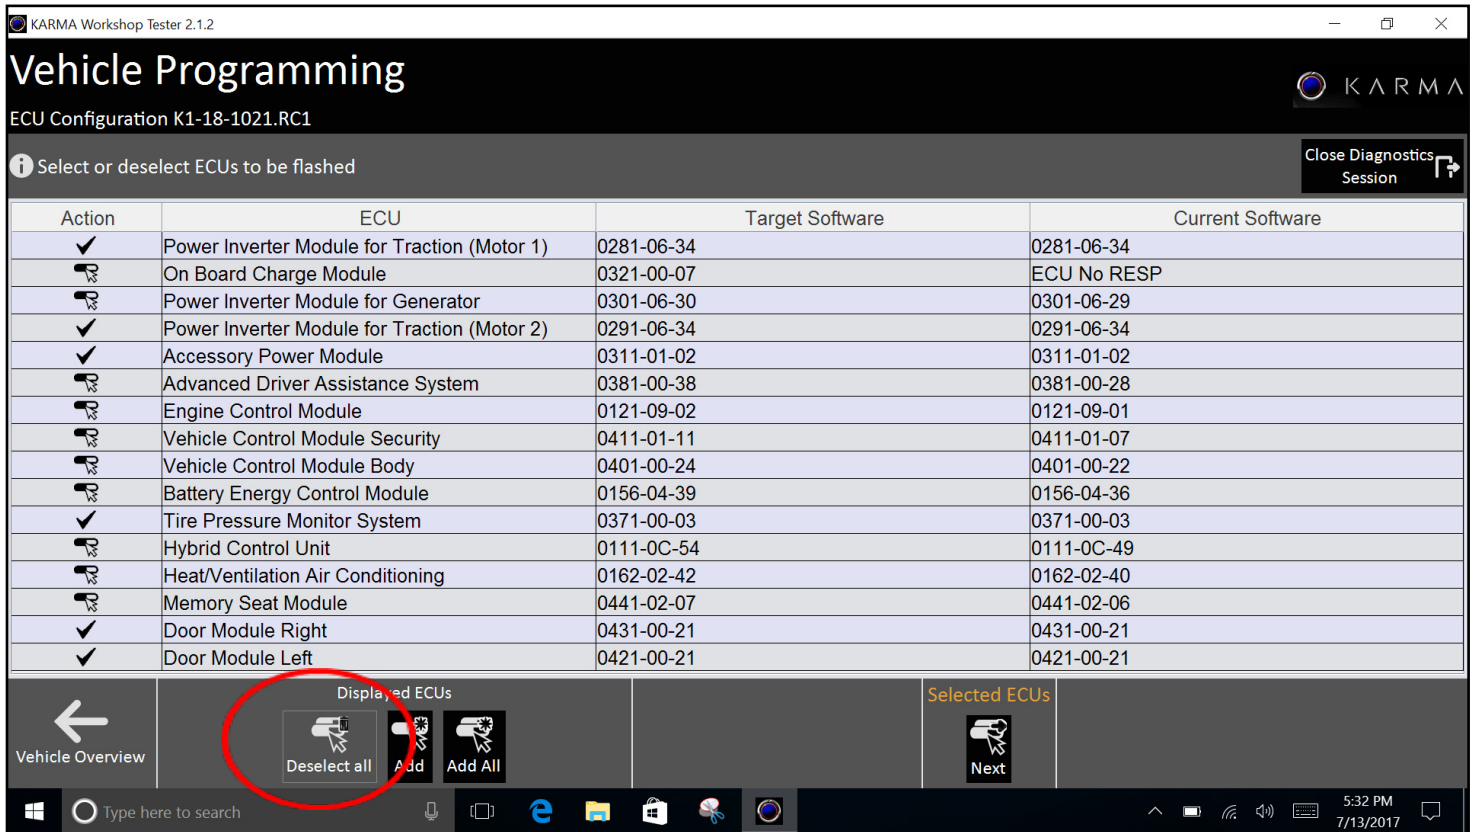
fig.7a

Click **DESELECT ALL** (fig. 7a)

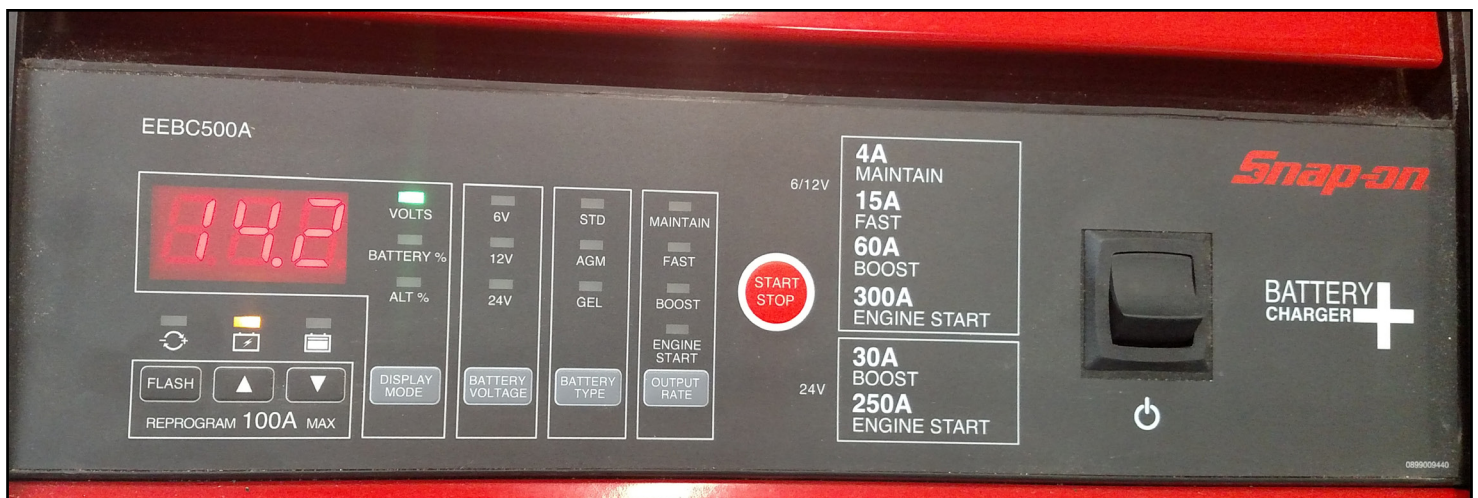
fig.8b

Below is an example of a suitable and recommended power supply (fig.8b)

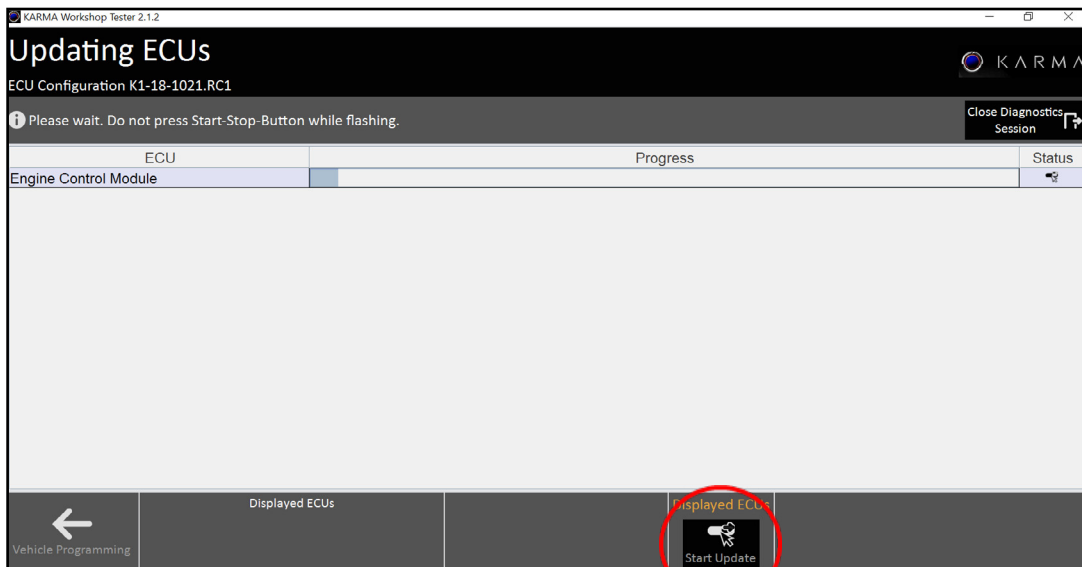
fig.9b

**Click “Start Update”**, the update will then begin. (fig.9b)

Do not interrupt the update until you see a green check mark or a red “x”.

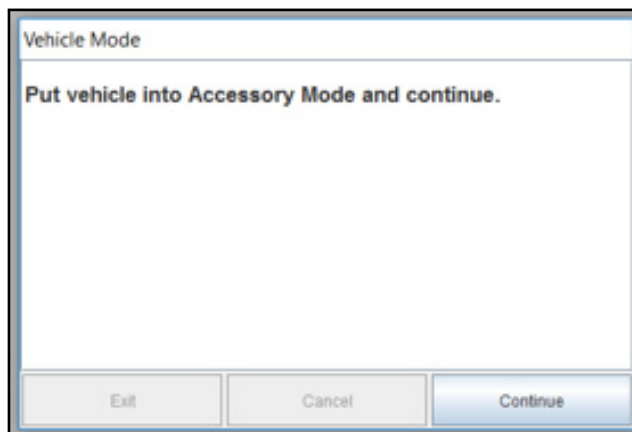
fig.10

7. When update complete the vehicle will power off by itself.  
 Once the update is complete, the vehicle mode dialog will appear. (fig.10)  
 Turn the car back on in Accessory Mode

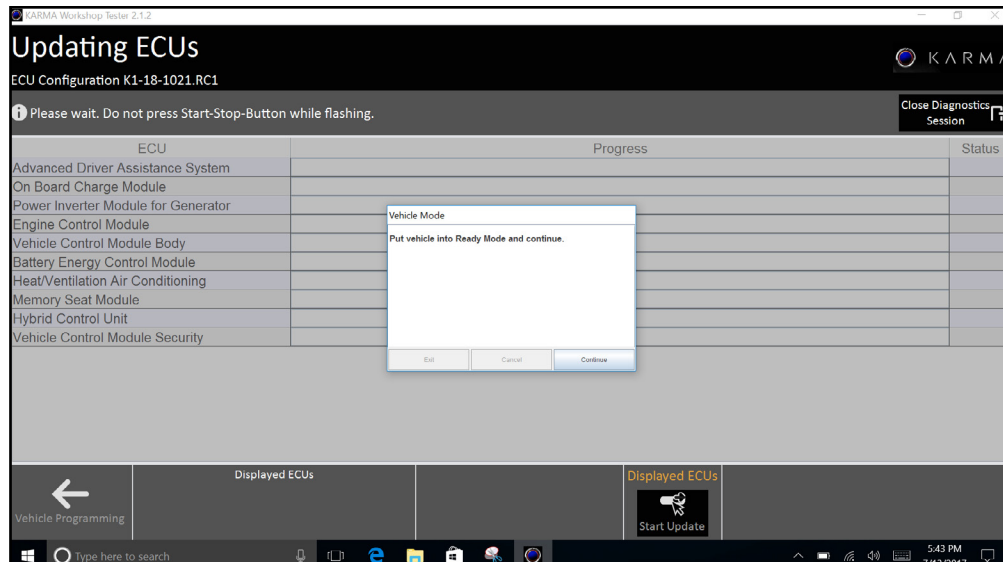
fig.15b

As instructed place vehicle in Ready Mode (fig.15b)

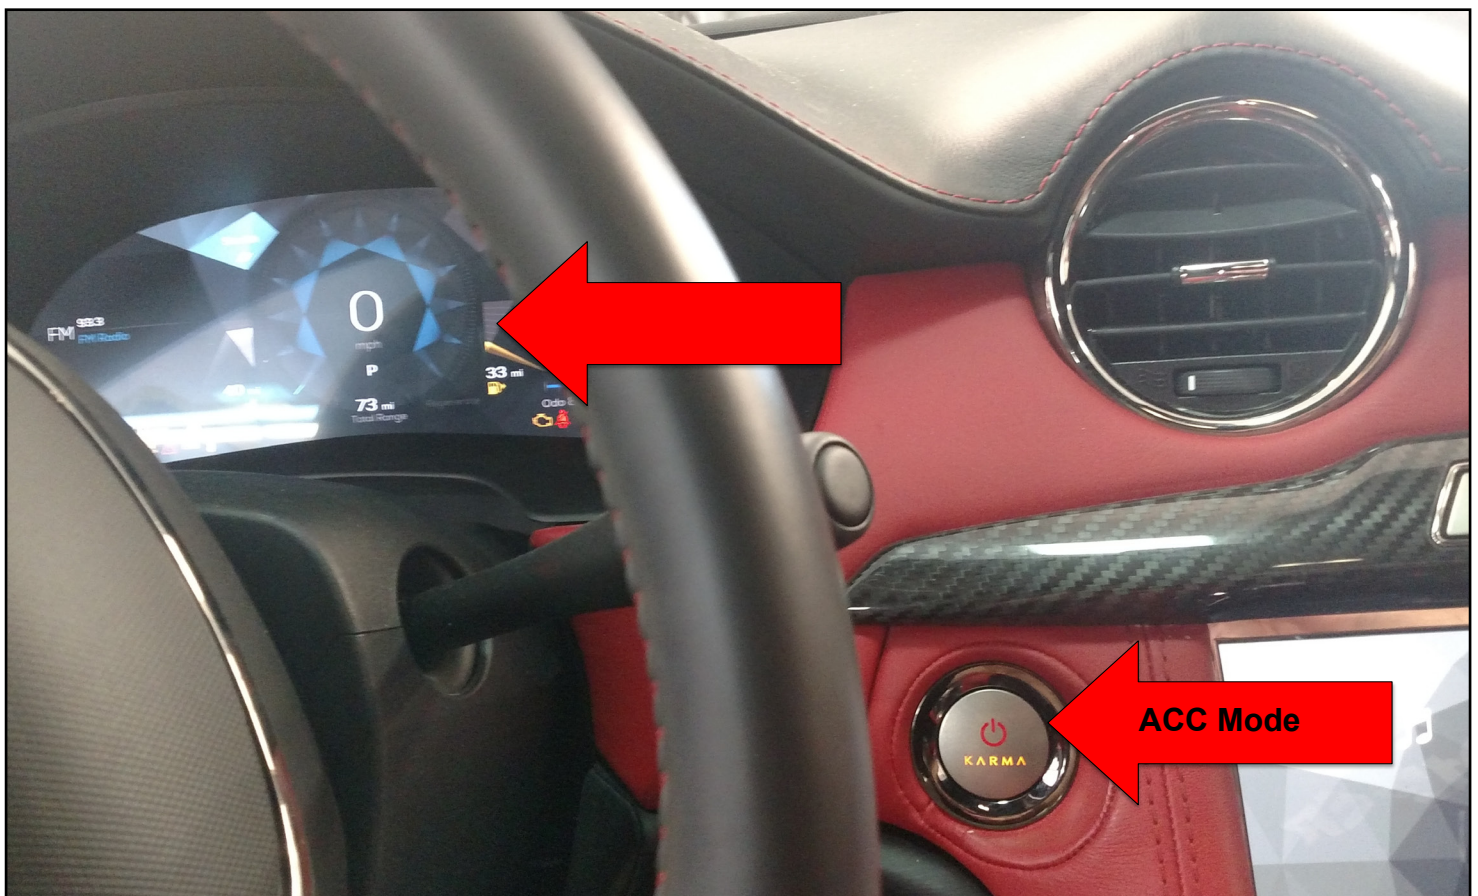
fig. 17

During the ADAS flash the request to enter Accessory Mode is performed by the vehicle. This may take up to two minutes to complete the ADAS flash. Note: Inspection of the vehicle will show the DIS appearing as Ready mode but the power mode button on the dash is YELLOW, because it is in Accessory Mode. The button state is the tell tale (fig. 17). When complete the Sync tool will proceed follow any prompts provided CAREFULLY.

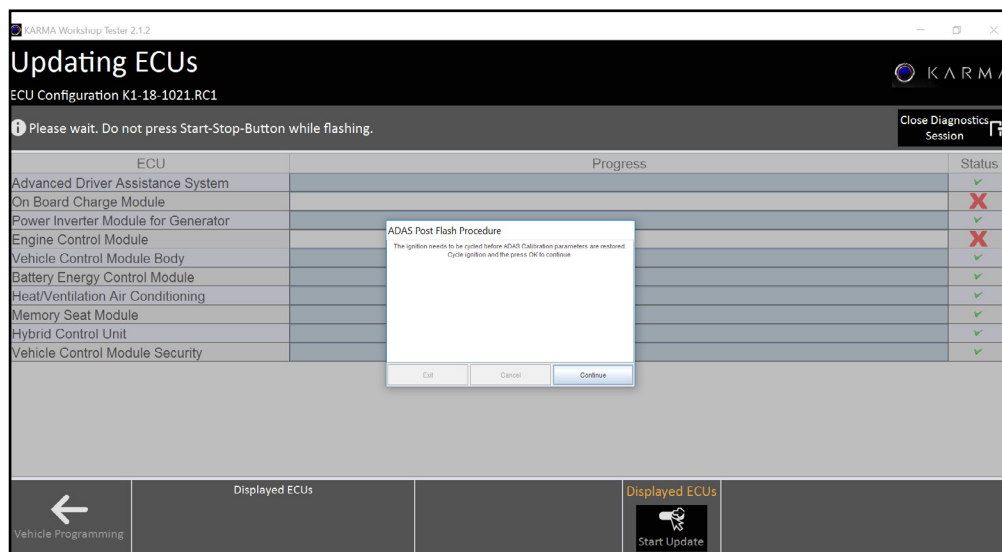
fig.20

16. ADAS post flash procedure will require the vehicle to be placed in Ready Mode (fig. 20). Cycle the mode button to Ready mode.

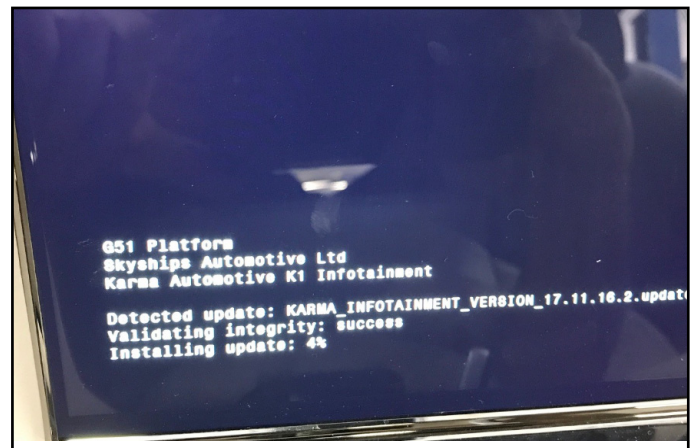
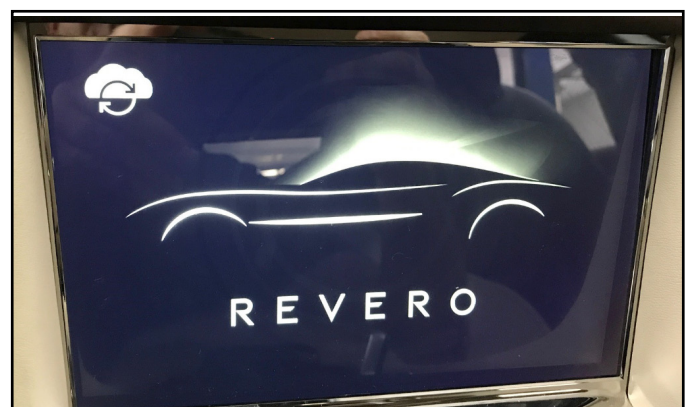
Below are the screens of the TPI read out as the CIU is updating (Fig.23 a,b,c,d,e) When this is completed updating, the screen may go blank or black or cycle on and off, normal function will resume upon cycling the mode button.

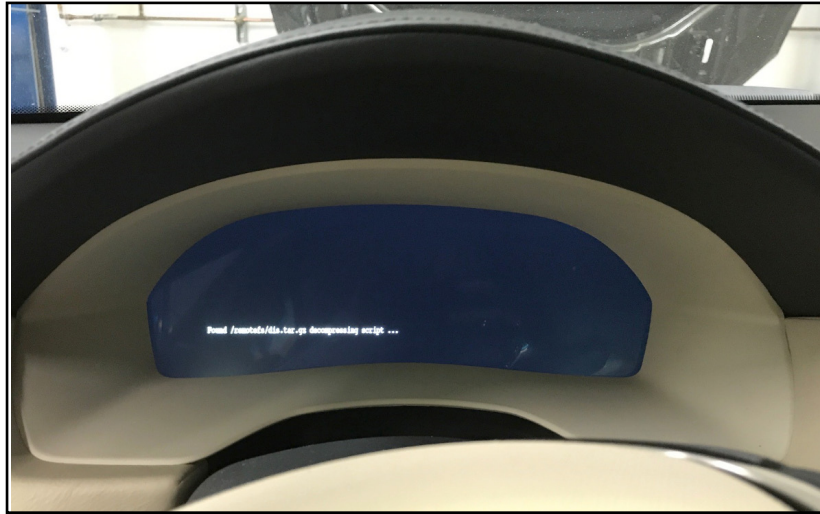
fig. 24

This is the image of the DIS during the update (fig. 24)
