Technical Journal

IHU, no communication, blank center displayREF NO:
TJ 32044.4.0ISSUING DEPARTMENT:
Technical ServiceCAR MARKET:
United States and CanadaPARTNER:
3 US 7510 Volvo Car USAISSUE DATE:
2017-02-01STATUS DATE:
2017-02-07FUNC GROUP:
3930FUNC DESC:
**Equipment for entertainment
(radio/TV/VC**

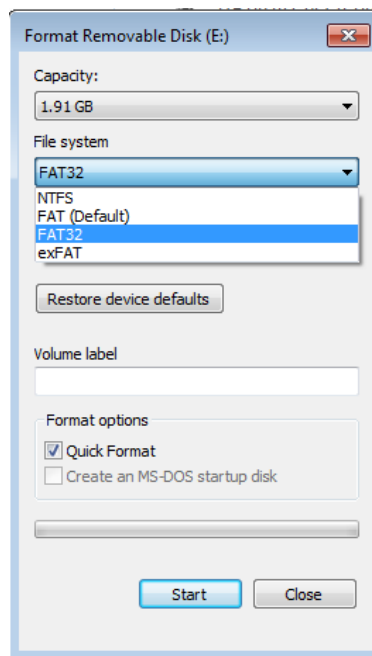
1. On your PC, format a USB stick to "FAT32" or "exFAT":

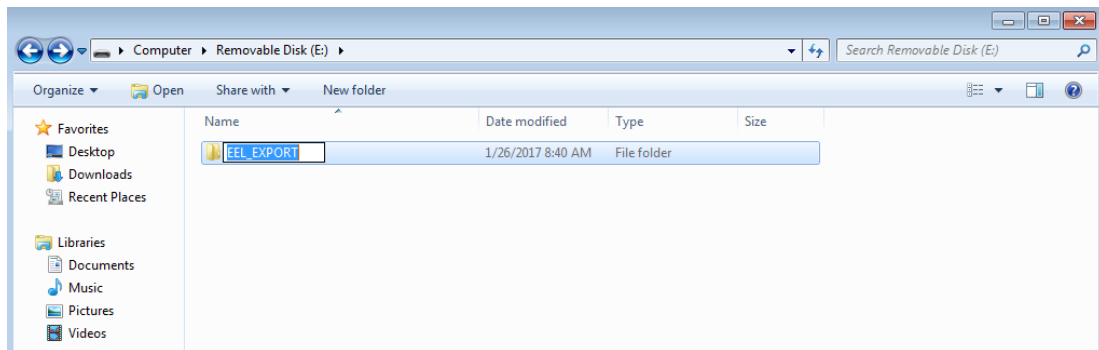
2. Create a new folder on the root directory of the USB and name it EEL_EXPORT

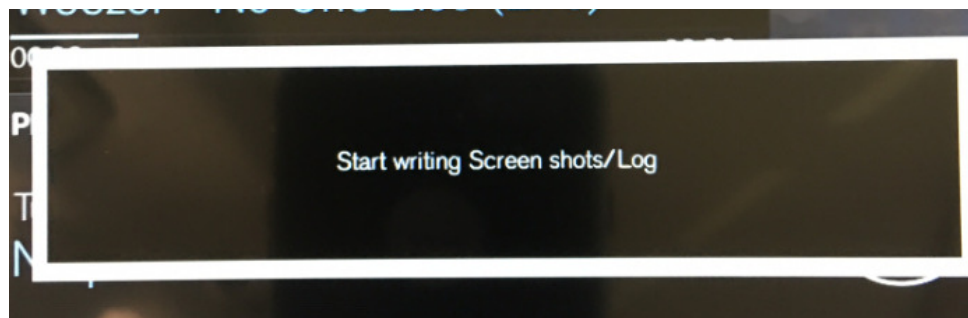
3. Insert the memory stick in the vehicle's USB port
 - If the vehicle has 2 USB ports, use the one *without* the white rectangle
4. A pop-up will appear on the center display indicating that a log file is being written:

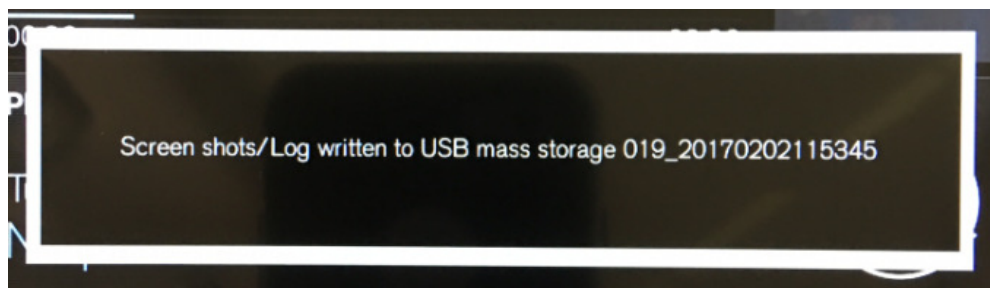
5. Wait until a second pop-up appears on the CCD (approx. 45 seconds) indicating that the log has been written:

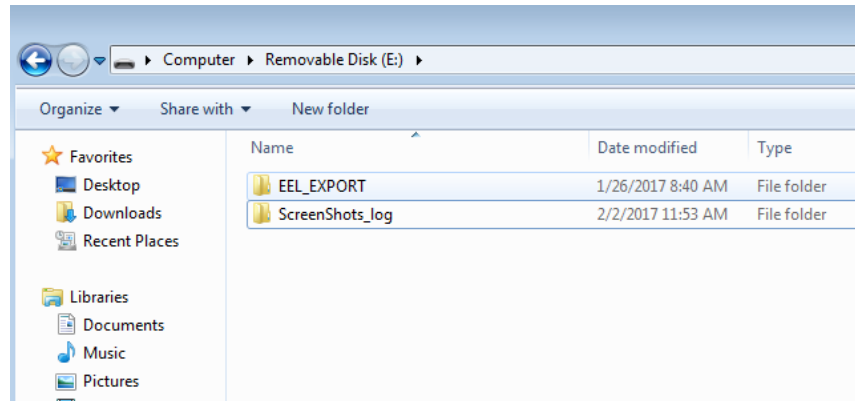
6. Return the memory stick to your PC and open it.
 - There will now be a folder called “ScreenShots_log” on the memory stick:

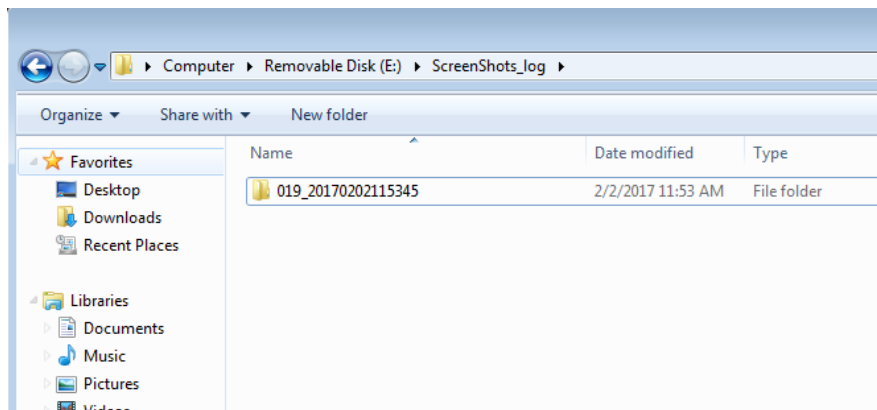
7. Within the *ScreenShots_log* folder, find the folder from the log that was just taken:

NOTE: The folder name indicates the time and date that the log was taken:

- 019_YYYYDDMMhhmmss
- 019_20170202115345 = February 2, 2017, 11:53:45am
