# Technical Journal

**RDAR replacement (Satellite radio tuner), Battery drain**

<b>REF NO:</b> TJ 26188.1.10	<b>ISSUING DEPARTMENT:</b> Technical Service	<b>CAR MARKET:</b> United States and Canada	
<b>PARTNER:</b> 3 US 7510 Volvo Car USA		<b>ISSUE DATE:</b> 2017-01-31	<b>STATUS DATE:</b> 2017-02-07
<b>FUNC GROUP:</b> 3920	<b>FUNC DESC:</b> Radio, complete	<b>Page 1 of 13</b>

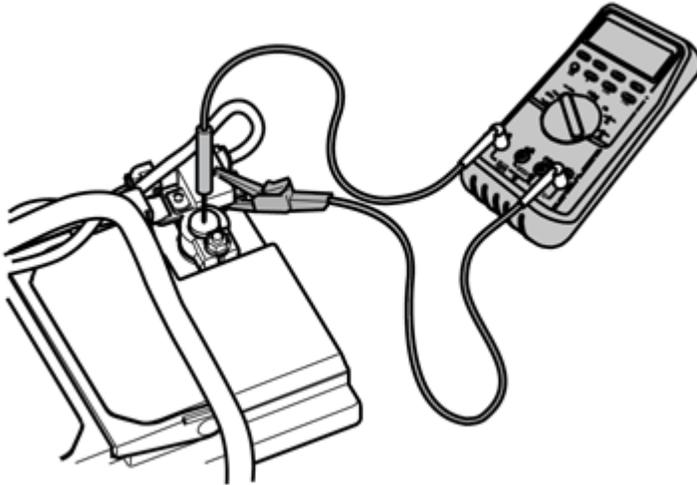
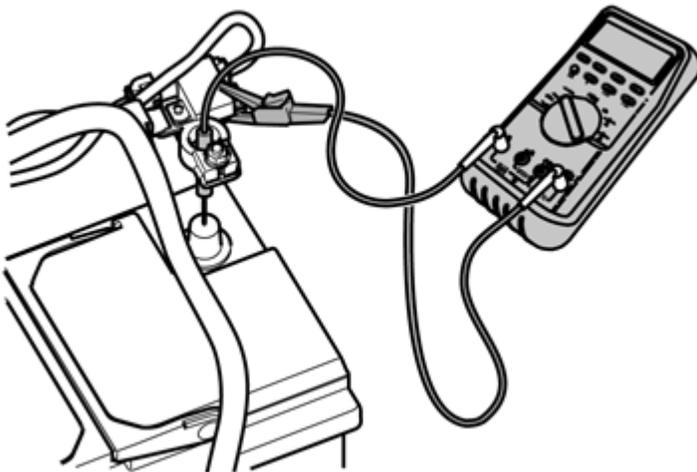
### Checking standby current current Measurement method

When measuring the vehicle's total power consumption, connect the measuring instrument in series with the battery at the battery's negative pole.

The procedure for checking Stand-By current is found in VIDA:

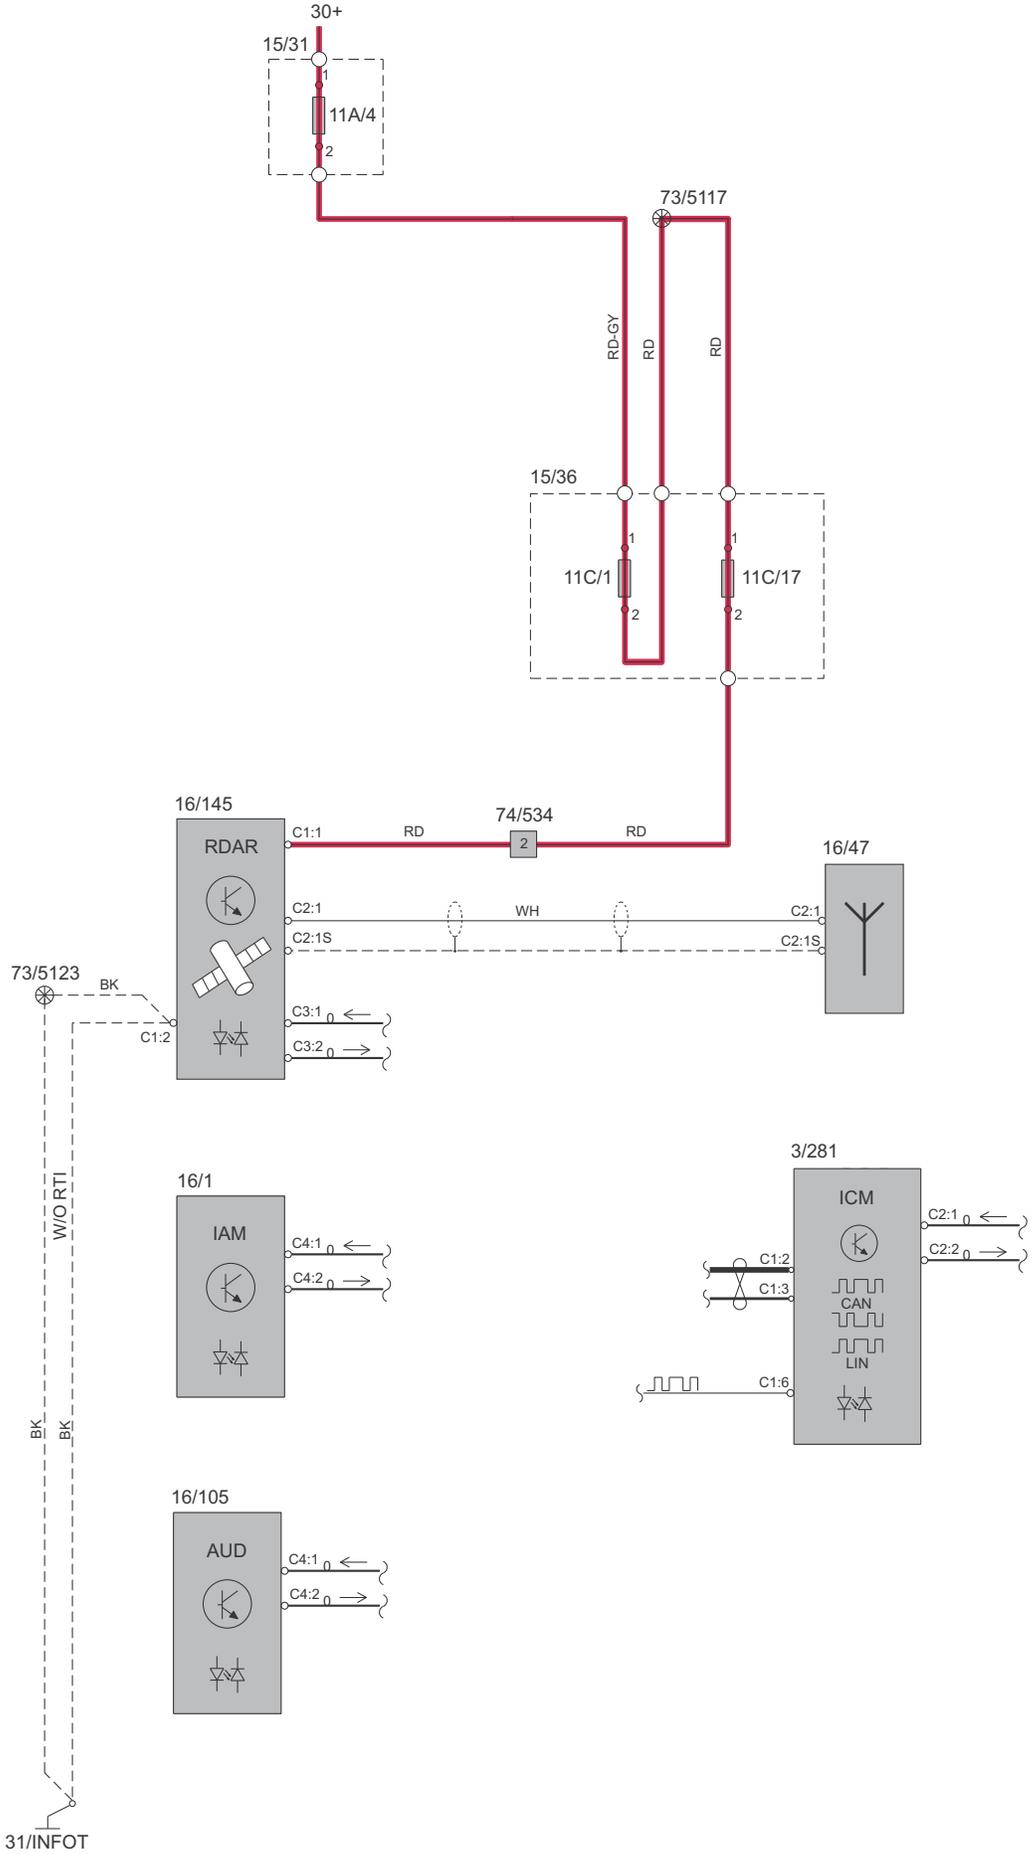
## Satellite radio

**Power/Ground**

**MOST**

**Antenna**

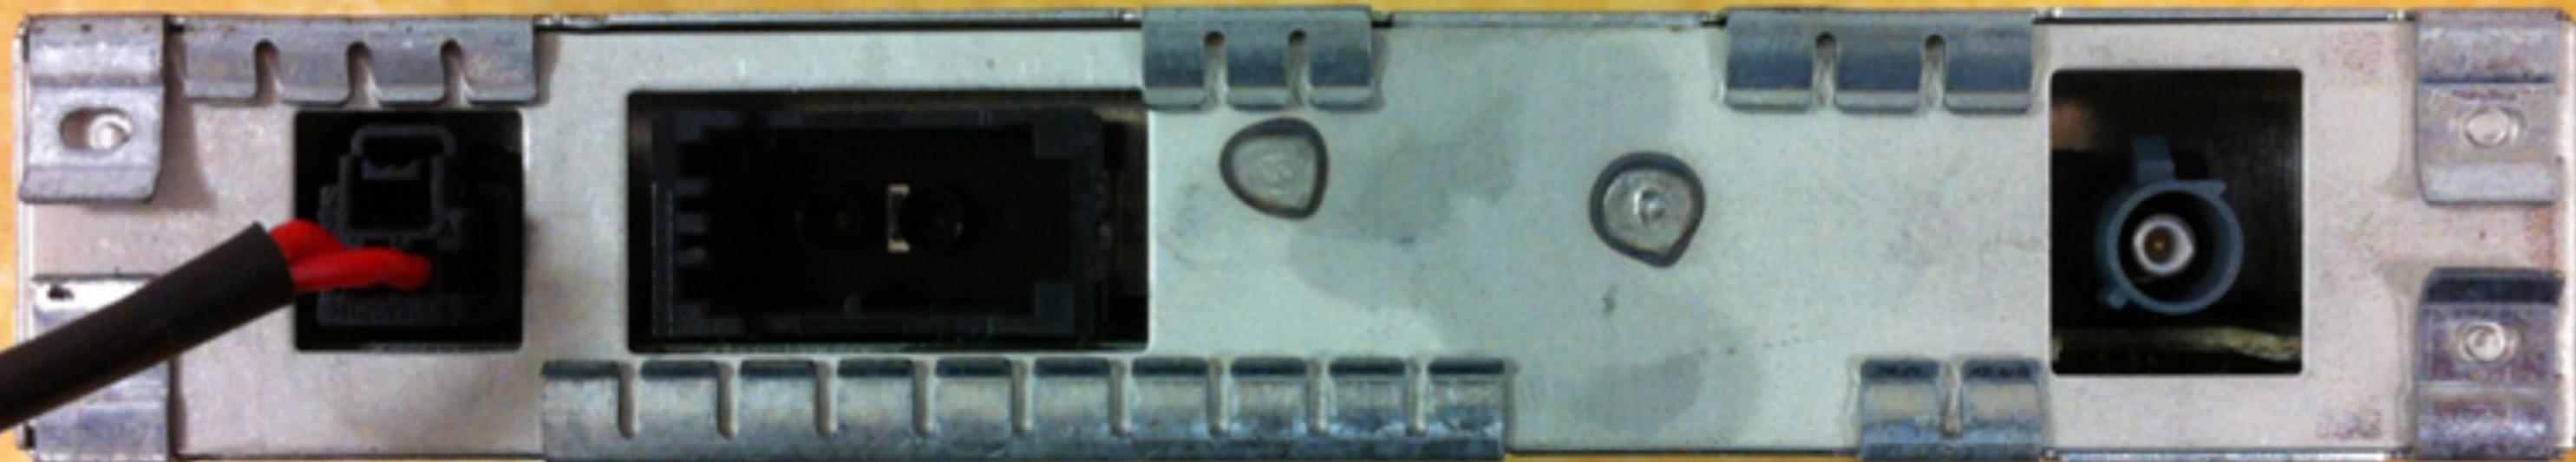
**P3:**

- ‡ RDAR-B1A8911 Satellite Antenna. General Electrical Failures. Circuit short to ground
- ‡ RDAR-B1A8912 Satellite Antenna. General Electrical Failures. Circuit short to battery
- ‡ RDAR-B1A8913 Satellite Antenna. General Electrical Failures. Circuit open
- ‡ RDAR-U300004 Control Module. General Signal Failures. System Internal Failures
- ‡ RDAR-U30004A Control Module. Component Failures. Incorrect component installed
- ‡ RDAR-U300055 Control Module. System Internal Failures. Not configured
- ‡ RDAR-U300087 Control Module. General Signal Failures. Missing message
- ‡ RDAR-U300098 Control Module. System Internal Failures. Component or system over temperature
- ‡ RDAR-U300362 Battery Voltage. Algorithm Based Failures. Signal compare failure

- ‡ RDAR-0001 Control module. Internal fault
- ‡ RDAR-0002 Antenna, satellite radio. Signal missing
- ‡ RDAR-0003 Antenna, satellite radio. Signal too low
- ‡ RDAR-0004 Antenna, satellite radio. Signal too high
- ‡ RDAR-0005 Incorrect Component Installed
- ‡ RDAR-0006 Control module. Configuration fault
- ‡ RDAR-0007 Control module. Configuration fault
- ‡ RDAR-0008 Control module. Overheated
- ‡ RDAR-0009 Battery voltage. Faulty signal
