TECHNICAL BULLETIN

413-08: Information and Message Center

Service Action: 'AEB' Not Available' Message Displayed In The Message Center

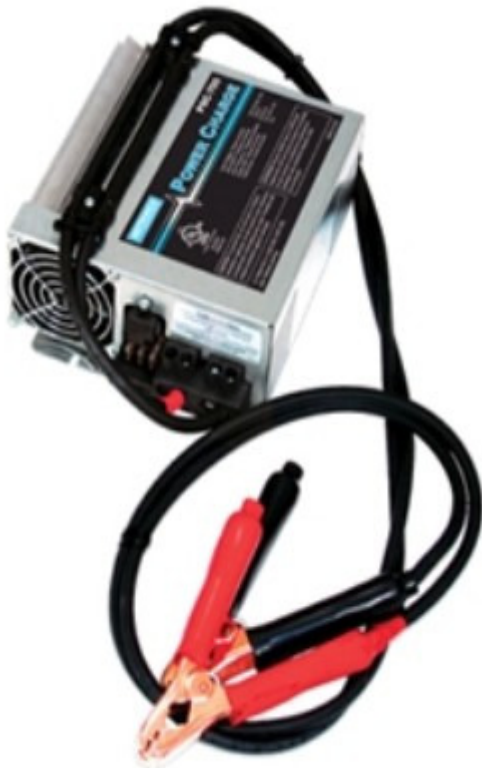
E192494

Jaguar Land Rover-approved Midtronics Battery Power Supply

- A Jaguar Land Rover-approved Midtronics battery power supply must be connected to the vehicle battery during diagnosis / module programming.
- Make sure all ignition ON/OFF requests are carried out; failure to perform these steps may cause damage to control modules in the vehicle.
