JAGUAR LAND ROVER SHOP FOREMAN CONFERENCE CALL
JANUARY 12, 2017

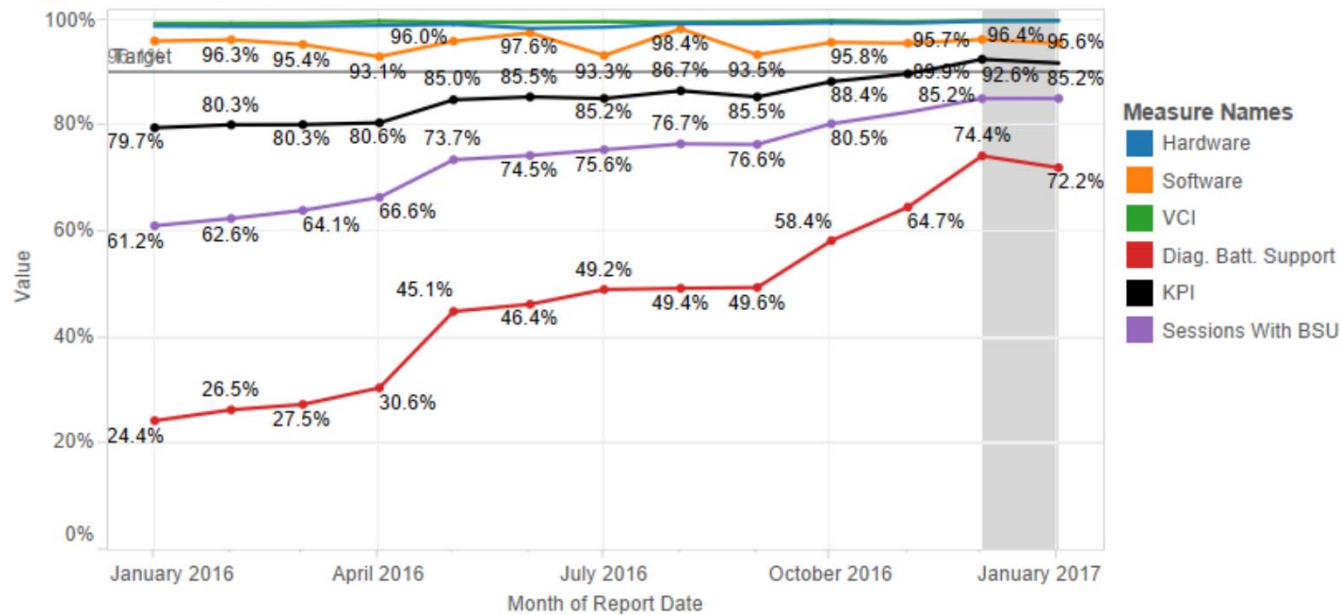
Diagnostic Compliance - All

While 2016 shows considerable progress towards compliance with JLR's Global Standards, 10 days into 2017 we have erased 1/4 of the progress obtained during the month of December. (decline seen in gray section of chart)
