August 2017

Dealer Service Instructions for:

Customer Satisfaction Notification T09 Interior Trim Level

2017 (JK) Jeep® Wrangler Rubicon

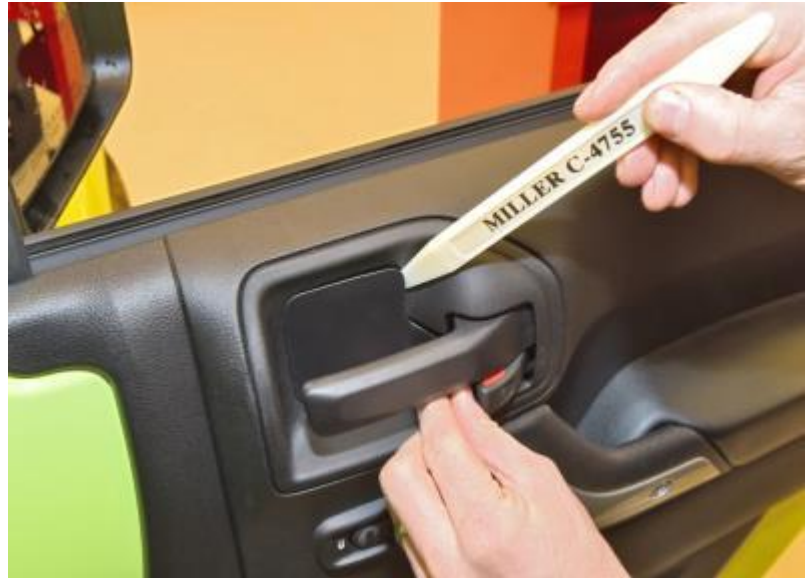
Figure 1 – Door Handle

1. Use a trim stick C-4755 or equivalent to separate the inside handle bezel cap from the bezel (Figure 1).

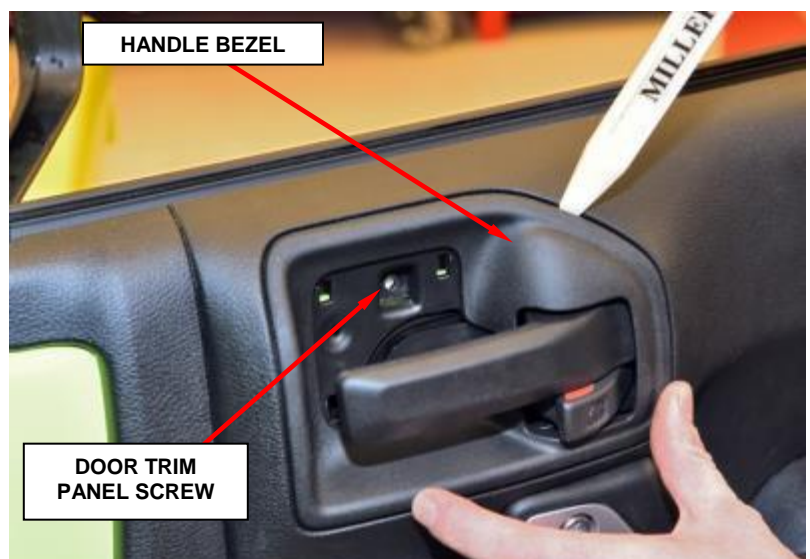
Figure 2 – Bezel

2. Remove the door trim panel bezel screw (Figure 2).
3. Use a trim stick C-4755 or equivalent to remove the inside handle bezel (Figure 2).

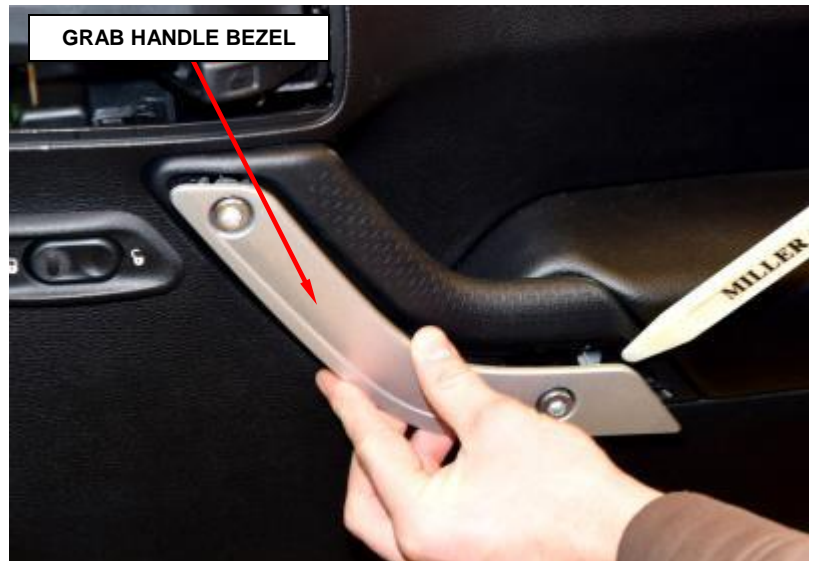
Figure 3 – Grab Handle

4. Use a trim stick C-4755 or equivalent to remove the grab handle bezel (Figure 3).

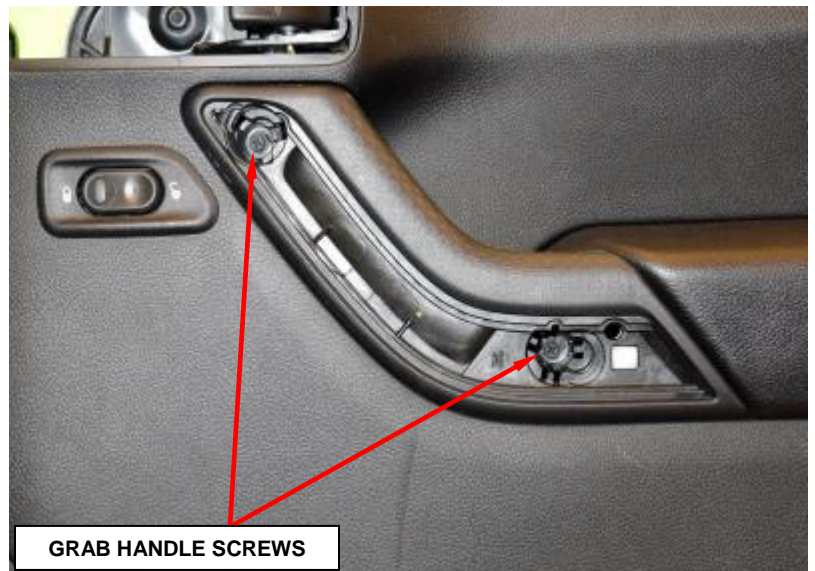
Figure 4 – Grab Handle Bezel Removed

5. Remove the two grab handle screws and save (Figure 4).

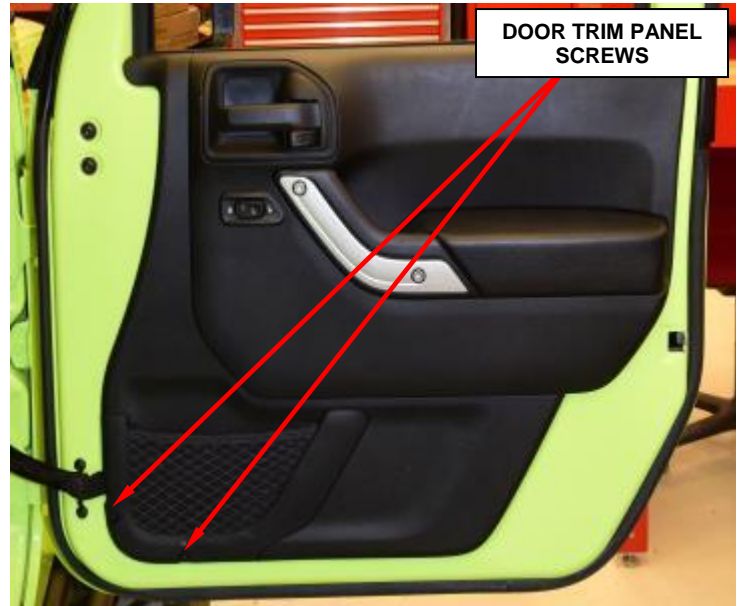
**Figure 5 – Door Trim Panel**

6. Remove the two door trim panel screws (Figure 5).

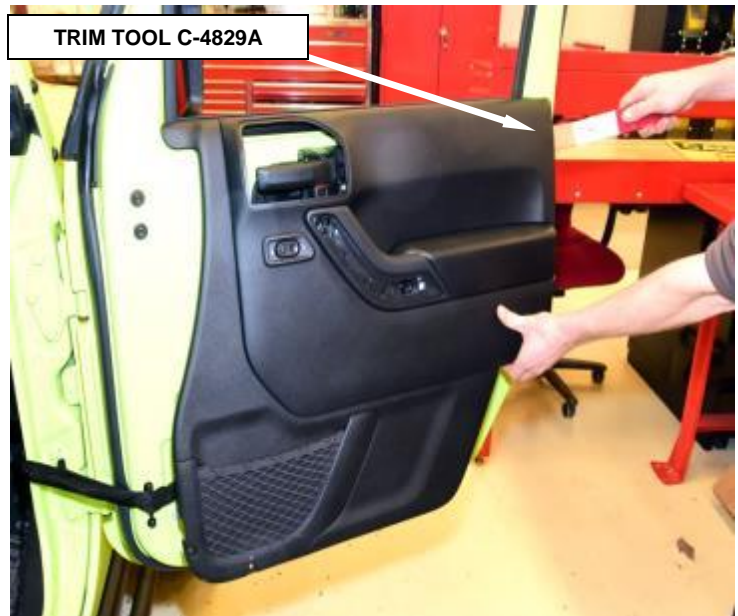
**Figure 6 – Door Trim Panel**

7. Using a trim tool C-4829A or equivalent, start at the bottom by the check strap to separate the push pin fasteners on the door trim panel to remove the door trim panel (Figure 6).

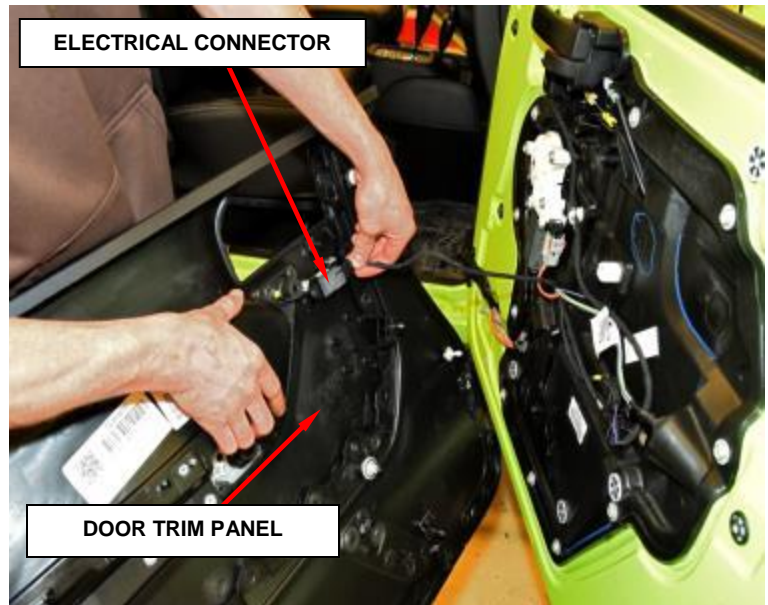
**Figure 7 – Door Trim Panel Removed**

8. Disconnect the door lock switch electrical connector and **discard** the door trim panel (Figure 7).

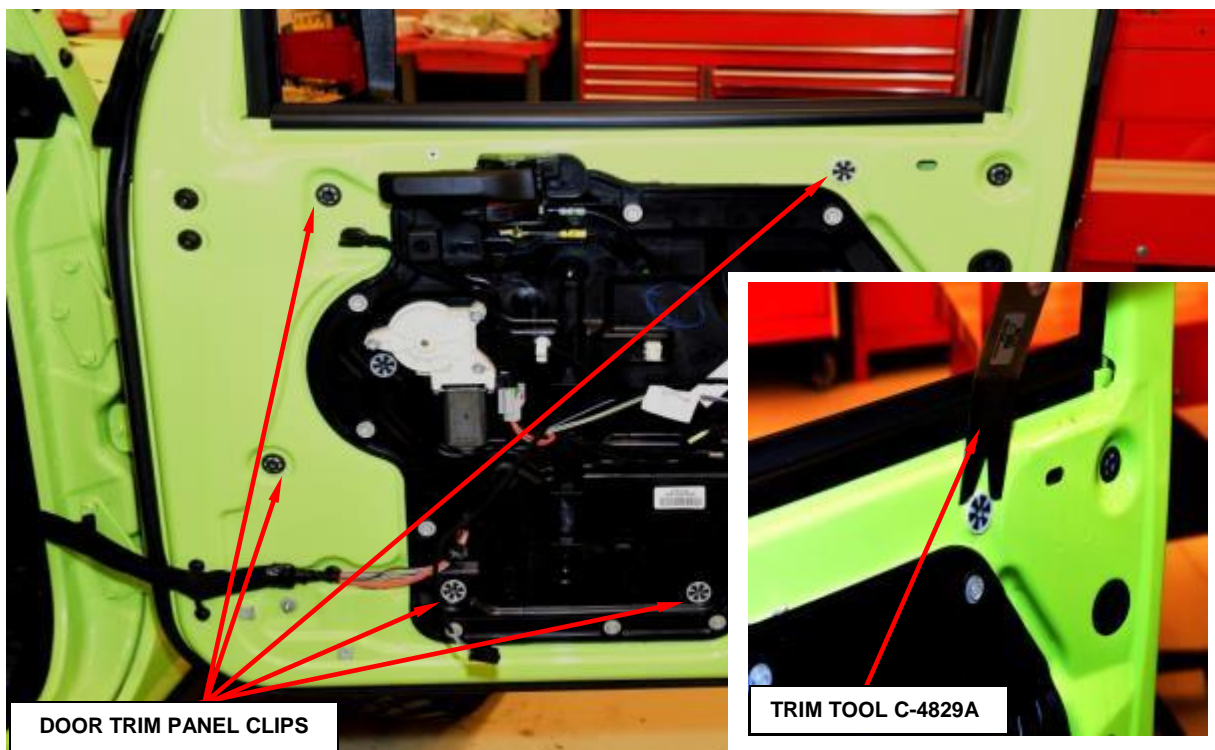
**Figure 8 – Door Trim Panel Clips**

9. Remove and **discard** the door trim panel clips that did not remain on the removed door trim panel (Figure 8).

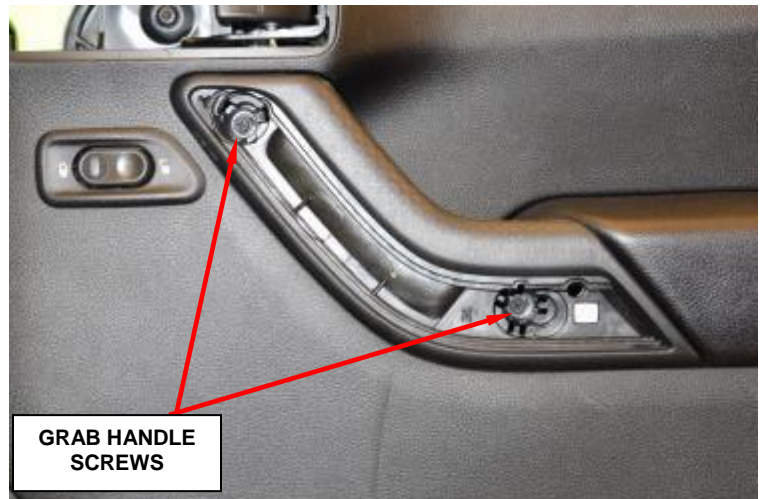
**Figure 9 – Grab Handle**

10. Position the **NEW** door trim panel close to the door and reconnect the electrical door lock switch connector.
11. Place the **NEW** door trim panel on the top door belt line and align the locating pins to existing holes on the door sheet metal.
12. Using moderate hand force, push on the **NEW** door trim panel to seat the door trim panel retaining clips around the perimeter of the door.
13. Install the grab handle screws (Figure 9).

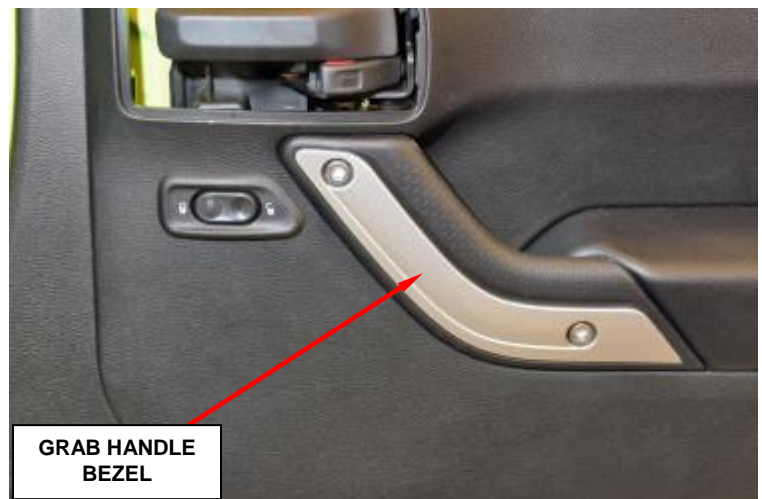
**Figure 10 – Grab Handle Bezel**

14. Position the grab handle bezel back into place on the grab handle and seat fully (Figure 10).

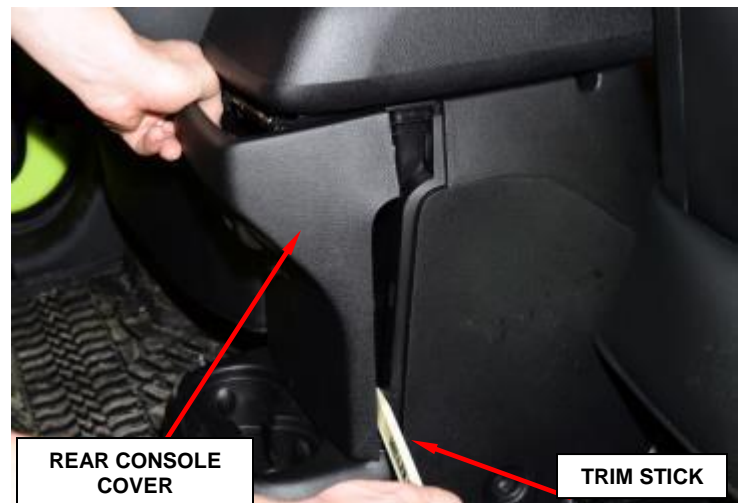
Figure 11 - Console

17. Use a trim stick or equivalent to remove the console cover from the rear of the floor console (Figure 11).
18. Lift the arm rest to expose the console bin (Figure 12).

29. Insert the key and verify the lock function.
30. Position the armrest onto the floor console and install the four screws (Figure 13).
31. Install the screw cover (Figure 12).
32. Install the console cover at the rear of the floor console (Figure 11).

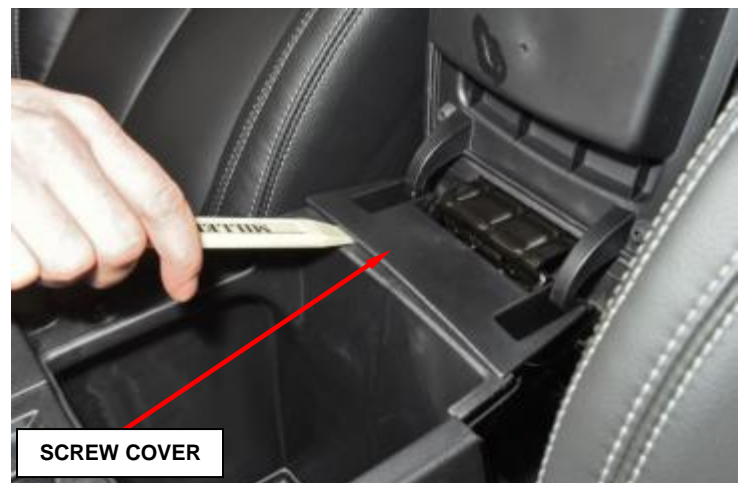
Figure 12 – Console Bin

19. Use a trim stick or equivalent to remove the screw cover to gain access to the armrest screws (Figure 12).

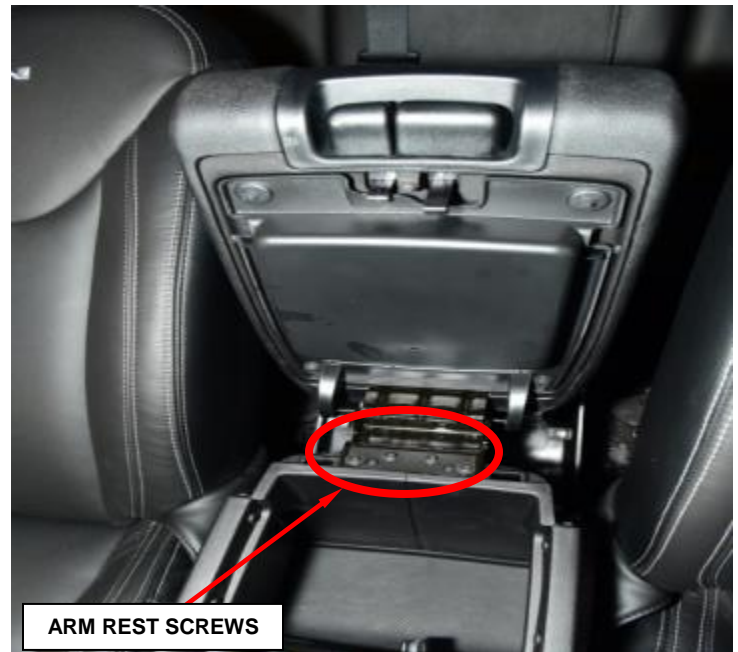
Figure 13 – Arm Rest

20. Remove and save the four screws, then remove the armrest (Figure 13).

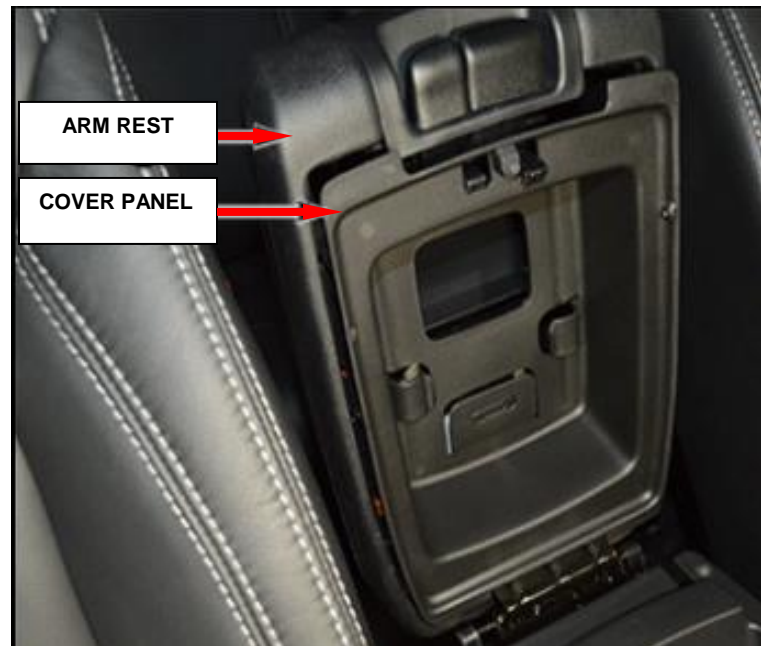
Figure 14 – Arm Rest Cover Panel

21. Remove the center console lock cylinder from the removed arm rest by following the steps below.
22. Use a trim stick or equivalent, to remove the cover panel (Figure 14).

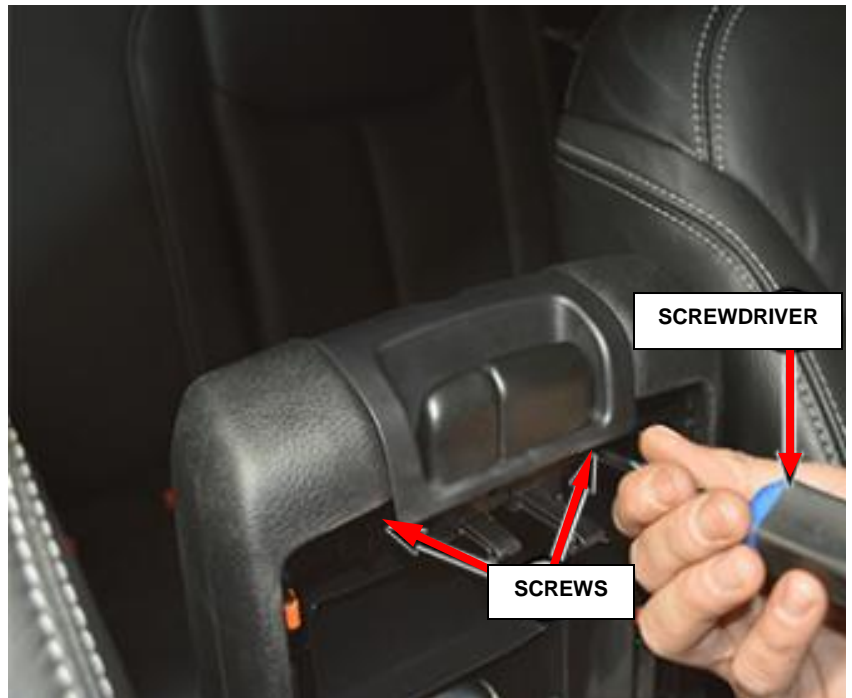
Figure 15 – Remove Screws

23. Use an appropriate screw driver to remove the two screws that fasten the latch assembly (Figure 15).

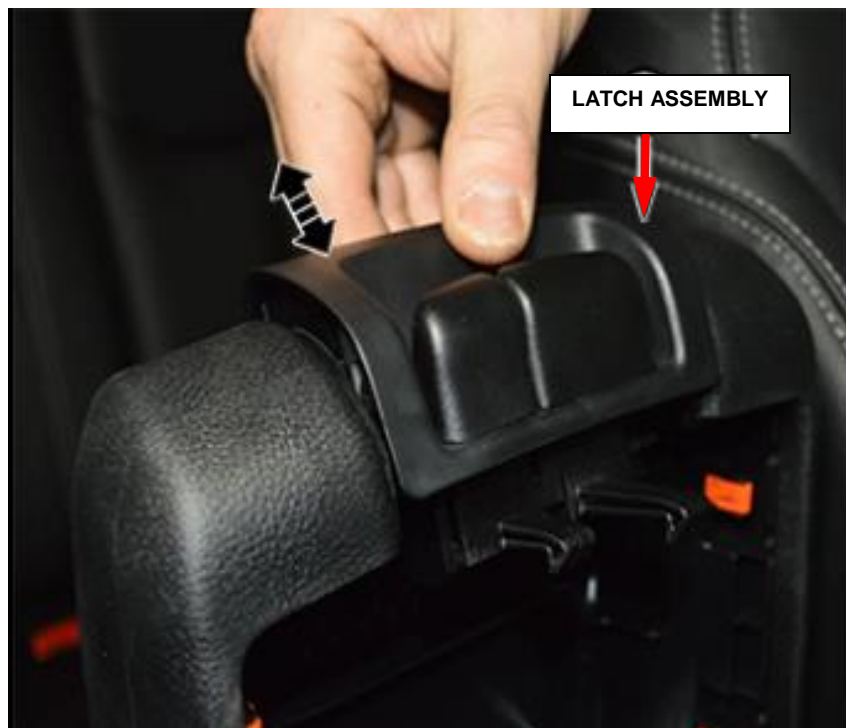
Figure 16 – Latch Assembly Removal

24. Grasp the latch assembly and pull upward to remove the latch assembly (Figure 16).

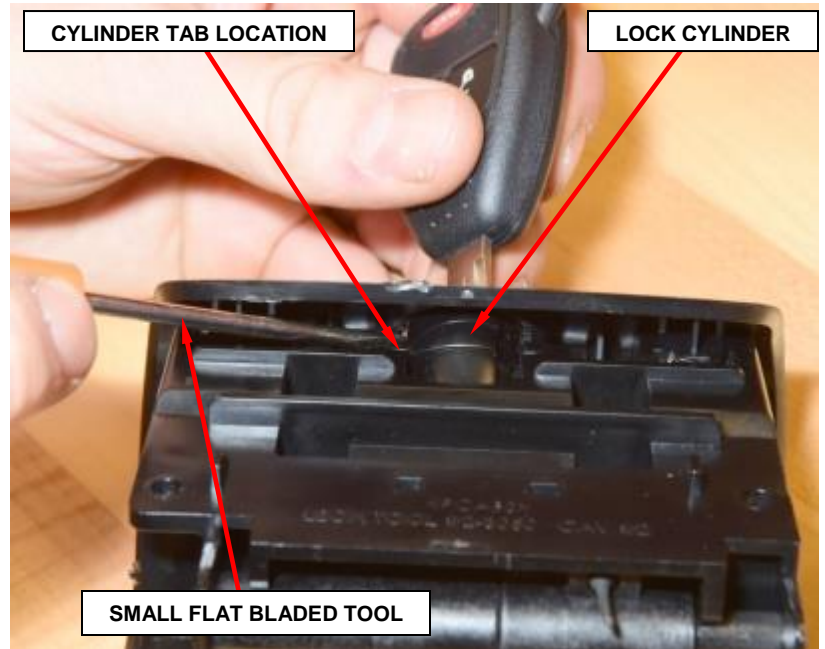
**Figure 17 – Latch Assembly**

25. Install the ignition key into lock cylinder and turn clockwise until it stops.
26. Using a small flat bladed tool, press the metal tab at the base of the lock cylinder, then rotate the key clockwise again until it stops (Figure 17).

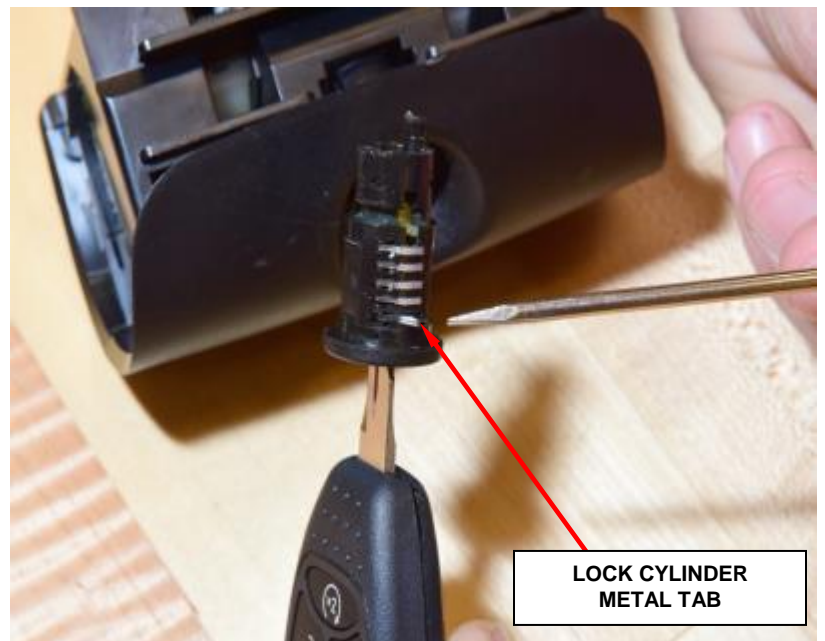
**Figure 18 – Lock Cylinder**

27. Pull on the key to remove the lock cylinder from the latch (Figure 18).

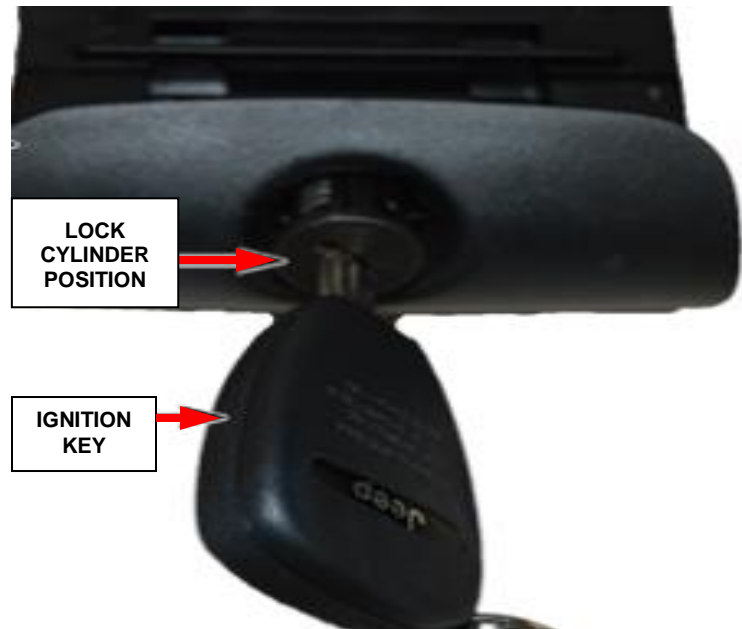
Figure 19 – Lock Cylinder Installation

28. Install the lock cylinder into the **NEW** arm rest latch assembly then turn counter-clockwise till the key can be removed (Figure 19).

NOTE: The lock cylinder needs to be in the proper position before inserted into the latch. This graphic shows the position (Figure 19).

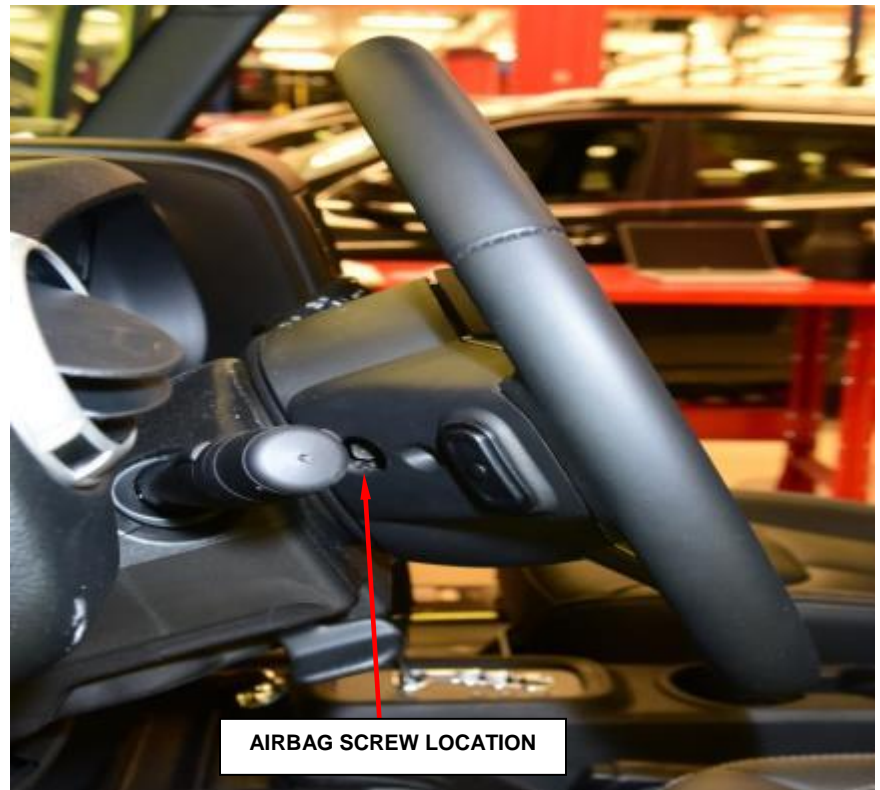
Figure 21 - AirBag

35. Working through the access holes in each side of the steering wheel trim cover; remove the two screws that secure the Driver AirBag (DAB) unit to the steering wheel armature (Figure 21).

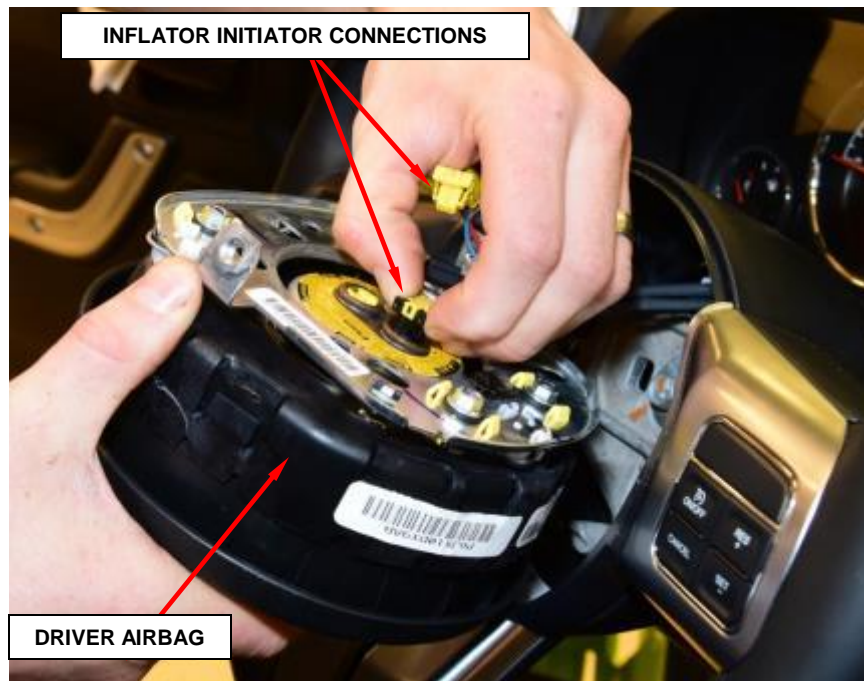
Figure 22 – Electrical Connectors

36. Pull the airbag and floating horn switch unit away from the steering wheel far enough to access the electrical connections at the back of the airbag housing and switch unit (Figure 22).

CAUTION: Do not pull on the clockspring pigtail wires or pry on the connector insulators to disengage them from the Driver AirBag (DAB) inflator initiator connector receptacles. Improper removal of these pigtail wires and their connector insulators can result in damage to the airbag circuits or the connector insulators.

NOTE: The clockspring Driver AirBag (DAB) pigtail wire connector insulators are secured by integral latches and a Connector Position Assurance (CPA) lock to the airbag inflator connector receptacles, which are located on the back of the DAB housing. Pull the lock straight out from the connector insulator, then pull the insulators straight out from the airbag inflator to disengage the latches and disconnect them from the connector receptacles.

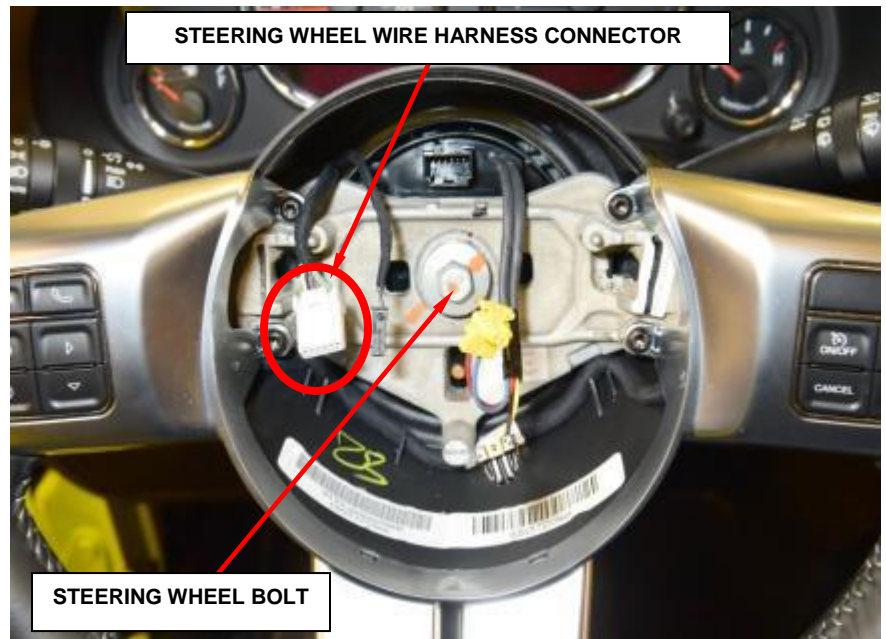
Figure 23 – Steering Wheel Electrical Connectors

39. Disconnect the steering wheel wire harness connector (Figure 23).

40. Partially remove the steering wheel bolt and leave the bolt on the column (Figure 23).

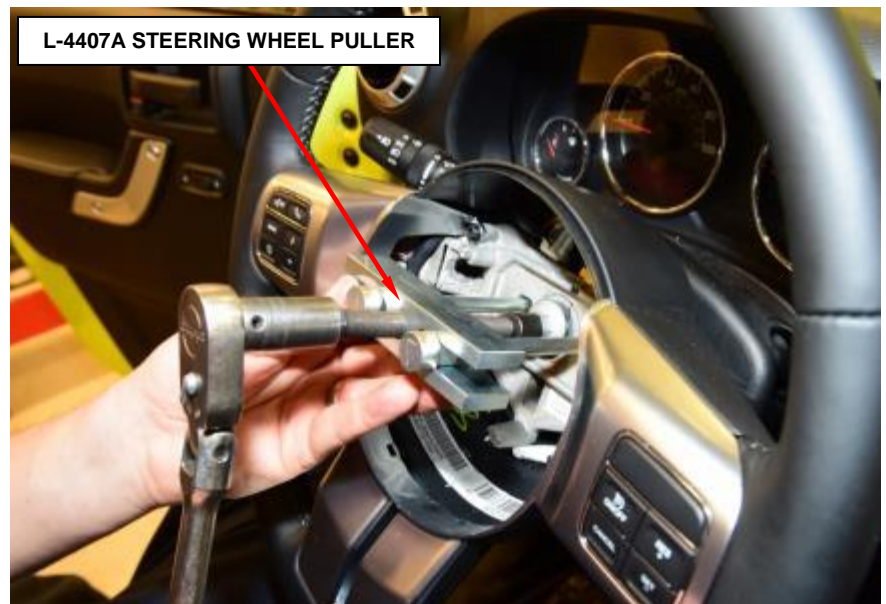
Figure 24 – Steering Wheel Puller

41. Install steering wheel puller L-4407A puller with OTC® 7929A jaws or equivalent using the top of the bolt to push on (Figure 24).

NOTE: Ensure the puller jaws are seated in the pockets of the steering wheel armature.

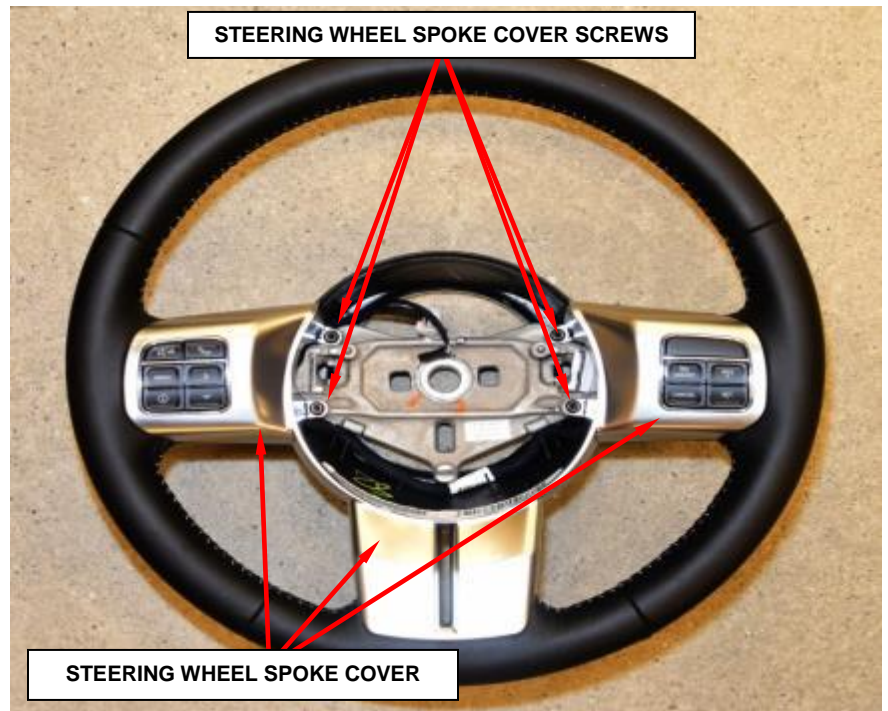
Figure 25 – Steering Wheel

43. Remove the four steering wheel screws that secure the front spoke cover to the steering wheel armature within the steering hub cavity (Figure 25).

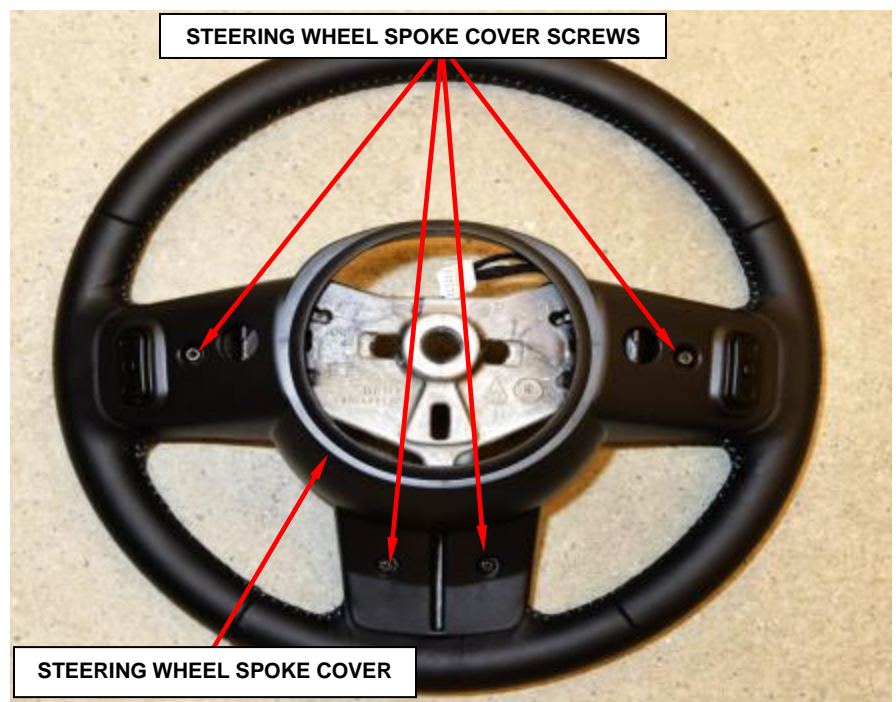
Figure 26 – Back Of Steering Wheel

44. Remove the four screws from the back of the steering wheel (Figure 26).

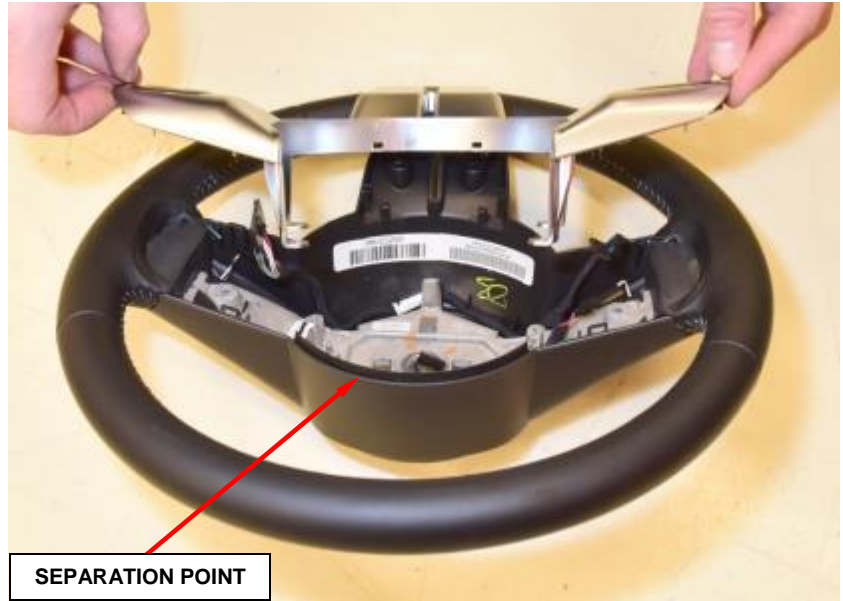
Figure 27 – Steering Wheel Front Bezel

45. Using a trim stick or equivalent tool, carefully pry the parting line between the front bezel and the steering wheel spoke cover enough to release the two horizontal electrical connectors from the steering wheel control switches (Figure 27).

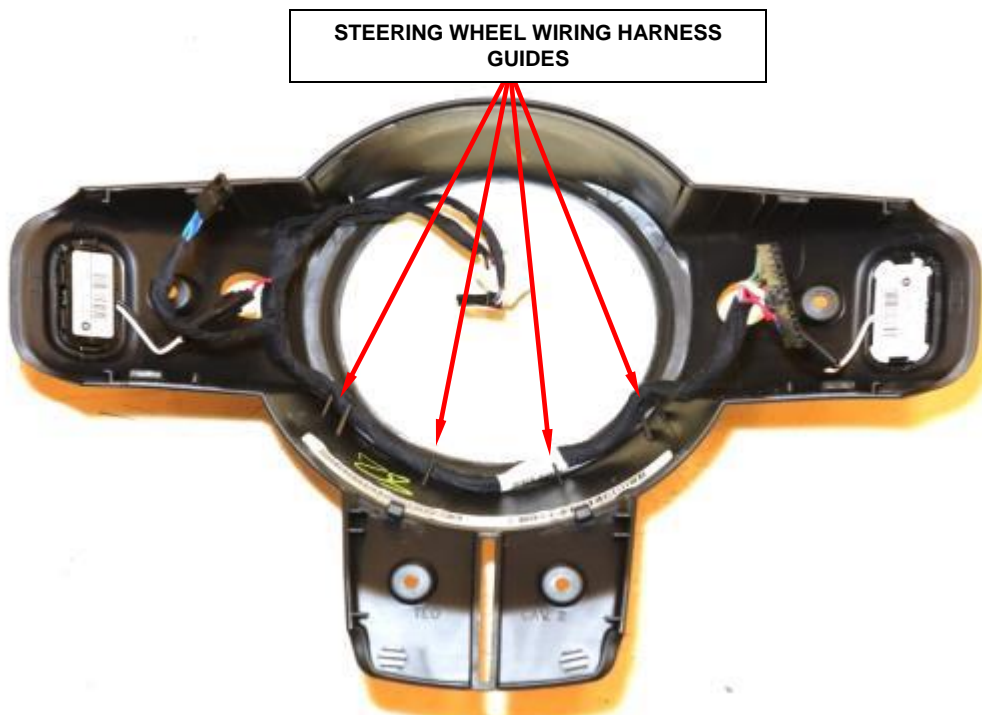
Figure 28 – Rear Steering Wheel Cover

46. Remove the steering wheel spoke cover from the steering wheel (Figure 28).

Note: The wiring harness stays intact to the lower steering wheel cover (Figure 28).
