06021 Version 1

## 2013-17 RDX: Judder from the Torque Converter Lock-Up Clutch

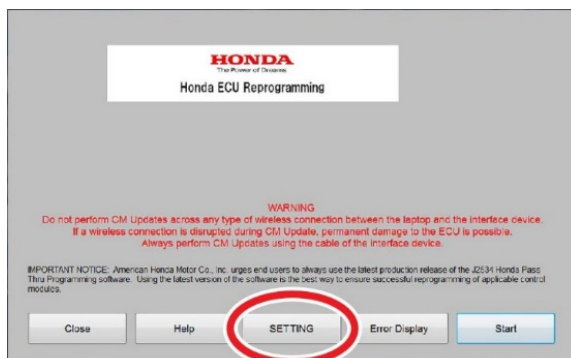
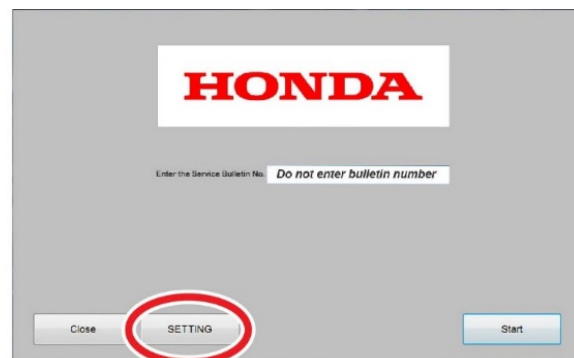
To change this, click on either of the **SETTING** selection buttons at the bottom of the J2534 initial screens as shown.
