January 28, 2017

05722 Version 3

## Product Update: 2011 RL Software Update for Lock-up Clutch Function

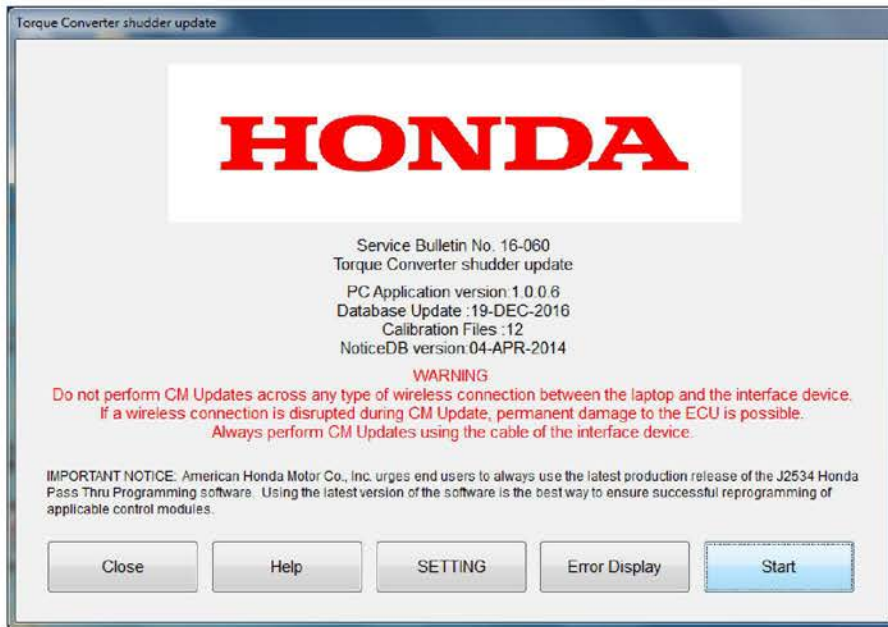
4. Confirm the software is the same **or later** as listed in SOFTWARE INFORMATION.
