January 26, 2017

05684 Version 1

2012–13 ZDX: Judder from the Torque Converter Lock-Up Clutch

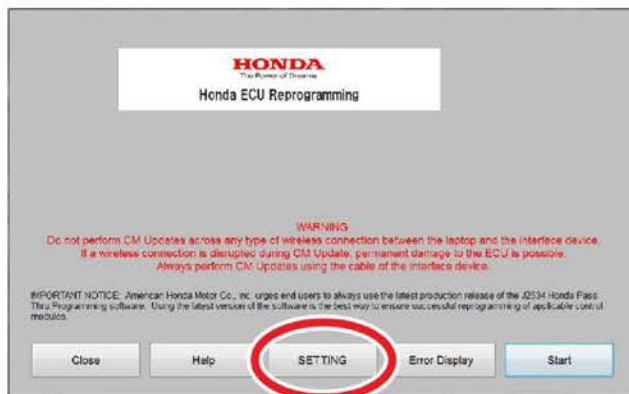
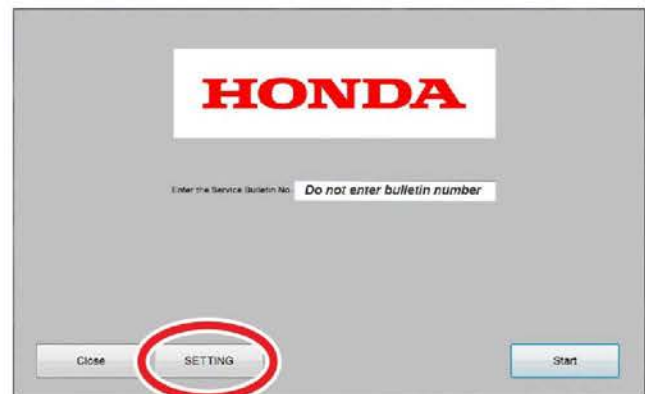
To change this, click on either of the **SETTING** selection buttons at the bottom of the J2534 initial screens as shown.

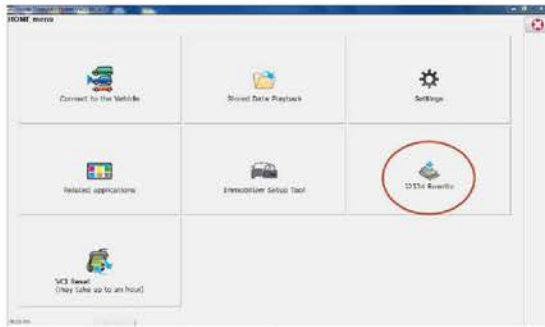
2. Select **J2534 Rewrite**.

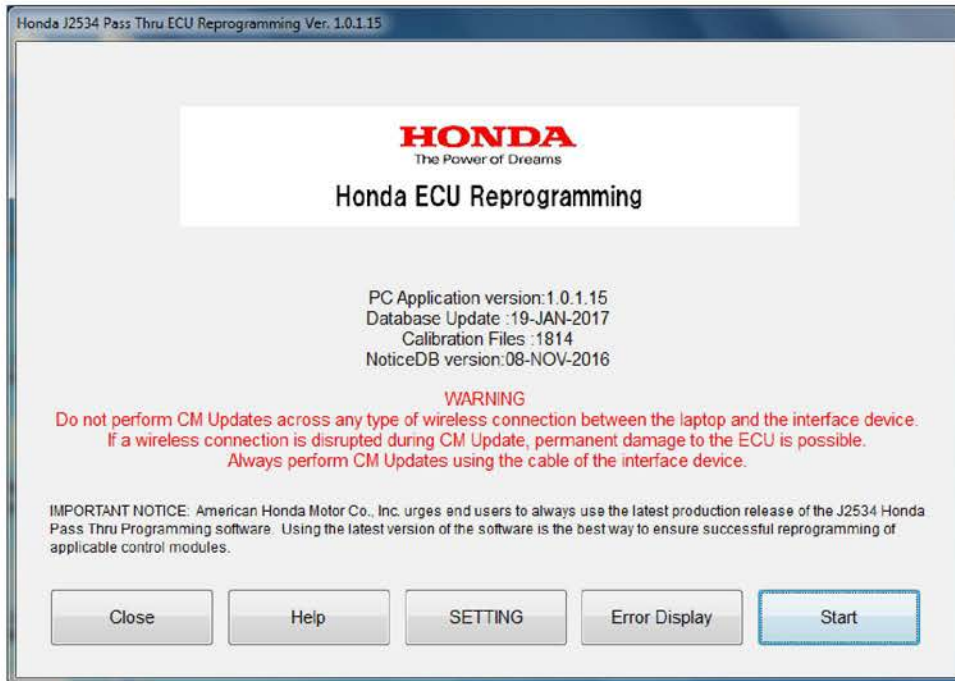
3. Confirm the software is the same **or later** as listed in SOFTWARE INFORMATION.

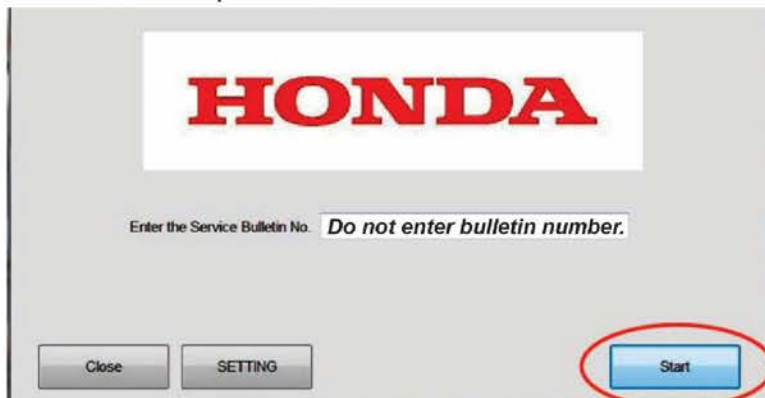
- **Do not enter a bulletin number.**
- If you receive a message that the vehicle has been already updated or that no update is available, check the transmission data list. The header should indicate one of the following numbers (or later):

37806-RP6-3080	37806-RP6-3090	37806-RP6-4060
----------------	----------------	----------------
- If the program part numbers do not match those listed above, the i-HDS software needs to be reinstalled. Contact the Special Tools Hotline at **800-346-6327** for assistance.
