# Technical Service Bulletin

SUBJECT: <b>INCORRECT DTC P0317 STORED ON TCM (6B31)</b>			No: <b>TSB-17-23-001</b>
			DATE: <b>February, 2017</b>
			MODEL: <b>2017 Outlander</b>
CIRCULATE TO:	<input type="checkbox"/> GENERAL MANAGER	<input checked="" type="checkbox"/> PARTS MANAGER	<input checked="" type="checkbox"/> TECHNICIAN
<input checked="" type="checkbox"/> SERVICE ADVISOR	<input checked="" type="checkbox"/> SERVICE MANAGER	<input checked="" type="checkbox"/> WARRANTY PROCESSOR	<input type="checkbox"/> SALES MANAGER

## PURPOSE

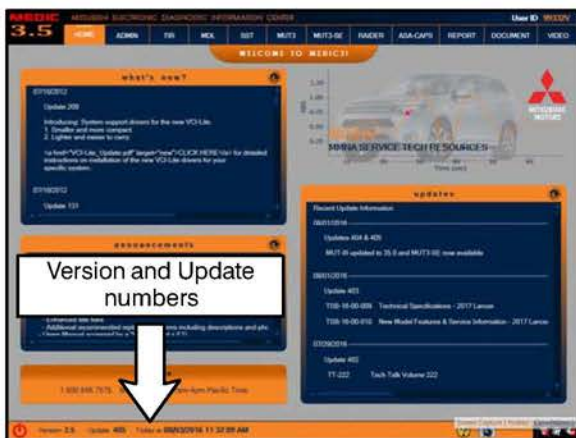
1. Verify that the TCM has not already been updated to the latest S/W number in the table above. If the TCM is at the latest level, reprogramming is not necessary.

**NOTE:** Reprogramming the TCM with the latest database (e.g., **N170101**) includes all past and current reprogramming for TSBs of affected vehicles. It is not necessary to reprogram the TCM for each previous TSB.

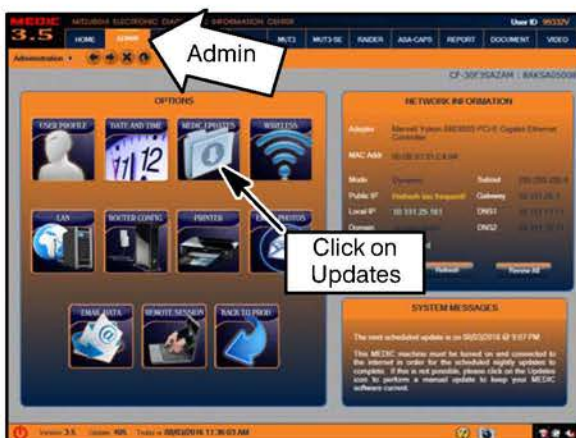
2. Verify the MEDIC 3.5/4 is at version 3.5 and at update **445** or higher.

If your **MEDIC 3.5/4 update is at least 445**, continue with the Reprogramming Procedure.

If your **MEDIC 3.5/4 update is below 445**, update your MEDIC as follows.

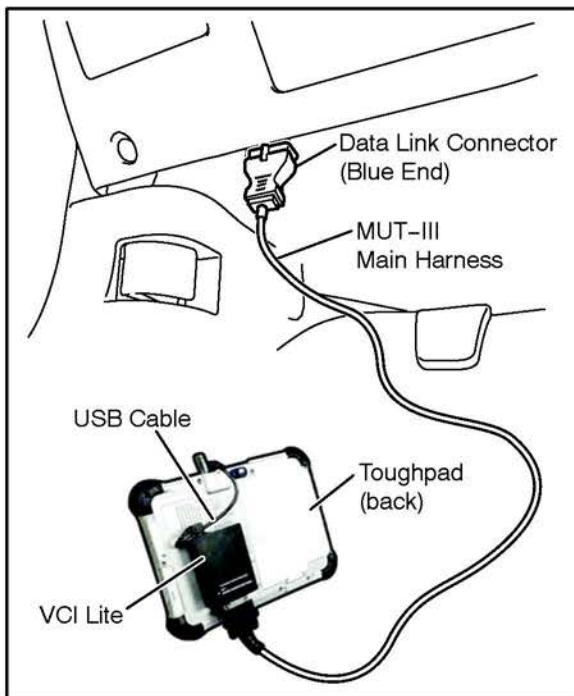
1. Connect the equipment as follows:

**NOTE:** VCI Lite and MEDIC 4.0 Toughpad shown for illustration purposes only.

- Turn the MEDIC PC/tablet on. If the battery indicator in the lower right hand corner of the screen does not show a full charge, it is recommended that either the battery be charged prior to beginning, or be used with the A/C power adaptor connected.
- Connect the USB cable to the VCI/VCI Lite.
- When the laptop/tablet displays the MUT-III main screen, connect the USB cable to the device.
- Connect the MUT-III main harness with the blue DLC connection to the VCI/VCI Lite.
- Connect the blue connection of the MUT-III main harness to the vehicle's data link connector.
- Turn the VCI power switch ON. Verify that the indicator lamp in the upper right corner of the screen is green.

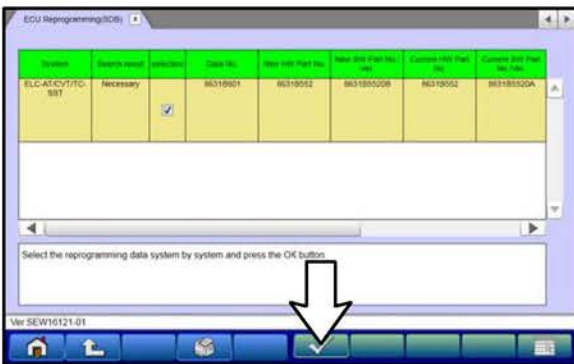
8. Verify the correct system is selected in the System List, then click the check mark.

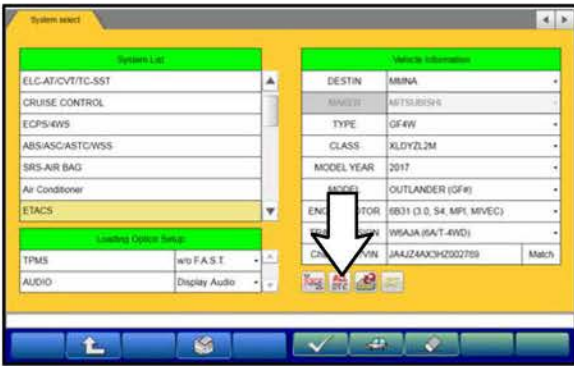
13. Verify the correct information is listed in the table, then click the check mark at the bottom of the page.

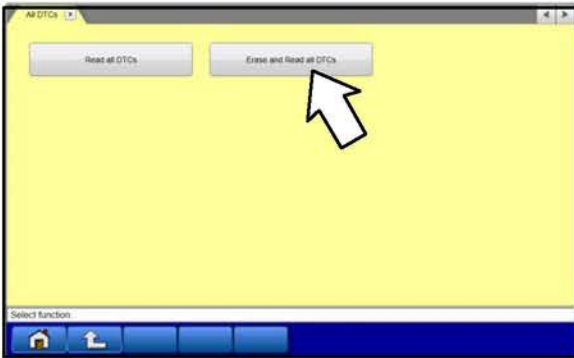
14. Perform an Erase and Read All DTCs.

- a. Click the home button to go back to the System Select menu.

Click the "ALL DTC" button.

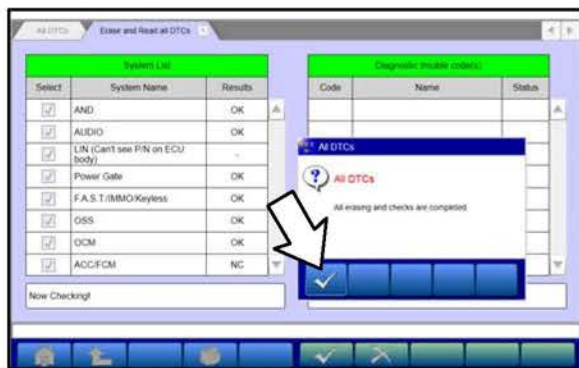
- d. The "System List" on the left side of the screen will have all selections checked. Do not change these selections. DTCs may be set if the vehicle is equipped with options that are unchecked.

- e. Click the check mark to continue.
