January 12, 2017

05060 Version 1

Product Update: 2011 RL Software Update for Lock-up Clutch Function

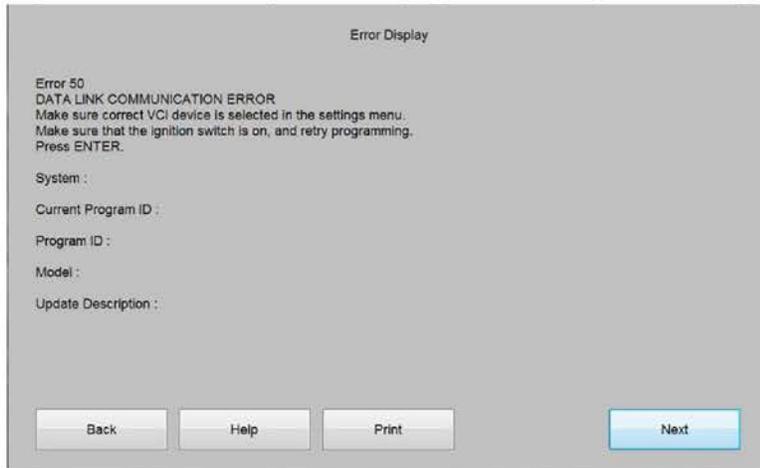
- You can't update the vehicle using the MVCI as a standalone tool.
- **Do not** use the MongoosePro VCI tool.
- Make sure the 12-volt battery is fully charged before starting an update.
- Connect a fully charged jumper battery to the vehicle, and leave it connected during the entire procedure to maintain steady voltage.
- Never turn the ignition to OFF or ACCESSORY during the update. If there is a problem with the update, leave the ignition turned to ON.
- To prevent PCM damage, do not operate anything electrical (headlights, audio system, brakes, A/C, power windows, door locks, etc.) during the update.
- If you see the following **Error Display**, check that you are using the correct tool (MVCI or DST-i) with the i-HDS.

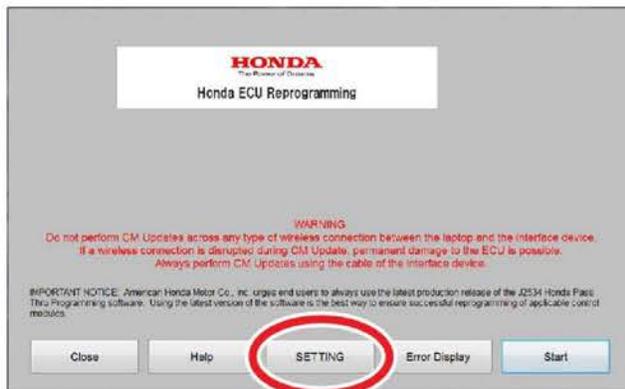
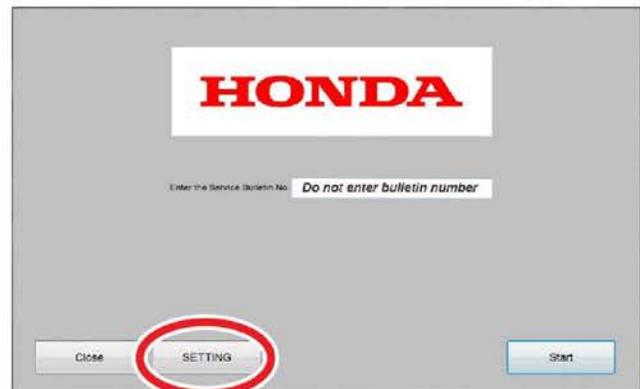
To change this, click on either of the **SETTING** selection buttons at the bottom of the J2534 initial screens as shown.

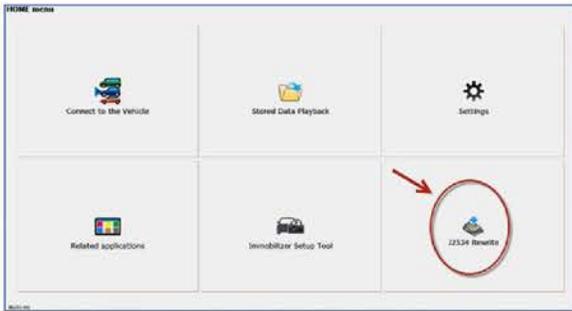
3. Select J2534 Rewrite.

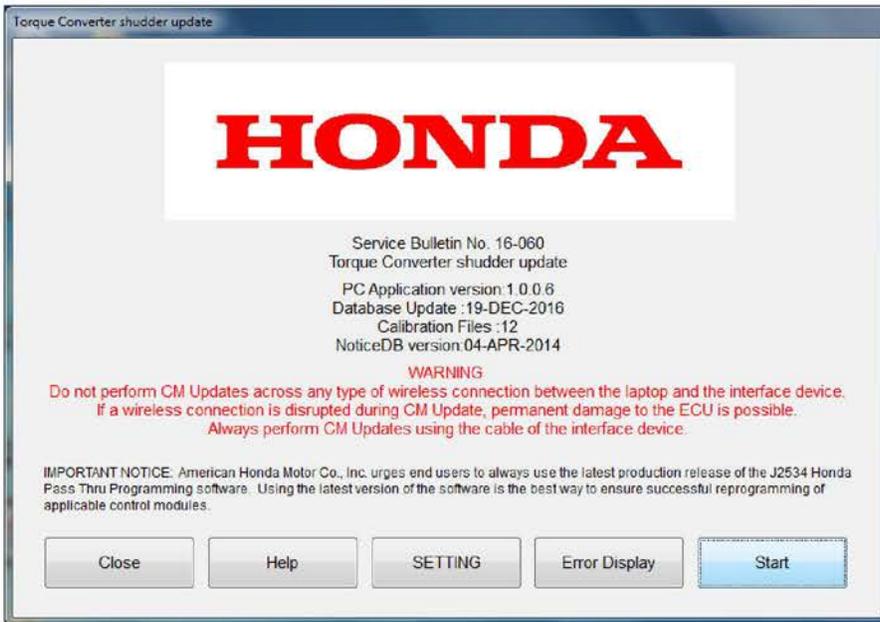
4. Confirm the software is the same **or later** as listed in SOFTWARE INFORMATION.

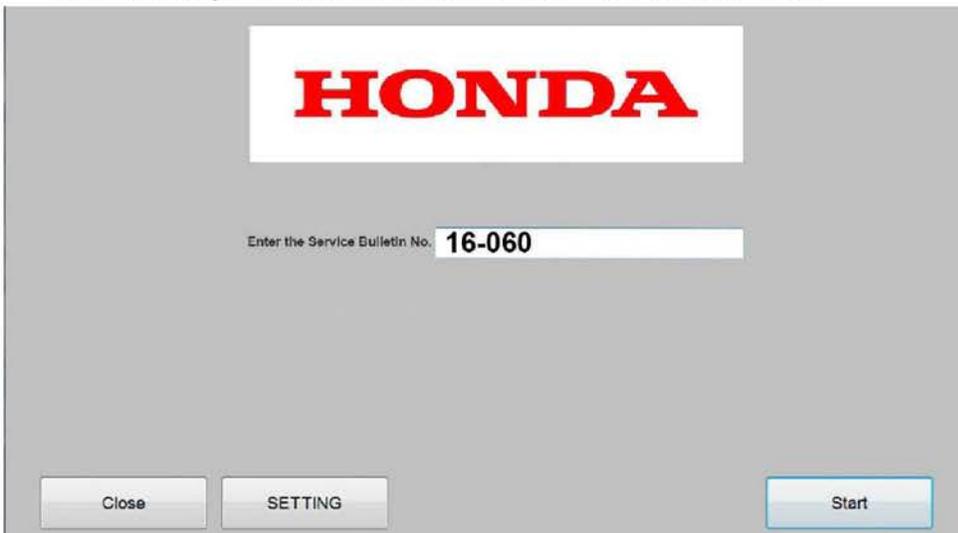
5. Enter the service bulletin number 16-060, select **Start**, then follow the on-screen prompts.

- If you receive a message that the vehicle has been already updated or that no update is available, check the PGM-FI data list. The header should indicate one of the following numbers (or later).
