January 17, 2017

05639 Version 2

**Product Update: 2011 RL Software Update for Lock-up Clutch Function**Supersedes 16-060, dated January 12, 2017, to revise the information highlighted in **yellow**Replaces 16-003, *Torque Converter Shudder***AFFECTED VEHICLES**

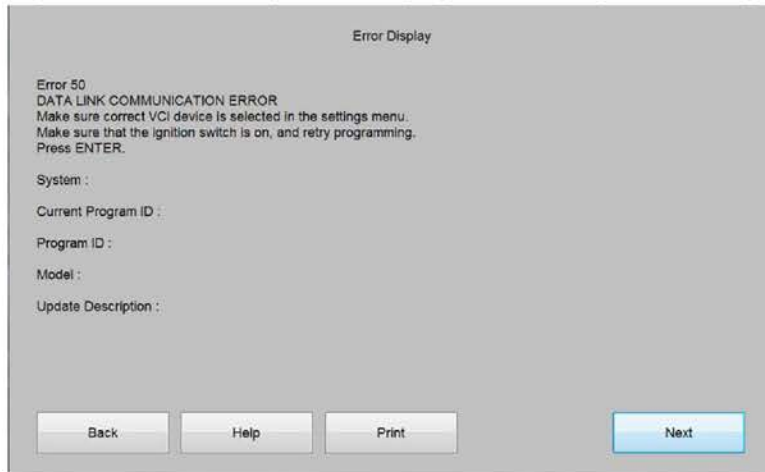
- You can't update the vehicle using the MVCI as a standalone tool.
- **Do not** use the MongoosePro VCI tool.
- Make sure the 12-volt battery is fully charged before starting an update.
- Connect a fully charged jumper battery to the vehicle, and leave it connected during the entire procedure to maintain steady voltage.
- Never turn the ignition to OFF or ACCESSORY during the update. If there is a problem with the update, leave the ignition turned to ON.
- To prevent PCM damage, do not operate anything electrical (headlights, audio system, brakes, A/C, power windows, door locks, etc.) during the update.
- If you see the following **Error Display**, check that you are using the correct tool (MVCI or DST-i) with the i-HDS.

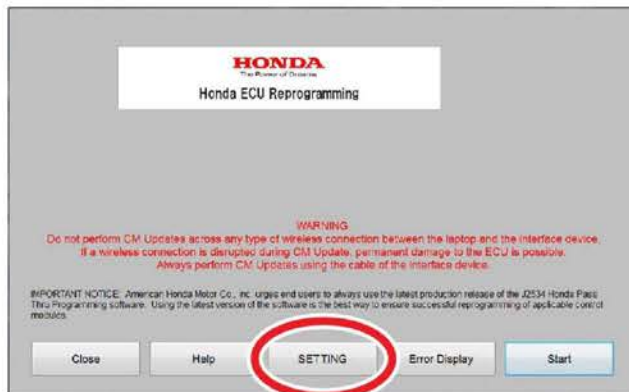
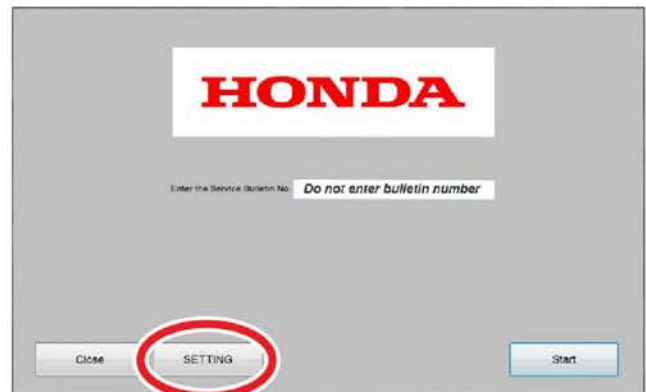
To change this, click on either of the **SETTING** selection buttons at the bottom of the J2534 initial screens as shown.

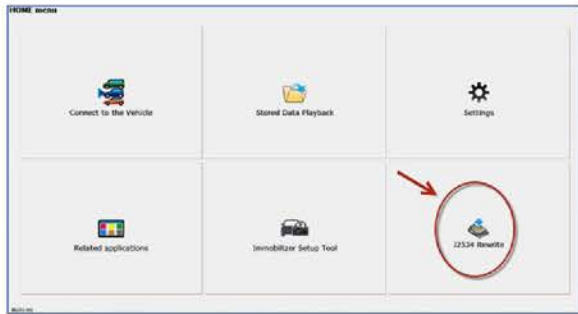
3. Select J2534 Rewrite.

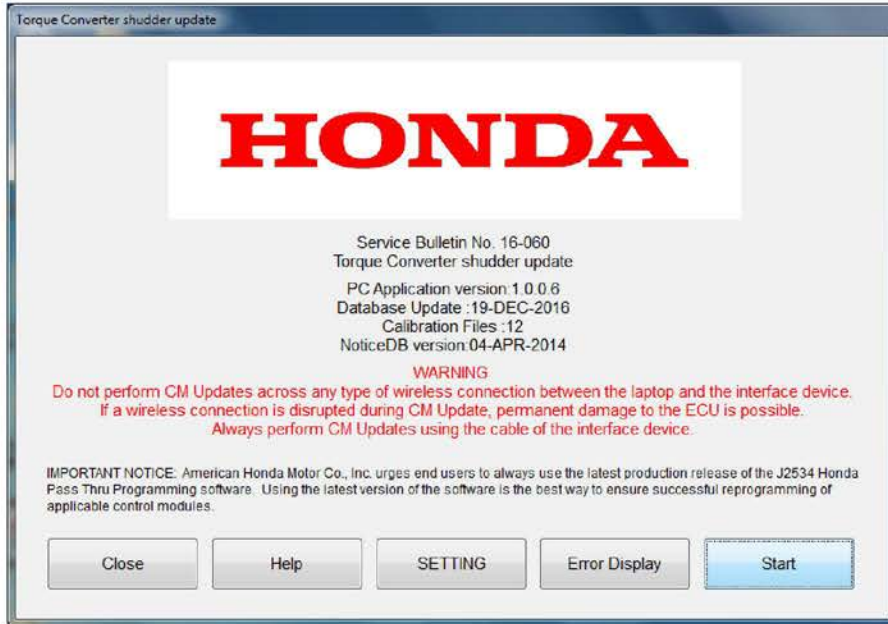
4. Confirm the software is the same **or later** as listed in SOFTWARE INFORMATION.

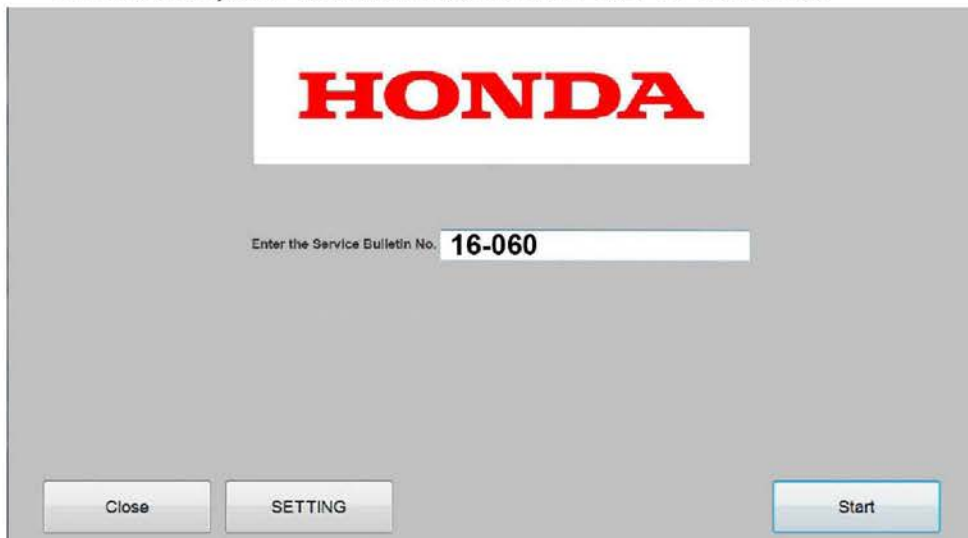
5. Enter the service bulletin number 16-060, select **Start**, then follow the on-screen prompts.

- If you receive a message that the vehicle has been already updated or that no update is available, check the PGM-FI data list. The header should indicate one of the following numbers (or later).
