05595 Version 2

2012–15 MDX: Judder from the Torque Converter Lock-Up Clutch

Supersedes 16-062, dated November 2, 2016, see REVISION SUMMARY

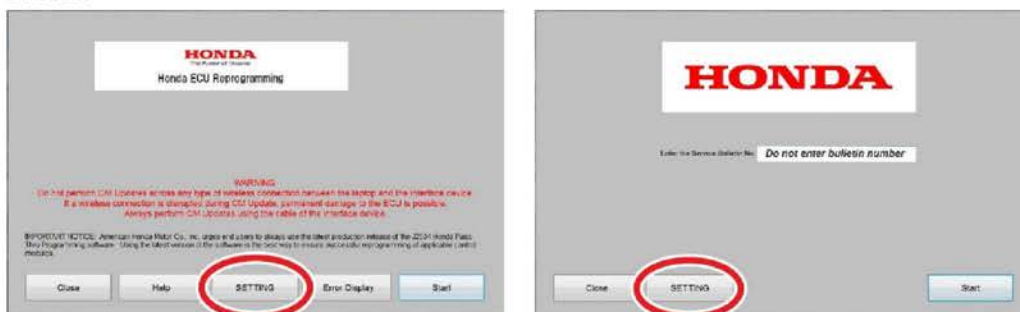
To change this, click on either of the SETTING selection buttons at the bottom of the J2534 initial screens as shown.

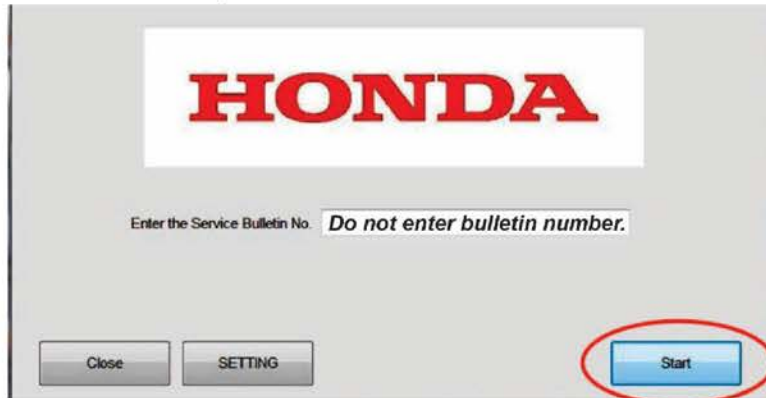
4. Select **Start**, then follow the screen prompts.

- **Don't enter a bulletin number.**
- If you receive a message that the vehicle has been already updated or that no update is available, check the transmission data list. The header should indicate one of the following numbers (or later).
