February 23, 2017

05851 Version 3

Warranty Extension: 2010 Accord Crosstour Software Update for Lock-up Clutch Function Based on Customer Complaint

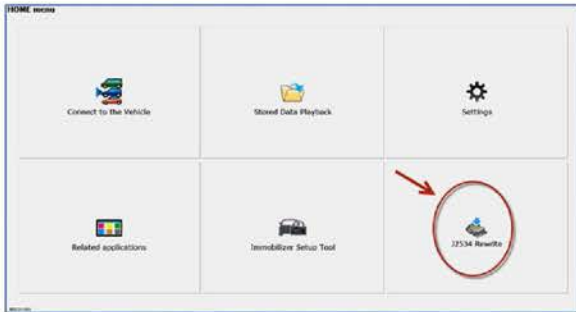
- Select **J2534 Rewrite**.

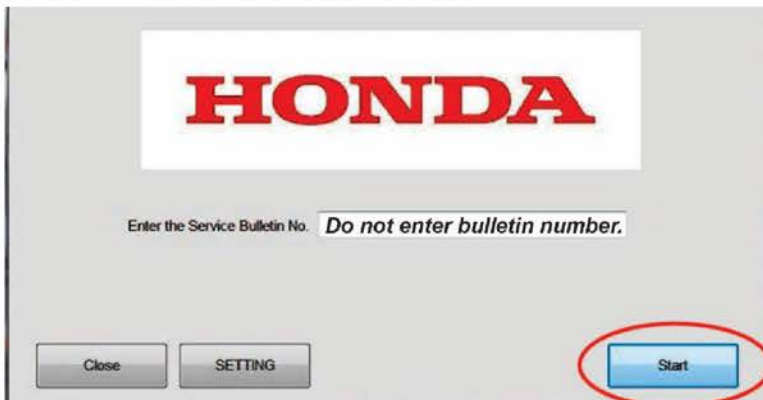
- Select **Start**, then follow the screen prompts.

NOTE: Don't enter a bulletin number.
