**March 1, 2017**

05809 Version 2

**2016 Civic 1.5L Turbo RPM Surges at Highway Speeds (45–70 MPH)**

Supersedes 16-028 dated March 17, 2016, see REVISION SUMMARY

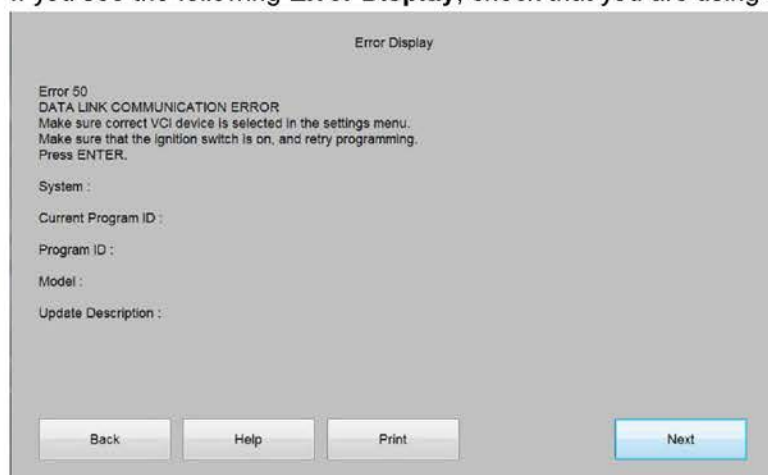
- You cannot update the vehicle using the MVCI as a standalone tool.
- Do not** use the MongoosePro VCI tool.
- Make sure the 12-volt battery is fully charged before starting an update.
- Connect a fully charged jumper battery to the vehicle, and leave it connected during the entire procedure to maintain steady voltage.
- Never turn the ignition to OFF or ACCESSORY during the update. If there is a problem with the update, leave the ignition turned to ON.
- To prevent PCM damage, do not operate anything electrical (headlights, audio system, brakes, A/C, power windows, door locks, etc.) during the update.
- If you see the following **Error Display**, check that you are using the correct tool (MVCI or DST-i) with the i-HDS.

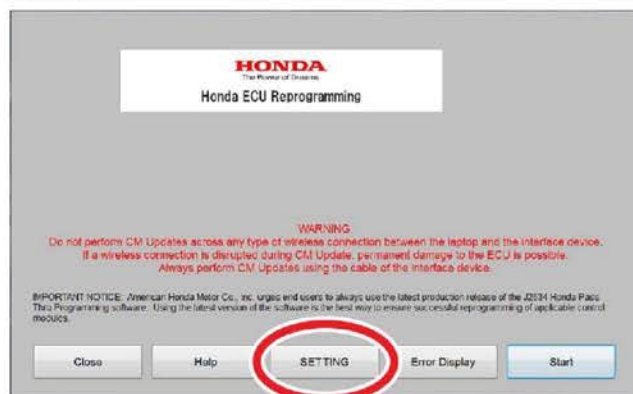
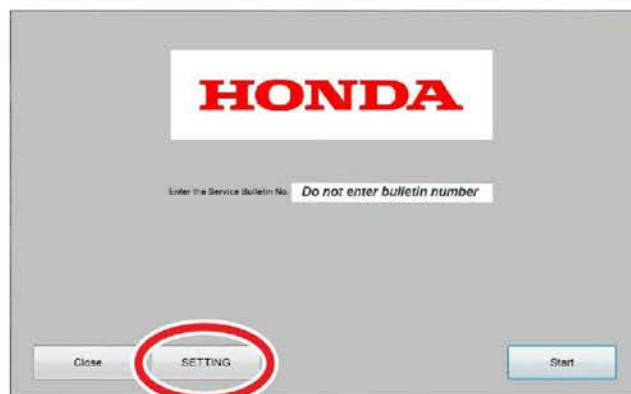
To change this, click on either of the **SETTING** selection buttons at the bottom of the J2534 initial screens as shown.

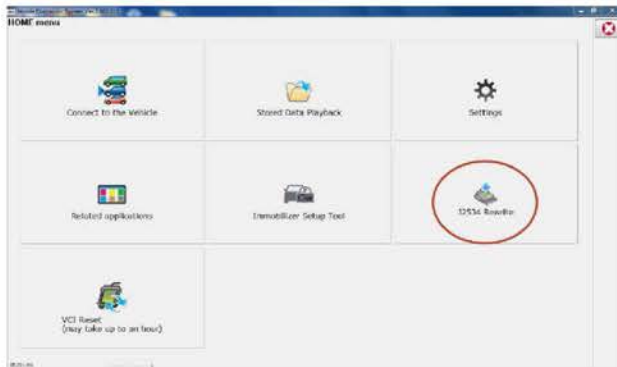
2. Select **J2534 Rewrite**.

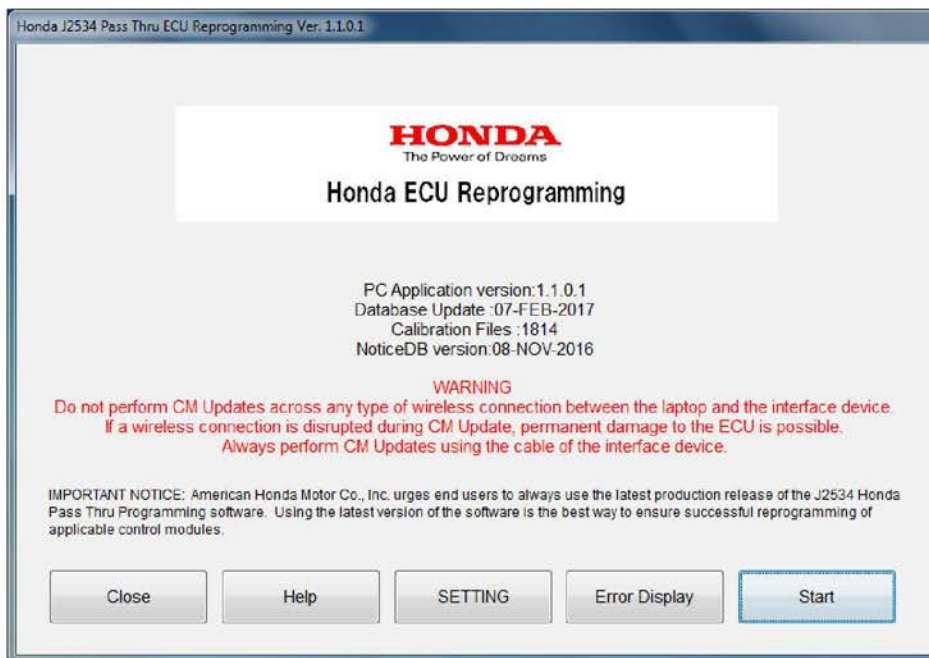
3. Confirm the software is the same **or later** as listed in SOFTWARE INFORMATION.
