05920 Version 2

## Audio-Navigation Unit Software Update

Year	Model	Trim	VIN Range
2016	Pilot	EX and above	ALL

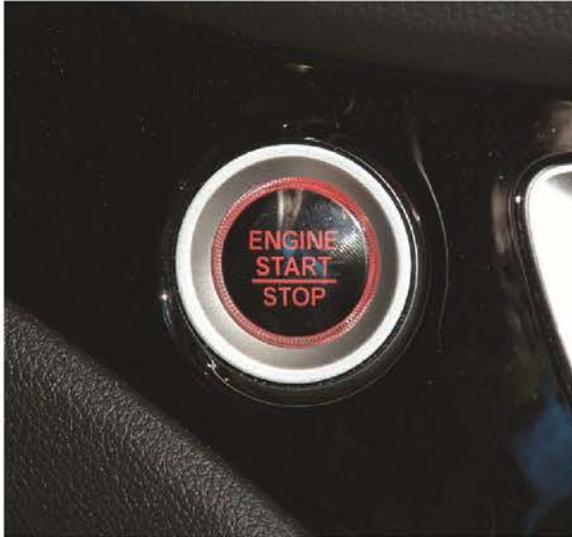
- If the vehicle arrives at the dealership with a blank screen, do a battery cable reset before doing the update.
1. Connect a battery charger or a fully charged jumper battery to the vehicle, and leave it connected during the entire update procedure to maintain a steady voltage.
  2. Turn the ignition to ON.

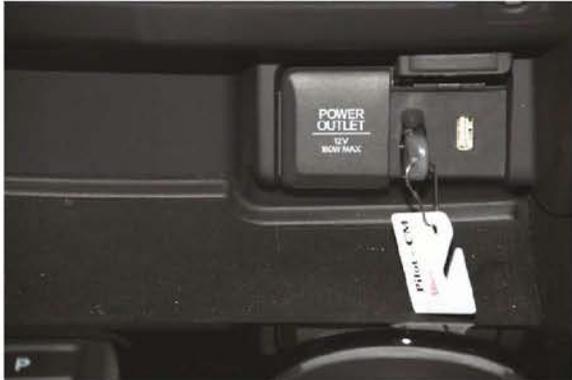
3. Insert the USB update device into the USB port.

**NOTE: If the screen goes blank after the USB update device is inserted, turn the ignition to OFF for 1 minute, then back to ON. The update should restart automatically.**

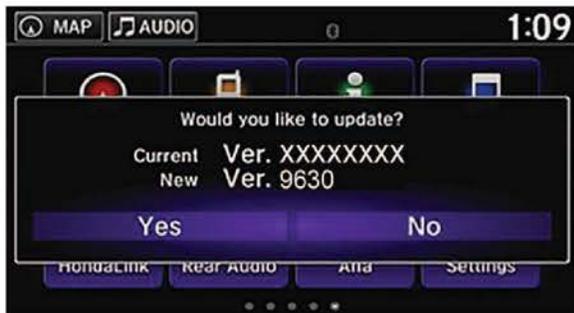
- When you see the message **Would you like to update**, select **Yes**.

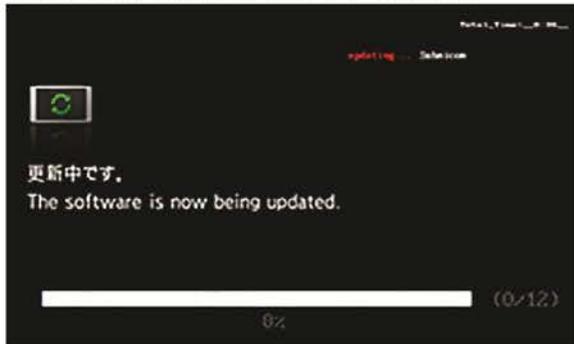
This screen will show after 1–2 minutes.

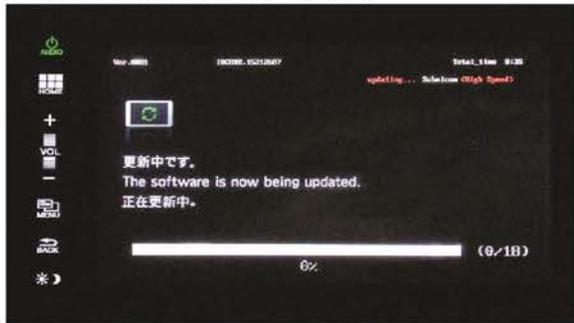
This screen will show 0% for about 20–25 minutes without updating. However, the update is still working and you do not have to oversee the update.

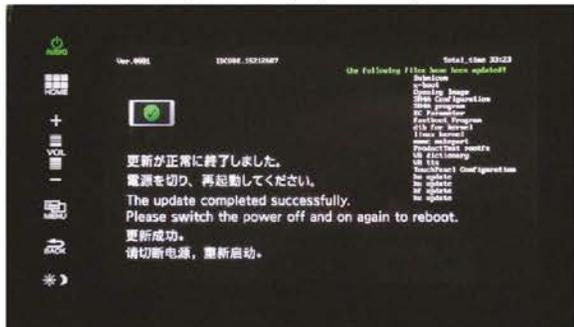
- When the screen shows **The update completed successfully**, turn the ignition OFF and remove the USB update device.

NOTE: You may hear a pop when you remove the device.

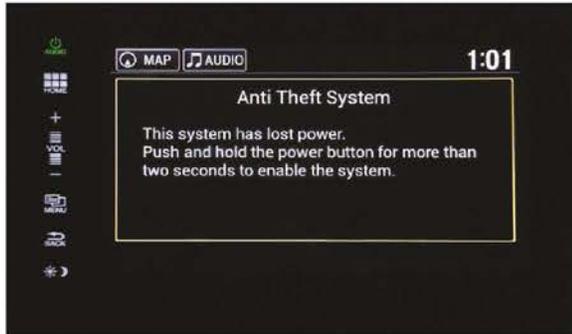
6. Start the engine, and wait until the **Anti-Theft System** screen appears. Then, press and hold the audio power button for more than 5 seconds. The update is complete.

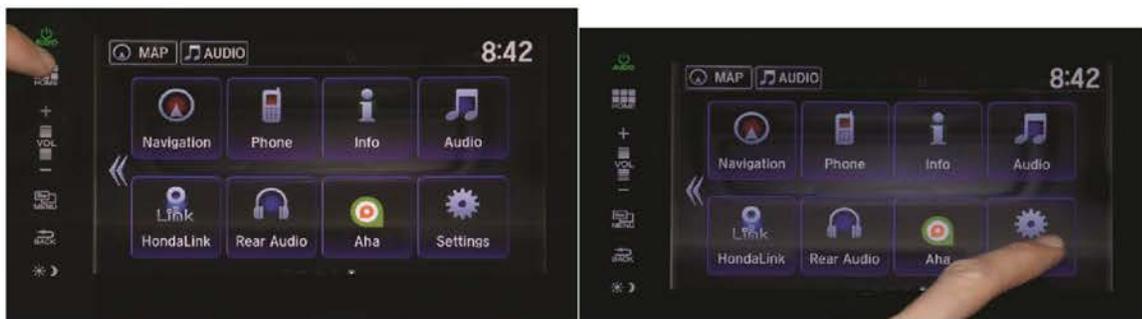
1. Select **HOME**, then **Settings**.

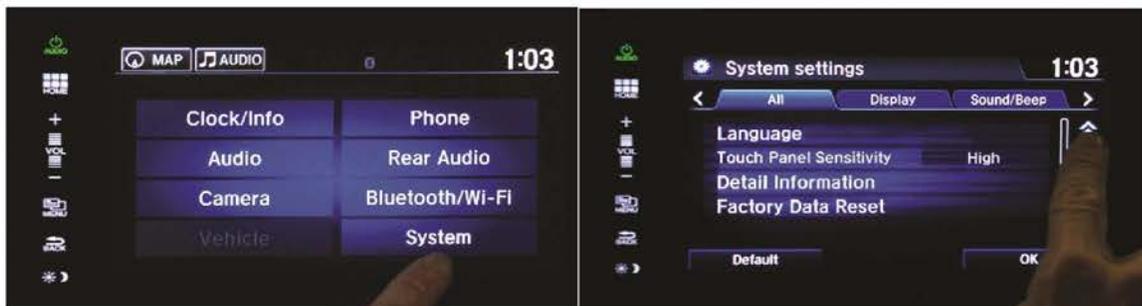
2. Select **System**, then scroll up until you see **Factory Data Reset**.

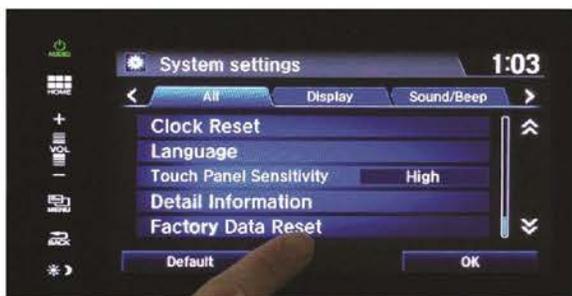
3. Select **Factory Data Reset**.

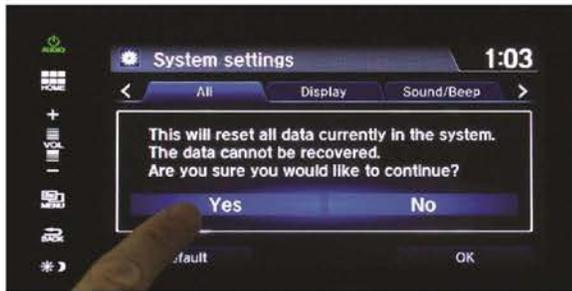
4. Select **Yes** on the pop-up screen. The system will reboot and return to normal. The phone now can be paired using the phone setup in the owner's manual.

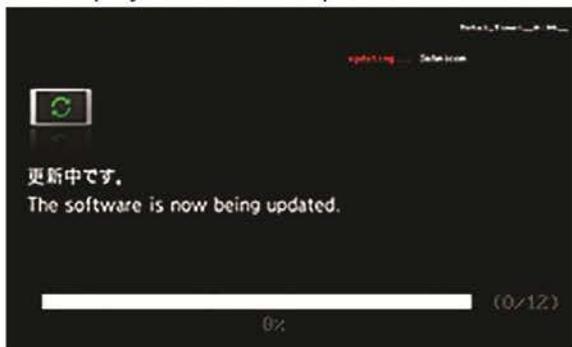
1. Turn the ignition to OFF.
2. Remove the USB update device.
3. Disconnect the negative battery cable for 2 minutes.
4. Connect the negative battery cable.
5. Turn the ignition to ON.
6. Insert the USB update device into the USB port. The display screen will continue to be blank for up to 10 minutes.

The display will show the update screen start back at 0 %.

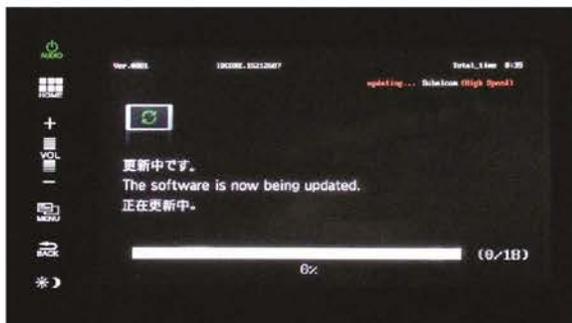
The screen will show 0% for about 20–25 minutes without updating. However, the update is still working.

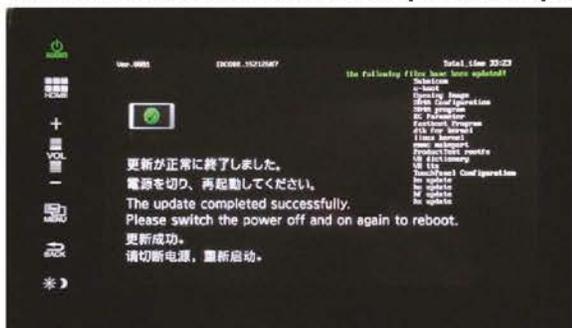
Wait until the screen shows **The update completed successfully.**

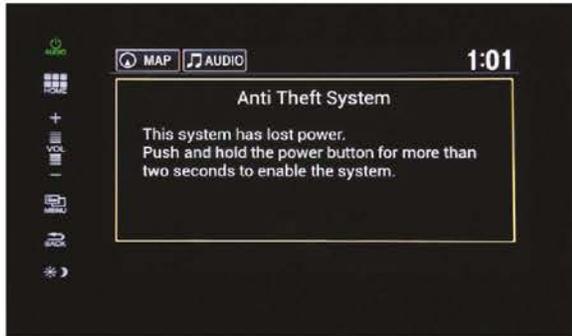
7. Turn the ignition to OFF, and remove the USB update device. You may hear a pop when you remove the device.
8. Start the engine and wait until the **Anti-Theft System** screen appears. Then, press and hold the audio power button for more than 5 seconds. The update is complete.
