March 4, 2017

05859 Version 1

2013–17 Accord: Judder from the Torque Converter Lock-Up Clutch

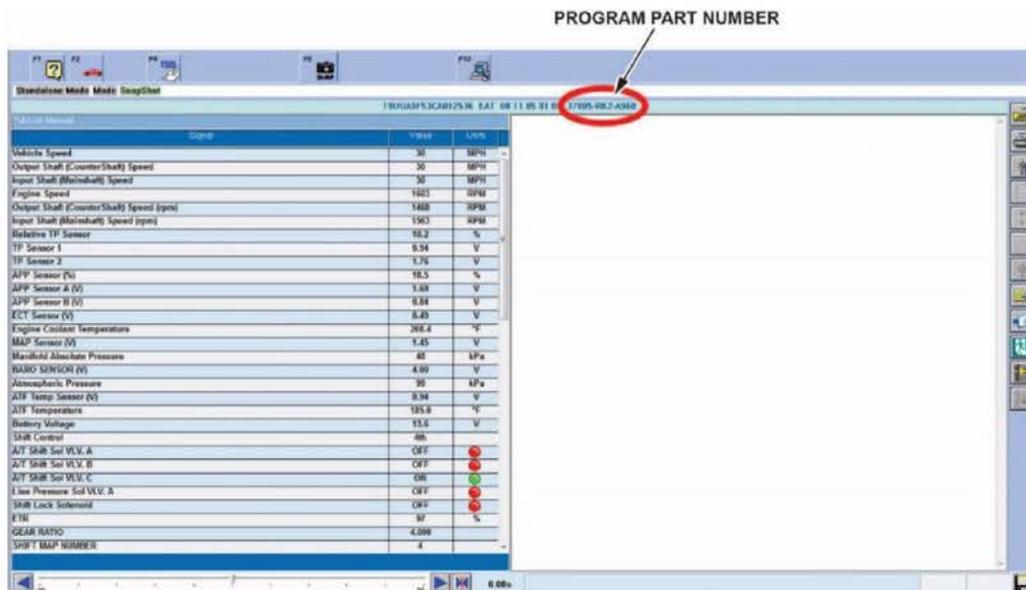
1. Connect the i-HDS, and go to the A/T Data List. Check to see if the software has been updated by comparing the program P/N against the table below.

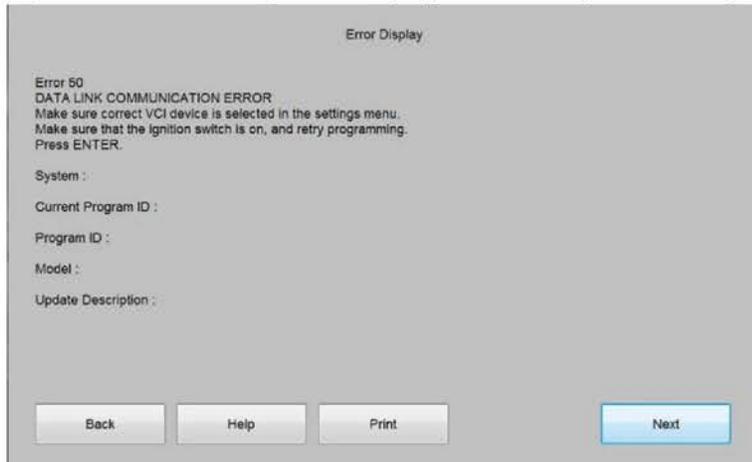
- You can't update the vehicle using the MVCI as a standalone tool.
- **Do not** use the MongoosePro VCI tool.
- Make sure the 12 volt battery is fully charged before starting an update.
- Connect a fully charged jumper battery to the vehicle and leave it connected during the entire procedure to maintain steady voltage.
- Never turn the ignition to OFF or ACCESSORY during the update. If there is a problem with the update, leave the ignition turned to ON.
- To prevent PCM damage, do not operate anything electrical (headlights, audio system, brakes, A/C, power windows, door locks, etc.) during the update.
- If you see the following Error Display, check that you are using the correct tool (MVCI or DST-i) with the i-HDS.

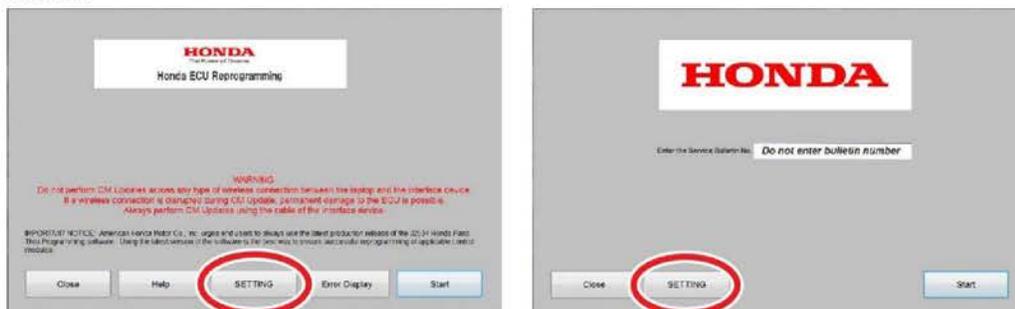
To change this, click on either of the SETTING selection buttons at the bottom of the J2534 initial screens as shown.

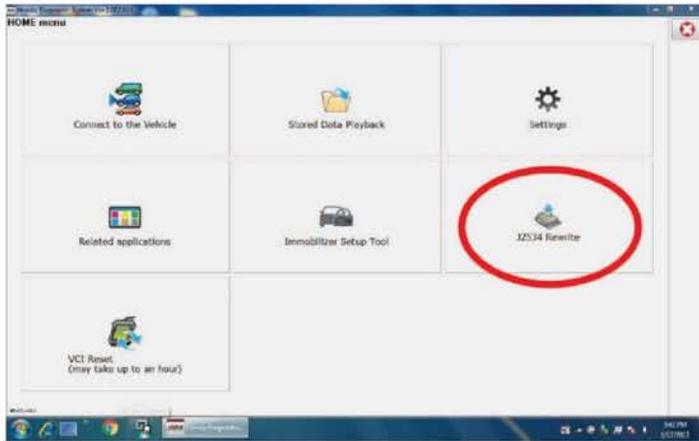
2. Select **J2534 Rewrite**.

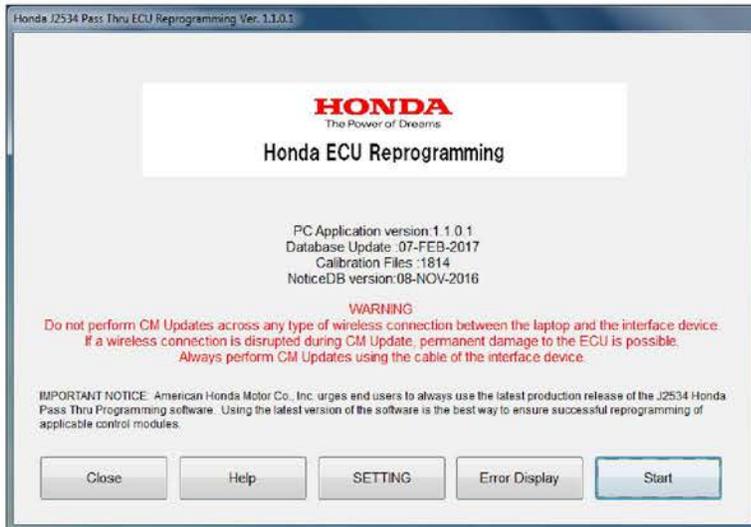
3. Confirm the software is the same **or later** as listed in SOFTWARE INFORMATION.

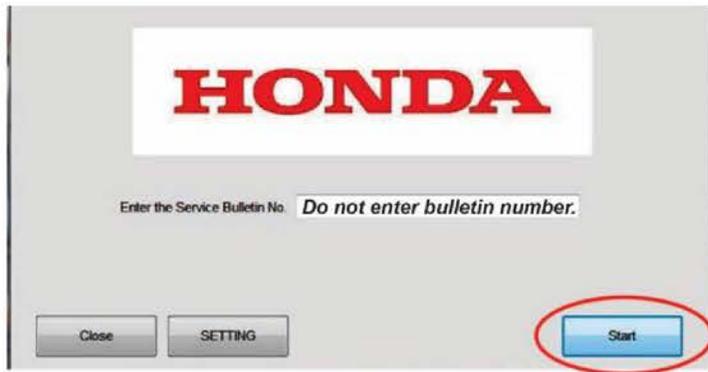
- **Don't enter a bulletin number.**
- If you receive a message that the vehicle has been already updated or that no update is available, check the transmission data list. The header should indicate one of the following numbers (or later).
