March 14, 2017

05323 Version 1

## Audio-Navigation Unit Software Update/Correct Phonebook Importing Errors

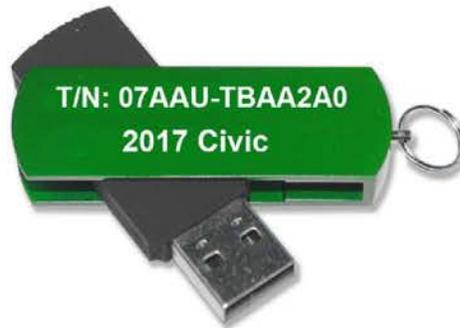
Tool Name	Part Number
Audio-Navigation System Update Device (Green USB Drive)	07AAU-TBAA2A0

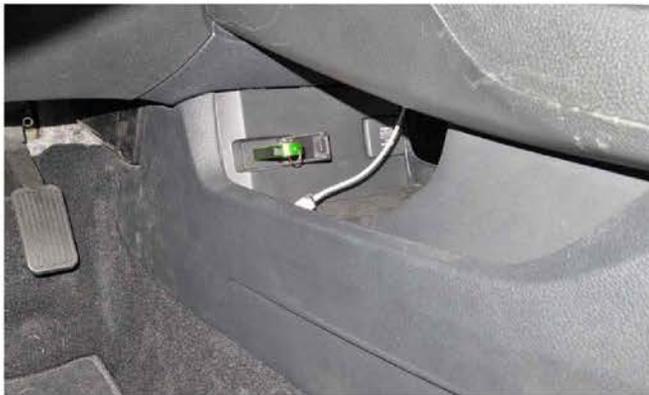
4. Push the Engine Start button twice for the Ignition ON mode (not Accessory mode).
  5. Plug the green USB update tool into the USB port below and behind the audio unit near the driver's knee area.

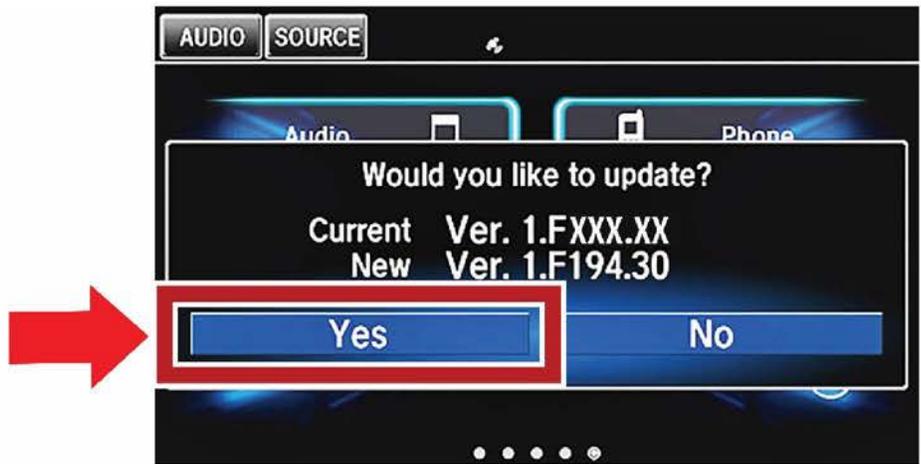
6. If a pop up window does not appear go to step 7. If a popup window does appear, select **Yes**, then go to step 9.

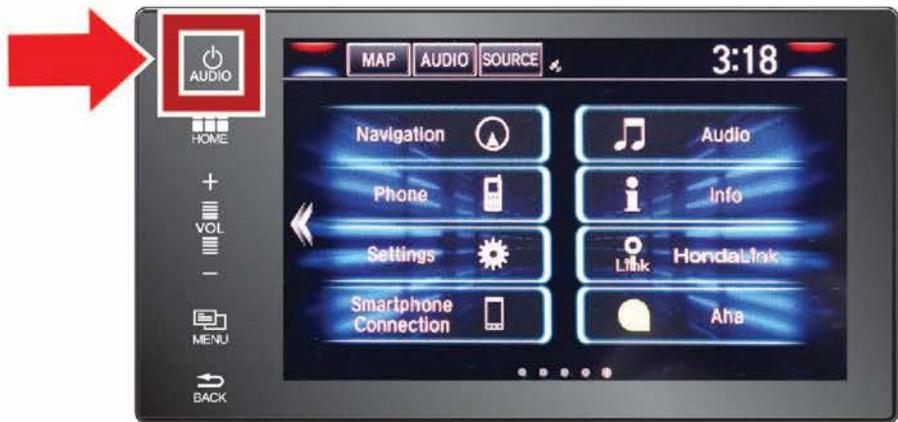
7. From the **HOME** screen, press and hold the **Audio Power** button for a few seconds.

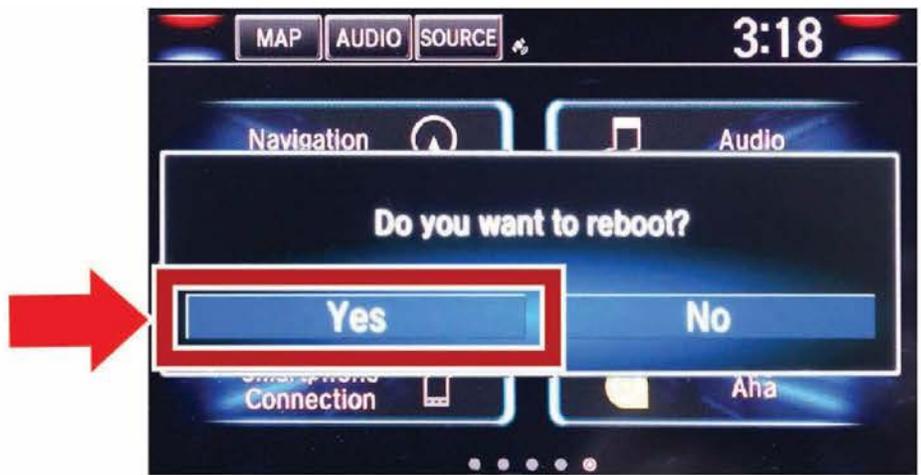
8. Press **YES** to reboot the unit.

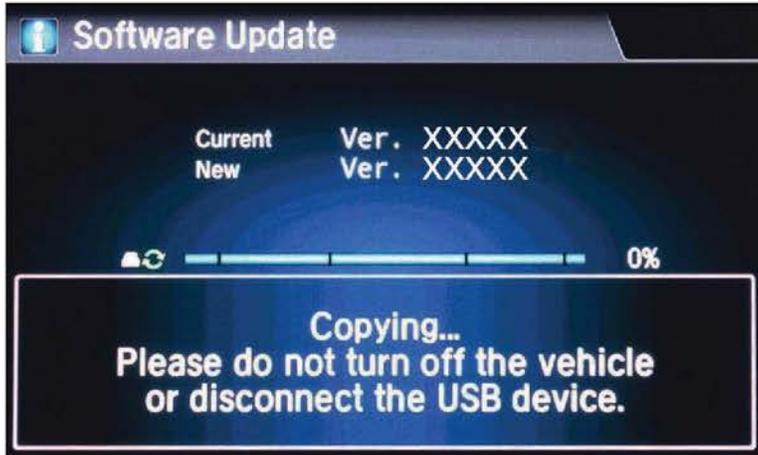
9. The software update should start. It takes up to 20 minutes to complete the update. Once you start the update, you do not have to stay with the vehicle.

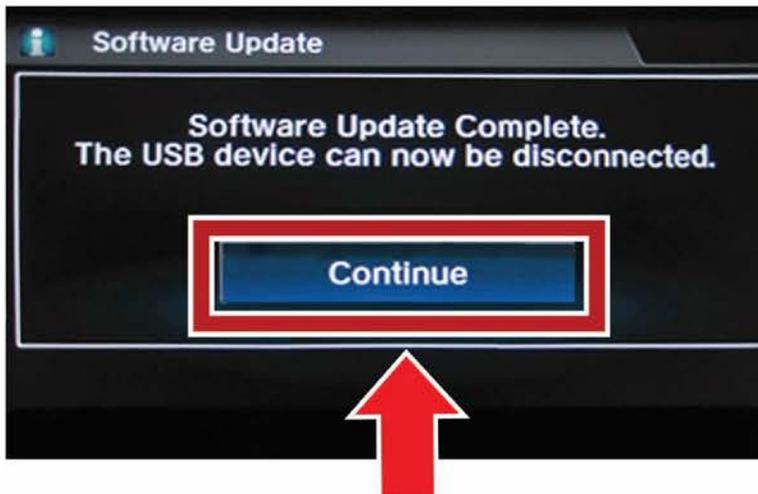
NOTE: After the update has completed, make sure you do not turn the engine or ignition off until the unit stays on the **HOME** screen for more than 2 minutes without any screen changes to make sure all of the update has finished completely.

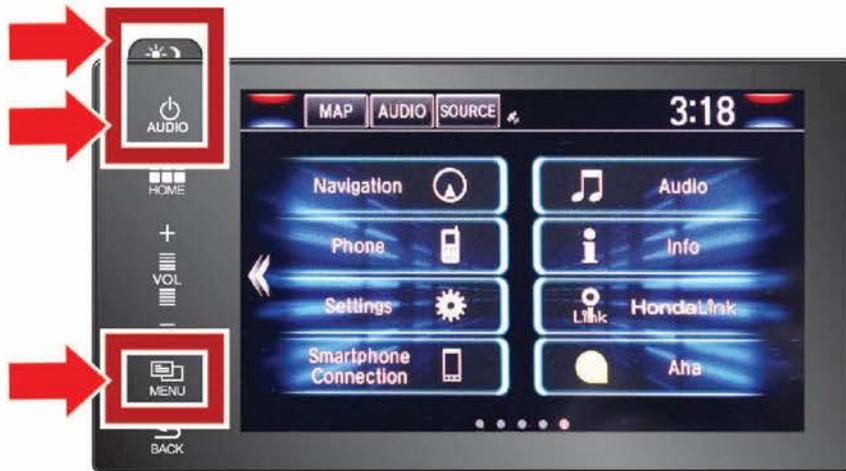
11. Press and hold the **Day/Night**, **Audio Power**, and **MENU** buttons at the same time.

NOTE: The system may ask to acquire GPS signal. If so, take the vehicle to a place to acquire signal.

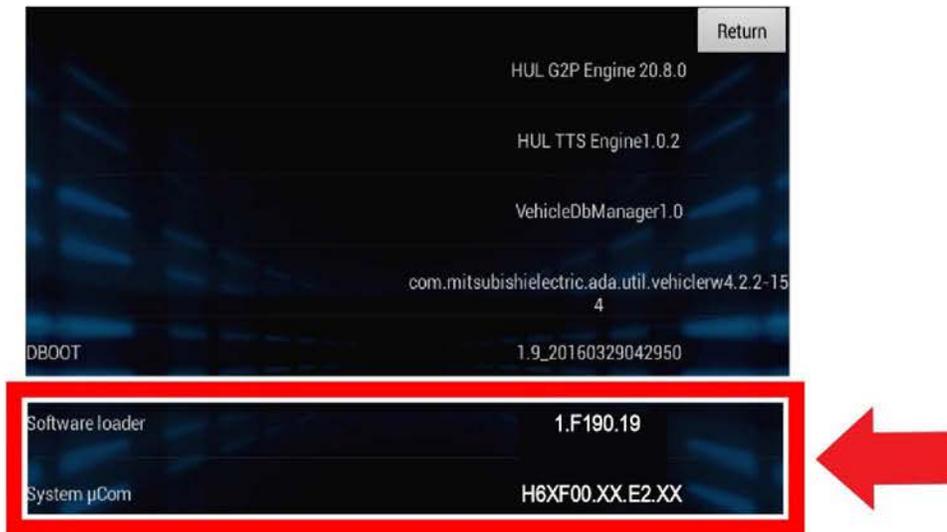
14. Scroll all the way to the bottom to: **Software loader** and **System μCom** and check the versions. The software should be updated to the following versions:

- **Software loader** : 1.F194.30
- **System μCom** : H61F0070.E2.12 (with XM radio function)  
H62F0070.E2.12 (without XM radio function)

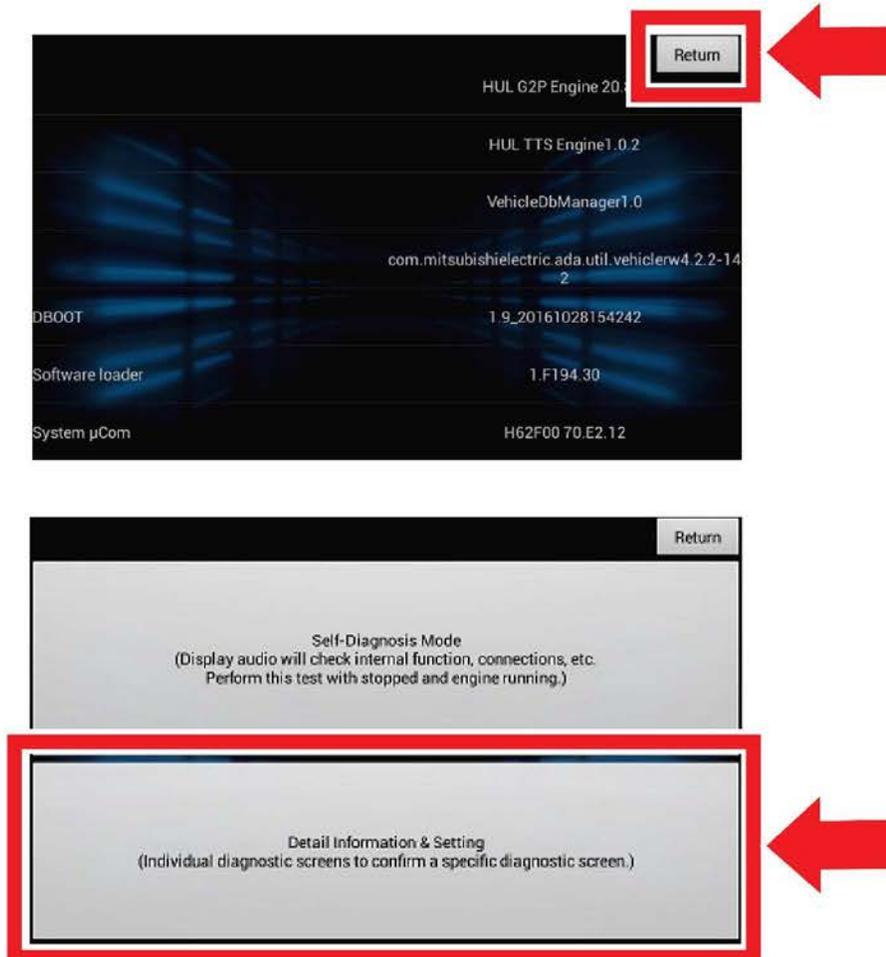
15. After verifying the software has been updated, select **Return** to return to the **Detail Information & Setting** screen.

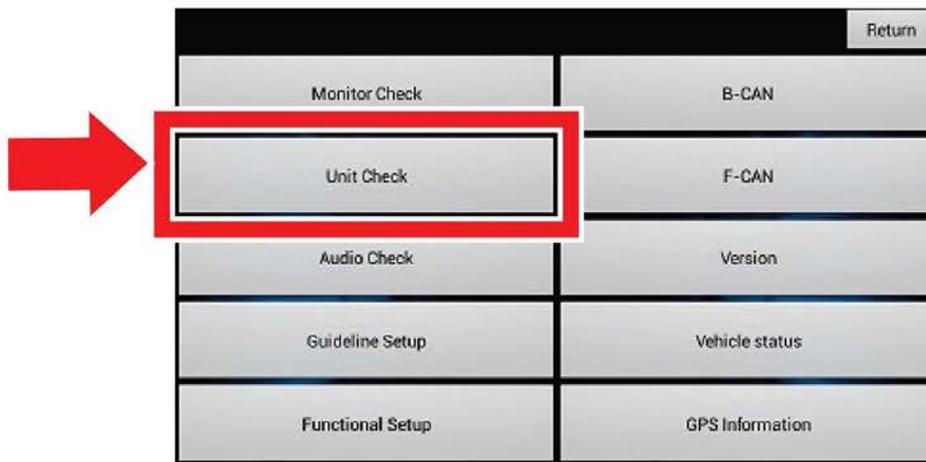
16. Select **Unit Check**.

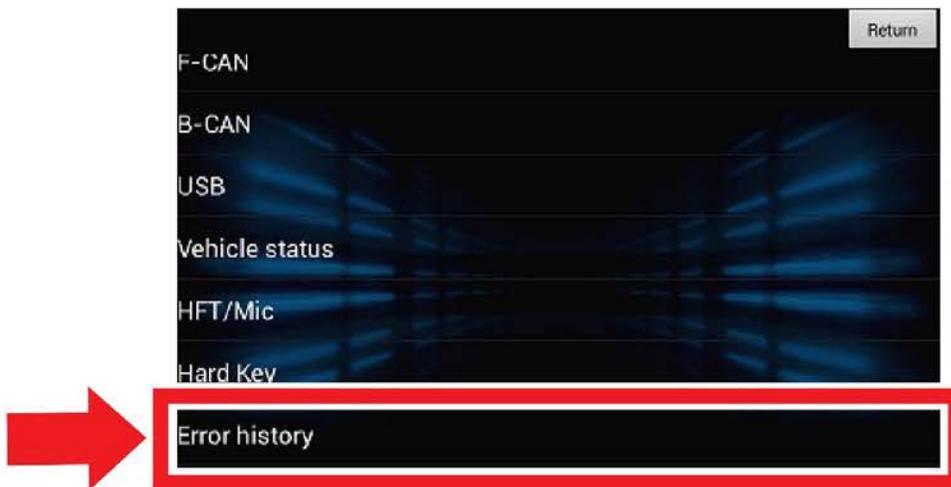
17. Select **Error History**.

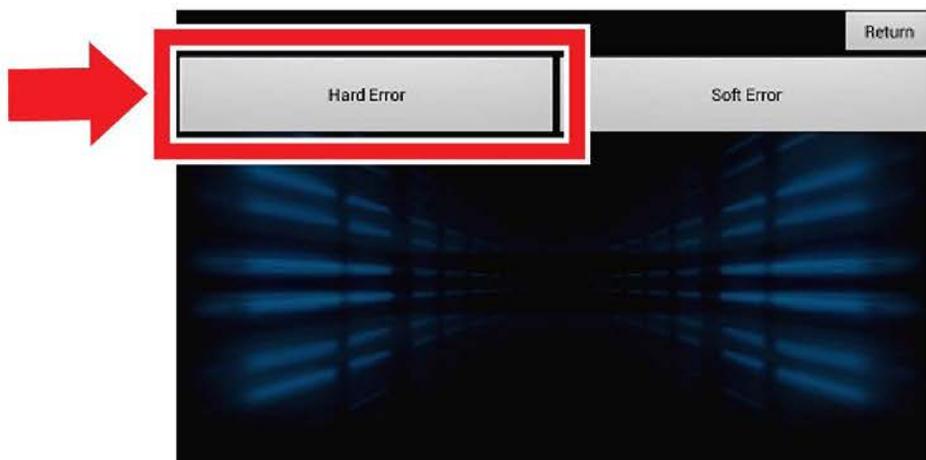
18. Select **Hard Error**.

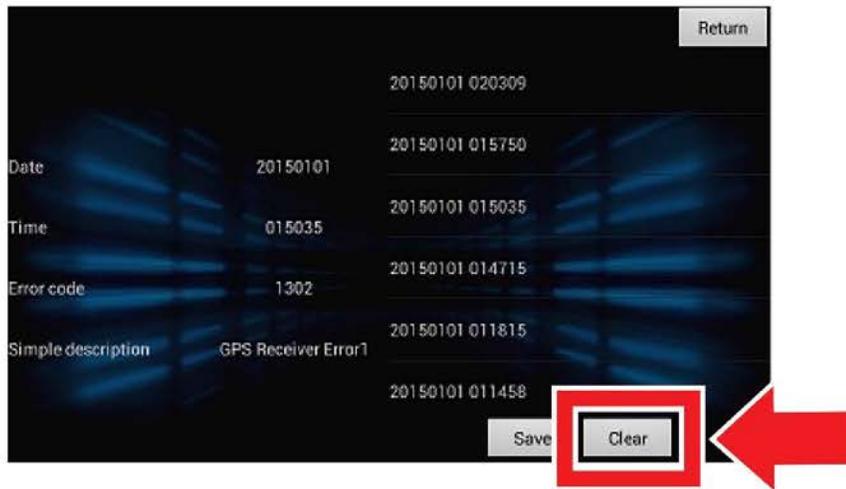
19. Select **Clear**.

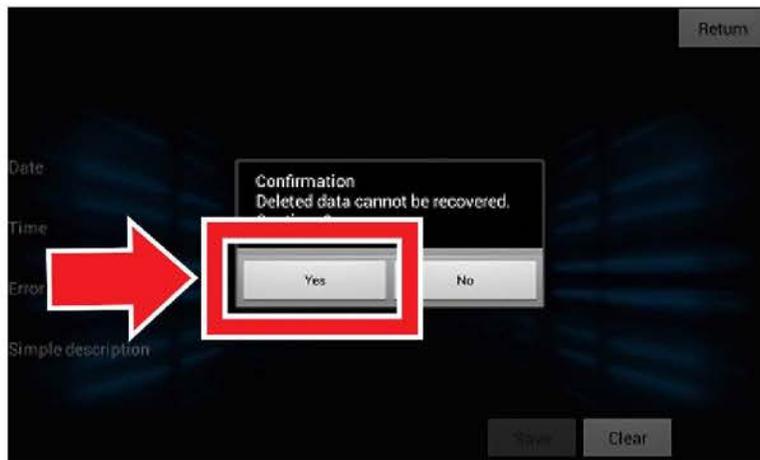
20. Select **Yes**.

NOTE: This will erase all user memory, including radio presets and *Bluetooth*<sup>®</sup> pairing profiles.

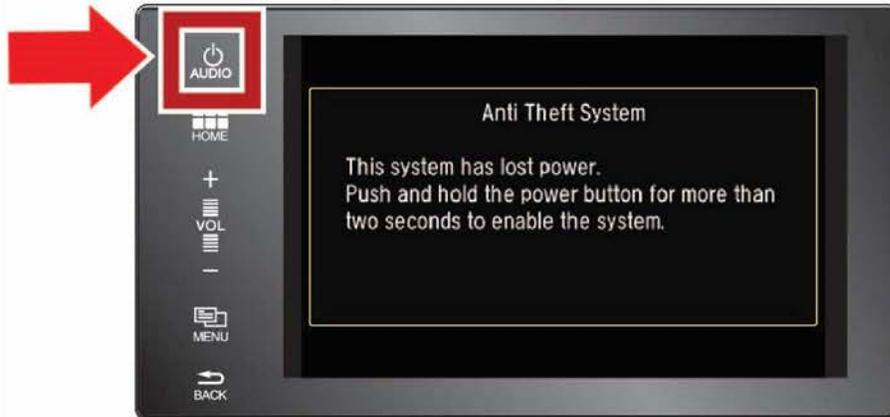
21. When the **Anti Theft System** screen appears, push and hold the **Audio Power** button for more than 2 seconds to enable the system.

- If nothing is done for 30 seconds, the screen goes black. Push the **Day/Night** or **BACK** button to return to the screen.
- If the vehicle is not running or the ignition is not in IG 2 the audio unit will not pass the security screen.

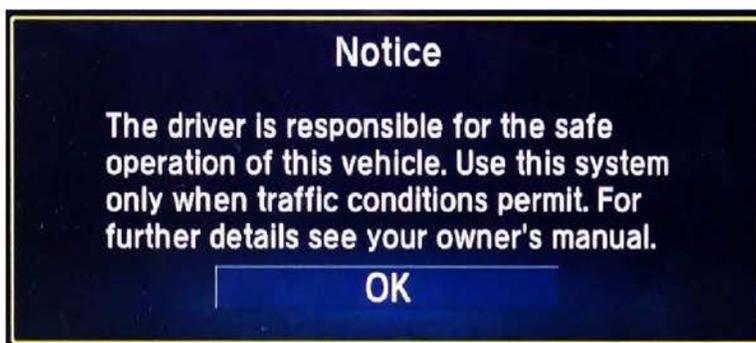
Once a GPS signal is received, a notification screen will appear briefly.

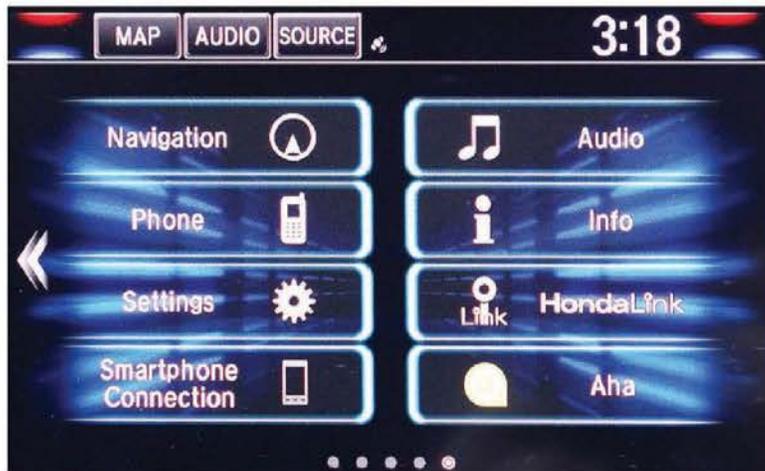
Then, the **HOME** screen will appear.
