06079 Version 2

Audio-Navigation Unit Software Update/Correct Phonebook Importing Errors

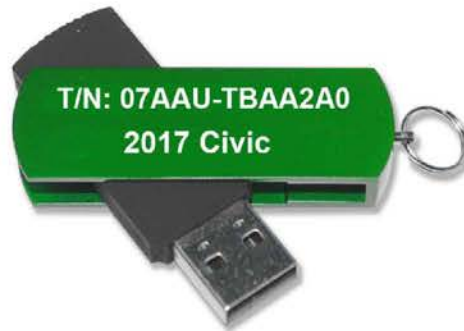
Tool Name	Part Number
Audio-Navigation System Update Device (Green USB Drive)	07AAU-TBAA2A0

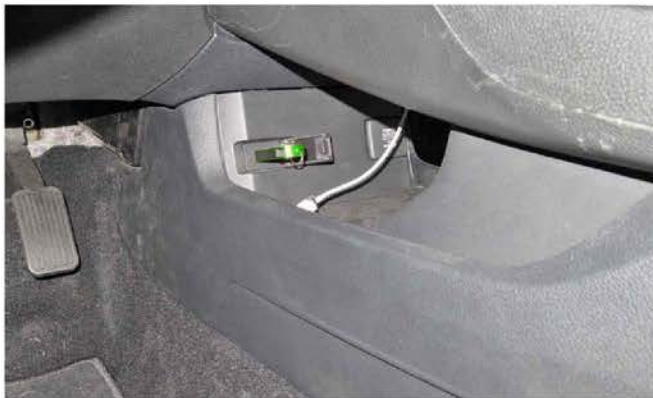
4. Push the Engine Start button twice for the Ignition ON mode (not Accessory mode).
 5. Plug the green USB update tool into the USB port below and behind the audio unit near the driver's knee area.

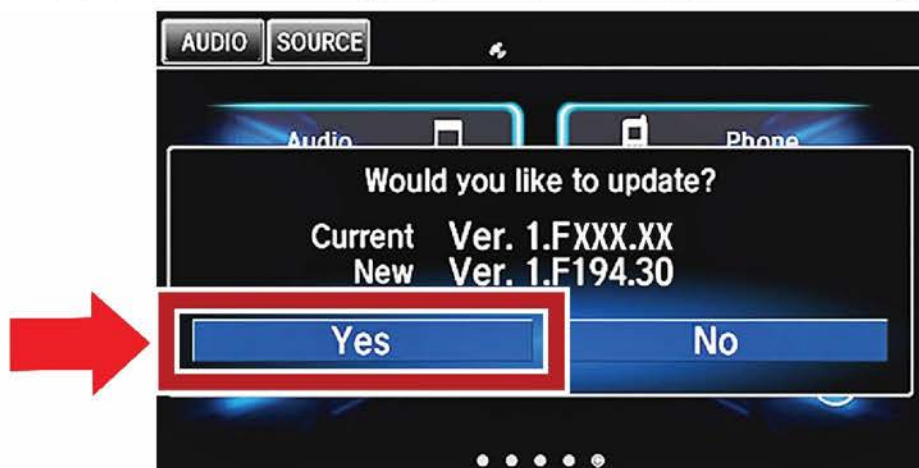
6. If a pop up window does not appear go to step 7. If a popup window does appear, select **Yes**, then go to step 9.

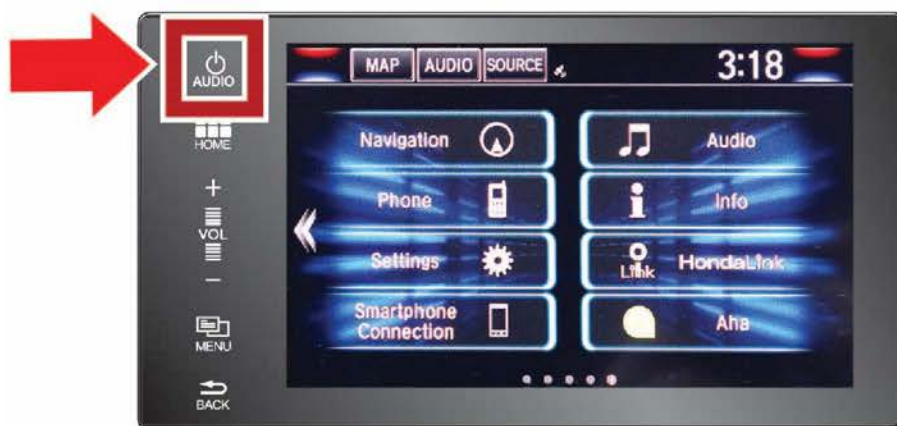
7. From the **HOME** screen, press and hold the **Audio Power** button for a few seconds.

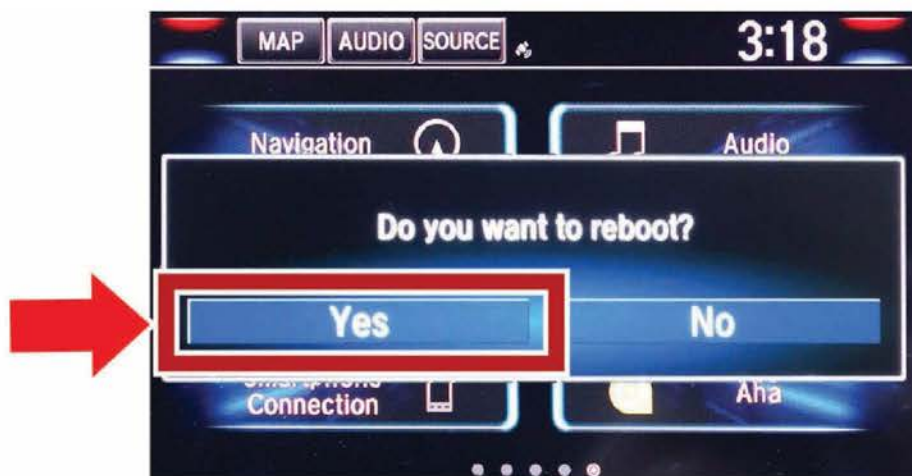
8. Press **YES** to reboot the unit.

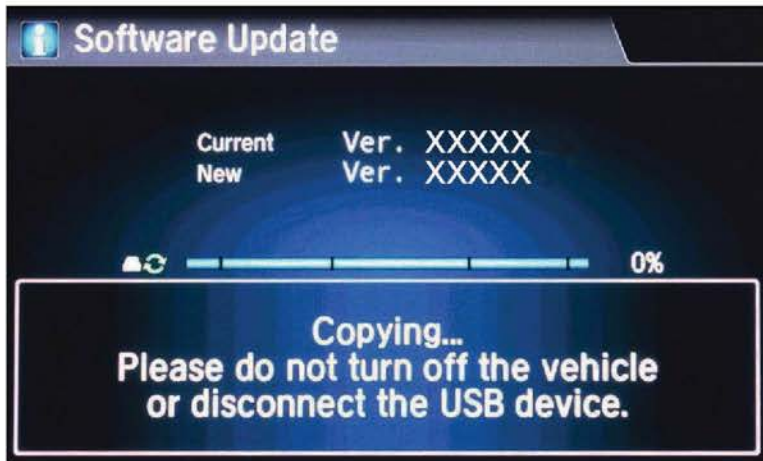
9. The software update should start. It takes up to 20 minutes to complete the update. Once you start the update, you do not have to stay with the vehicle.

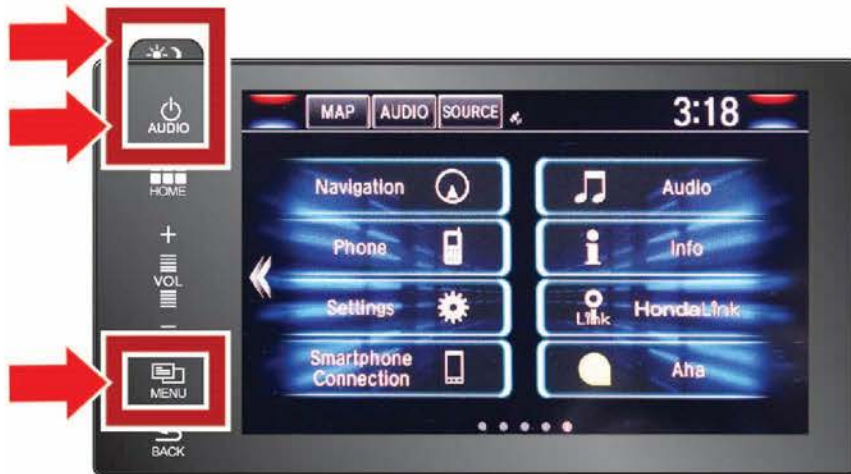
11. Press and hold the **Day/Night**, **Audio Power**, and **MENU** buttons at the same time.

NOTE: The system may ask to acquire GPS signal. If so, take the vehicle to a place to acquire signal.

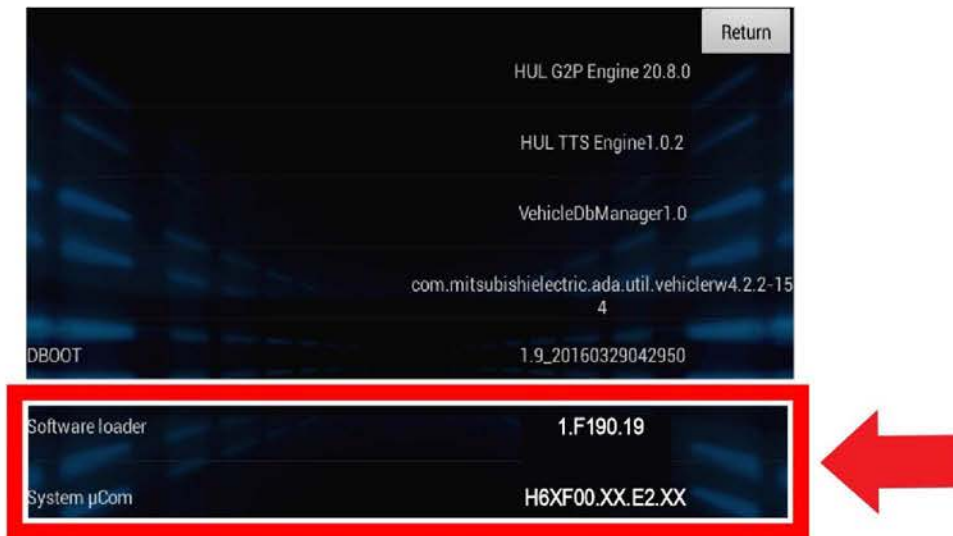
14. Scroll all the way to the bottom to: **Software loader** and **System μCom** and check the versions. The software should be updated to the following versions:

- **Software loader** : 1.F194.30
- **System μCom** : H61F0070.E2.12 (with XM radio function)
H62F0070.E2.12 (without XM radio function)

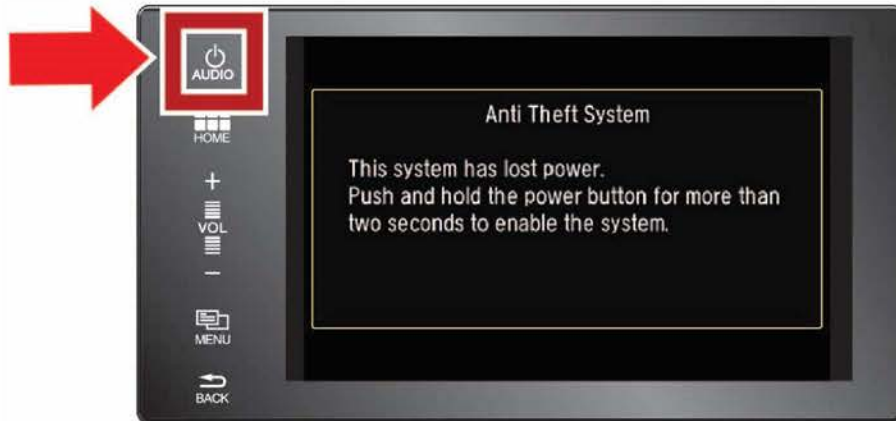
21. When the **Anti Theft System** screen appears, push and hold the **Audio Power** button for more than 2 seconds to enable the system.

- If nothing is done for 30 seconds, the screen goes black. Push the **Day/Night** or **BACK** button to return to the screen.
- If the vehicle is not running or the ignition is not in IG 2 the audio unit will not pass the security screen.
