March 24, 2017

06015 Version 2

2012 RL, 2014–17 RLX: Judder from the Torque Converter Lock-Up Clutch

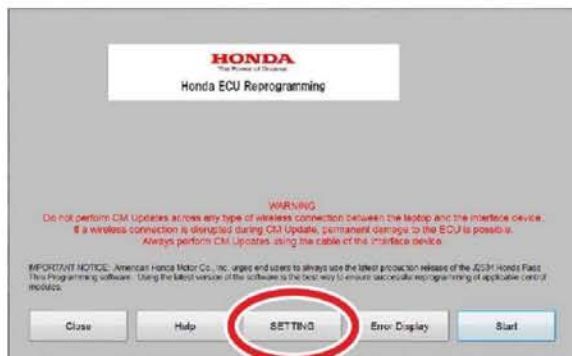
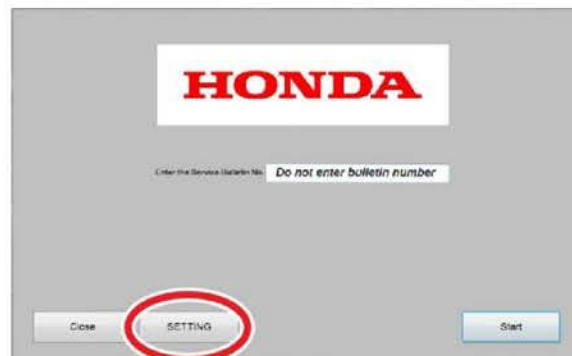
To change this, click on either of the **SETTING** selection buttons at the bottom of the J2534 initial screens as shown.

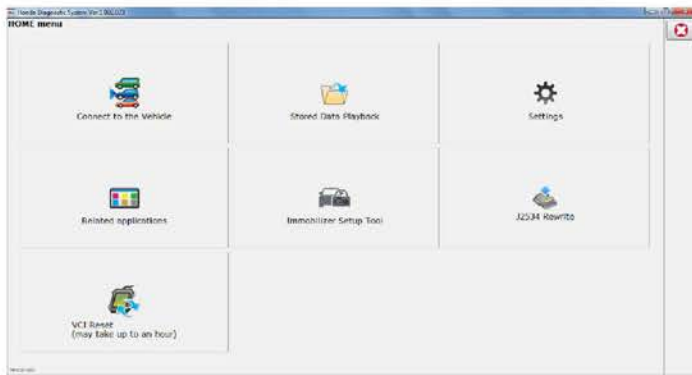
2. Select **J2534 Rewrite**.

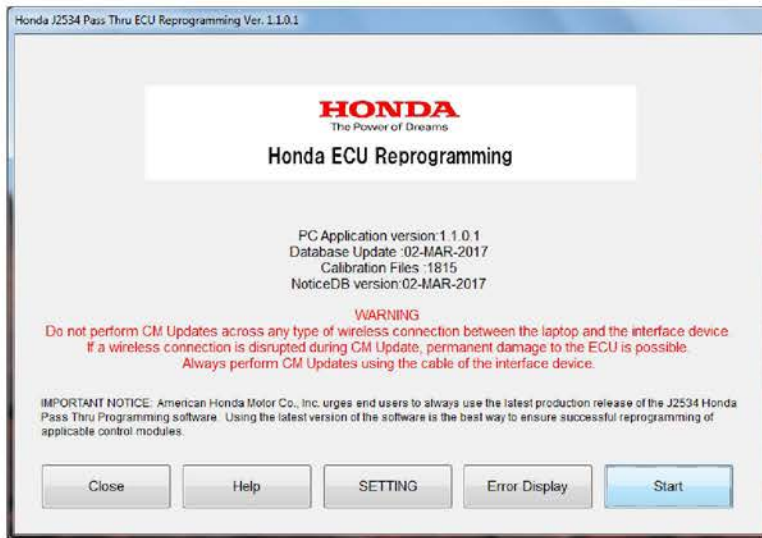
3. Confirm the software is the same **or later** as listed in SOFTWARE INFORMATION.

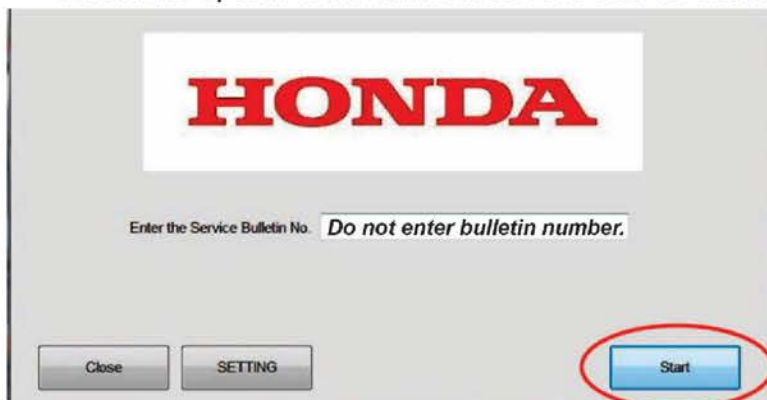
- **Don't enter a bulletin number.**
- If you see a message that the software has been already updated or that no update is available, check the **A/T data list**. The header should indicate one of the following numbers (or later).

- If the program part numbers do not match those listed above, the i-HDS software needs to be reinstalled. Contact the Special Tools Hotline at **800-346-6327** for assistance.
