06145 Version 1

MIL Comes On with DTC P0430

The MIL comes on with DTC P0430 (front bank catalyst system efficiency below threshold [Bank 2]).

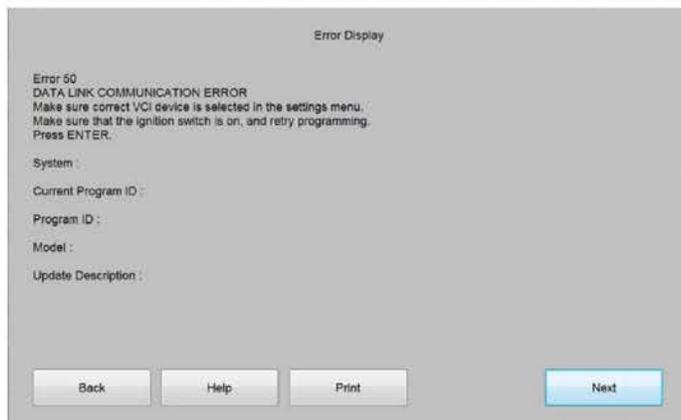
- You can't update the vehicle using the MVCI as a standalone tool.
- **Do not** use the MongoosePro VCI tool.
- Make sure the 12-volt battery is fully charged before starting an update.
- Connect a fully charged jumper battery to the vehicle, and leave it connected during the entire procedure to maintain steady voltage.
- Never turn the ignition to OFF or ACCESSORY during the update. If there is a problem with the update, leave the ignition turned to ON.
- To prevent powertrain control module damage, do not operate anything electrical (headlights, audio system, brakes, A/C, power windows, door locks, etc.) during the update.
- If you see the following **Error Display**, check that you are using the correct tool (MVCI or DST-i) with the i-HDS.

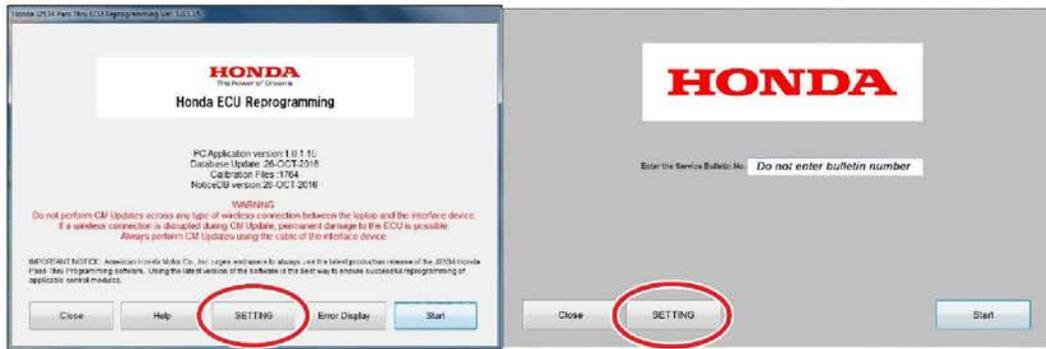
To change this, click on either of the **SETTING** selection buttons at the bottom of the J2534 initial screens as shown.

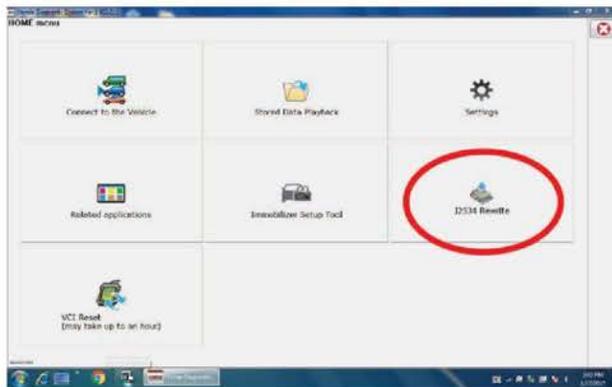
3. Select **J2534 Rewrite**.

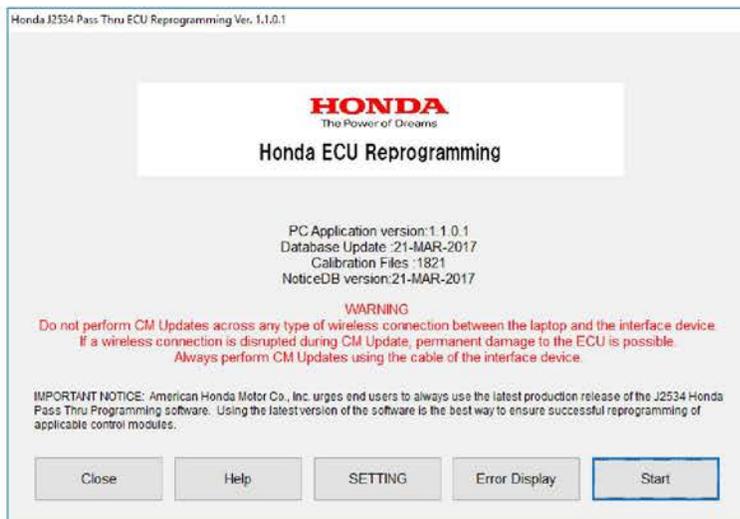
4. Confirm the software is the same **or later** as listed in SOFTWARE INFORMATION.

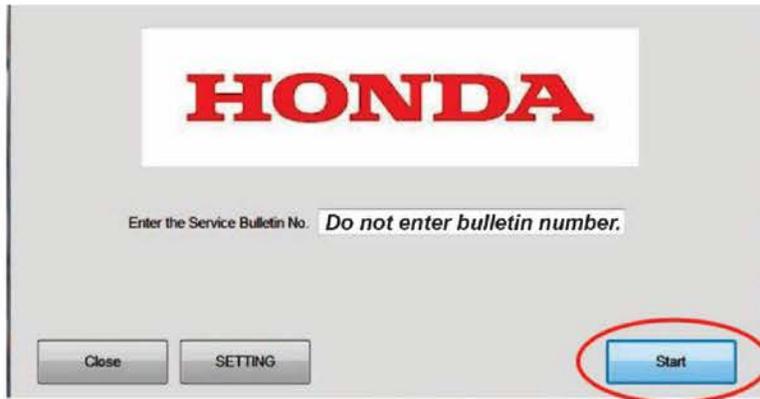
5. Select **Start**, then follow the screen prompts.

- **Do not** enter a bulletin number.
- If you receive a message that the vehicle has been already updated or that no update is available, check the PGM-FI data list. The header should indicate one of the following numbers (or later).
