GROUP ENG	MODEL 2018MY Sportage (QL)
	NUMBER 180 (Rev 1, 1/25/2018)	DATE December 2017
TECHNICAL SERVICE BULLETIN		
SUBJECT: SERVICE ACTION: 2.4L ENGINE START LOGIC IMPROVEMENT (SA320)

SERVICE ACTION: 2.4L ENGINE START LOGIC IMPROVEMENT (SA320)

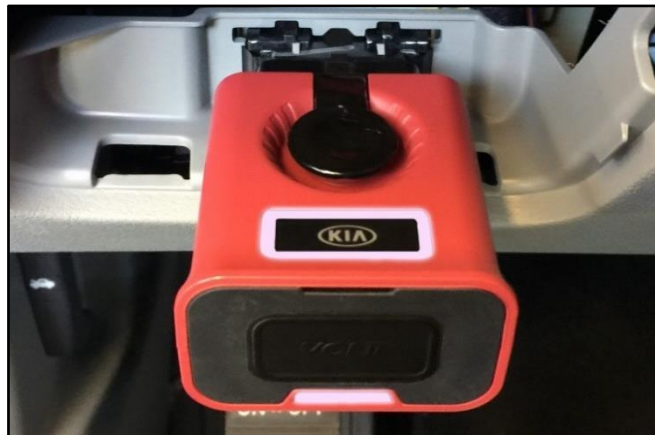
1. Connect the VCI-II to the OBD-II connector, located under the driver's side of the instrument panel.

The ECU upgrade function on KDS operates wirelessly. It is not necessary to perform the upgrade via USB cable.

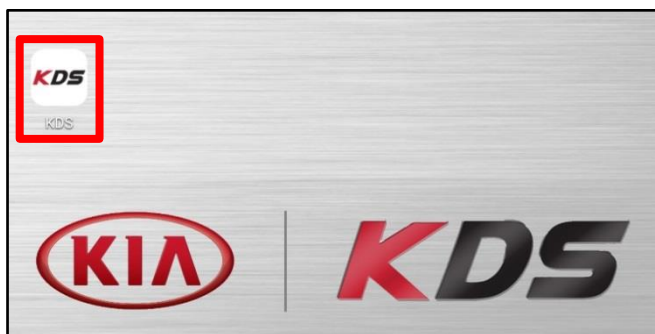
2. With the ignition ON, turn ON the KDS tablet. Select **KDS** from the home screen.

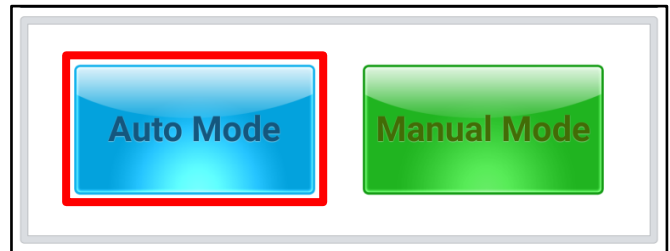
6. Select **Auto Mode**.

CAUTION
 Do NOT attempt to perform a Manual Mode upgrade UNLESS Auto Mode fails. Always follow the instructions given on the KDS in either Auto or Manual mode.

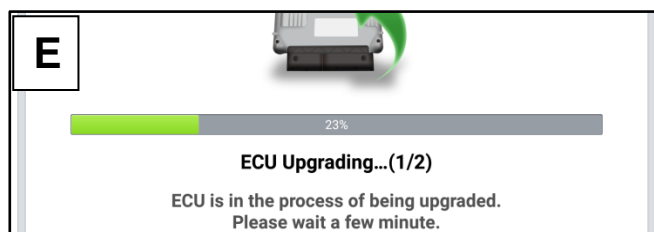
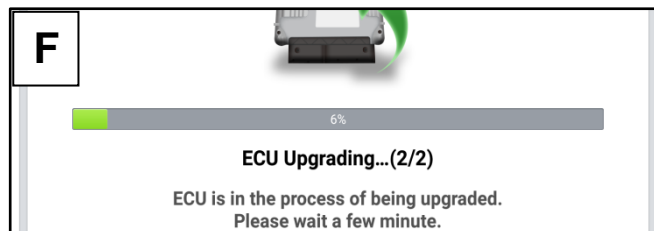
8. The ECU upgrade will begin and the progress of the upgrade will appear on the bar graph. Upgrade part (1/2) (E) will download the upgrade event to the VCI-II. Upgrade part (2/2) (F) will upgrade the ECU.

9. If a "Communication Fail" screen appears, verify that the VCI-II and KDS are communicating properly. Touch **OK** and restart the procedure from step 4.

10. When instructed on the KDS, turn the ignition **OFF** for ten (10) seconds then back on. Touch **OK** to continue.

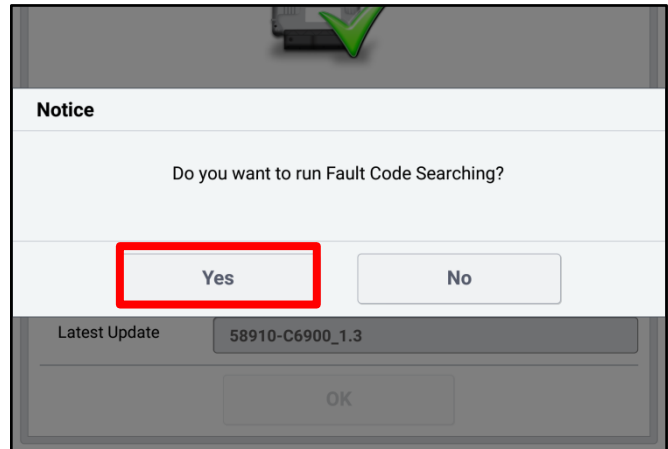
- 12. When prompted, select **YES** to check for Diagnostic Trouble Codes (DTC) and erase any DTCs stored such as EPS, ESC, and TPMS that may have been set during the upgrade.
