HYUNDAI Technical Service Bulletin	GROUP CAMPAIGN	NUMBER 18-01-002
	DATE January, 2018	MODEL(S) SONATA HYBRID (LF HEV) SONATA PLUG-IN HYBRID (LF PHEV)
SUBJECT: 2017 SONATA HYBRID/PLUG-IN HYBRID NAVIGATION SOFTWARE UPDATE (SERVICE CAMPAIGN T2S)

Description: This bulletin describes the procedure for updating the Navigation System Software for 2017 Model Year Sonata Hybrid and Plug-In Hybrid vehicles. This update allows for the driving information to be updated in the Electric Motor Use chart.

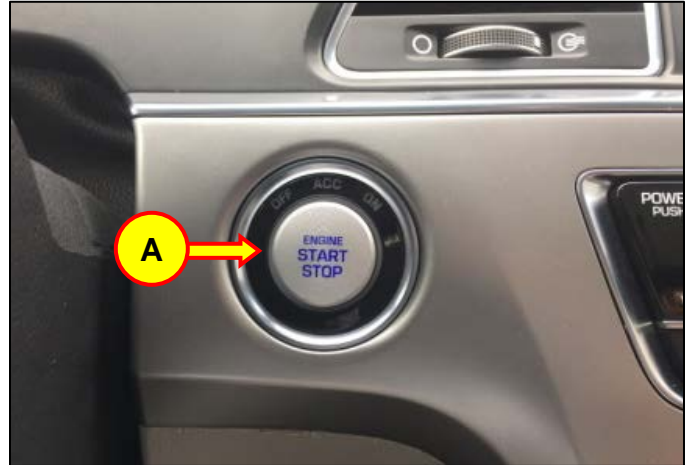
Press the **START STOP BUTTON (A)** to turn ACC "ON".

Depress the brake pedal and press the **START STOP BUTTON (A)** to start the vehicle.

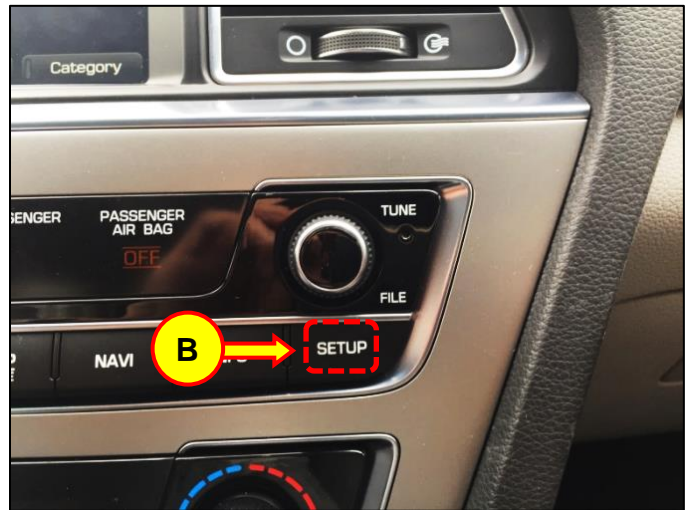
2. Press the 'SETUP' button (B) to enter the Setup menu.

If update does not resume, return to the “System Info” menu using steps 2-3 and touch the Update icon to initiate the update again.

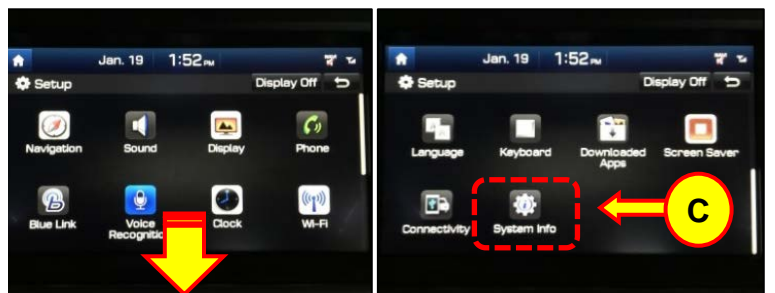
3. Scroll down and press the 'System Info' icon (C).

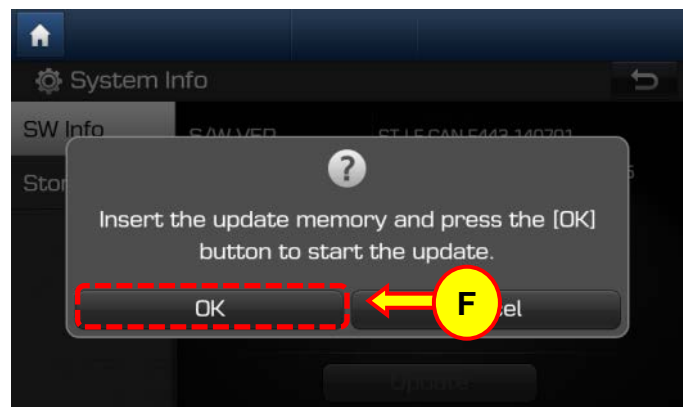
The software will automatically update through 6 steps:

0. Checking the update files
1. Copying Files (1/6)
2. a. Preparing System Update (2/6) *(System automatically reboots twice during this step. Blank screen will momentarily appear.)*
b. Updating the System
3. Updating Modem (3/6)
4. Updating GPS (4/6)
5. Updating Sub Micom (5/6)
6. Updating Main Micom (6/6)

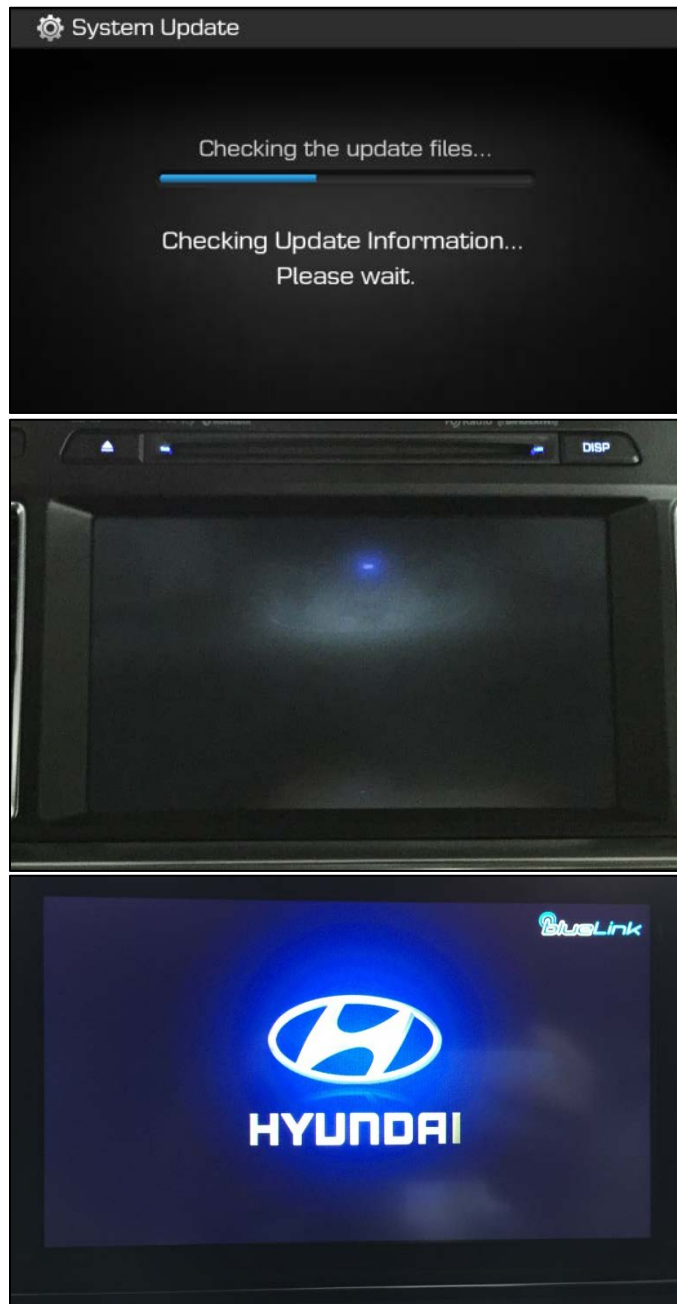
There will be multiple occurrences where the Hyundai logo will appear or display will be black during the update process. This is normal.

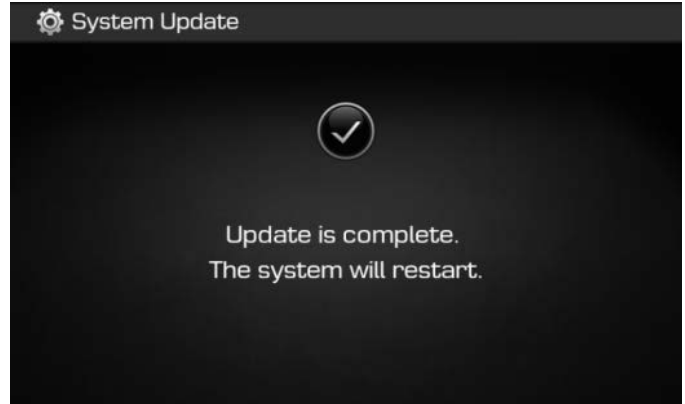
8. The system will reboot automatically after the “Update is complete” message appears.

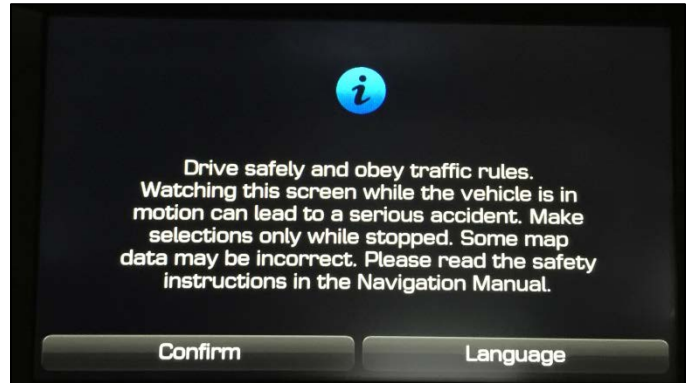
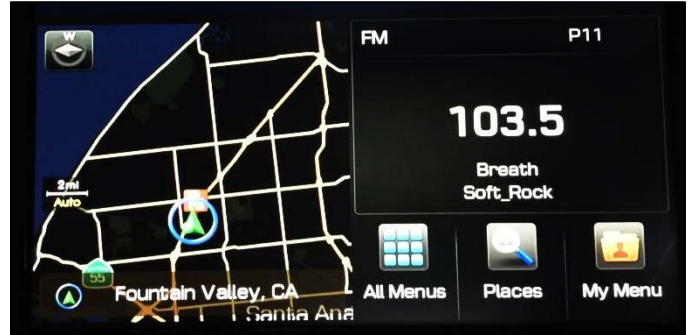
The software update is completed after the system reboots and the Disclaimer or the Home screen is displayed.

9. Confirm the new firmware version using steps 2-3 and the table listed below.

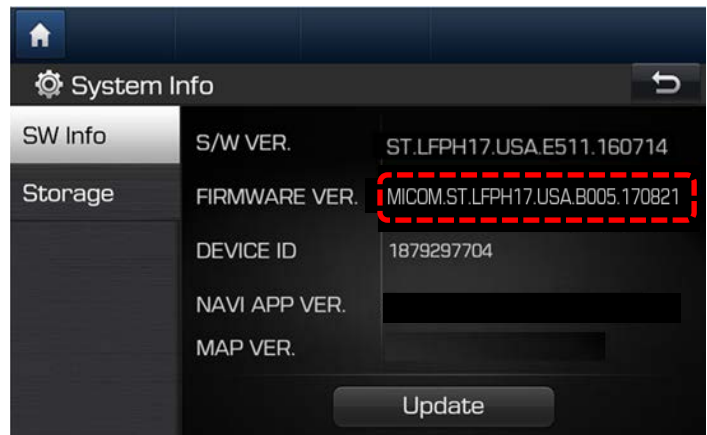
10. Remove the S/W Update SD Card from the slot and insert your original Map DB SD Card. The system will reboot automatically.

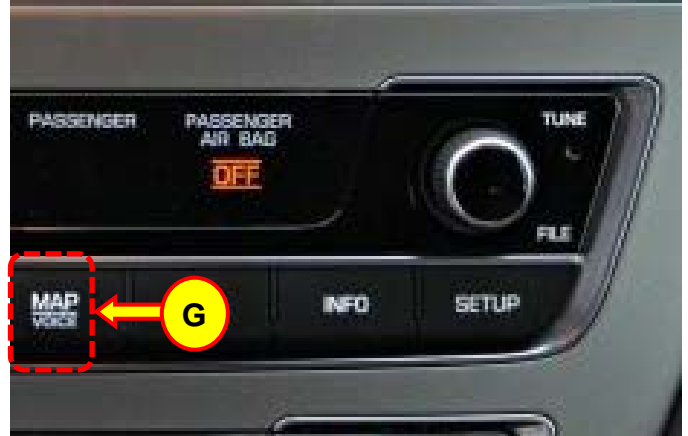
11. Once the system has rebooted, confirm that the Navigation map populates. Press the MAP button (G).
