GROUP ELE	MODEL 2018MY Stinger (CK)
	NUMBER 142	DATE January 2018
<b>TECHNICAL SERVICE BULLETIN</b>		
<b>SUBJECT: SERVICE ACTION: HEADLAMP “WELCOME BLINK” OPERATION – ICU LOGIC IMPROVEMENT (SA331)</b>

This bulletin provides the procedure to improve the logic of the Integrated Central Control Unit (ICU) on some 2018MY Stinger (CK) vehicles, produced from September 21, 2017 through December 15, 2017, which in very rare circumstances may experience inoperative “welcome blink” of the headlamps. To correct this concern, apply the improved logic to the ICU using the KDS ECU Upgrade function as described in this bulletin. For confirmation that the latest reflash has been applied to a vehicle you are working on, verify the ROM ID using the table on page 2 of this bulletin. Before conducting the procedure, verify that the vehicle is included in the list of affected VINs.

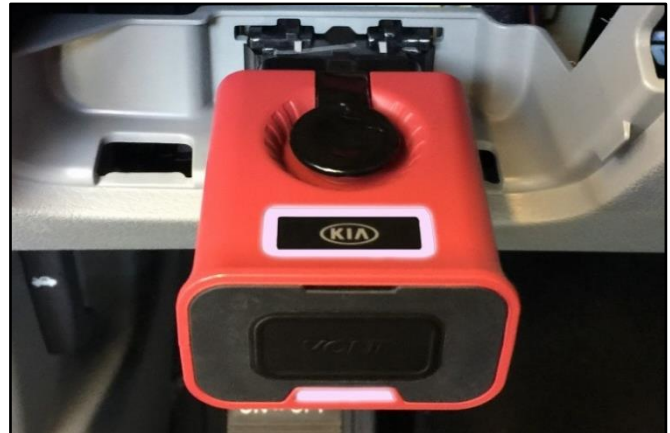
1. Connect the VCI-II to the OBD-II connector, located under the driver's side of the instrument panel.

**The ECU upgrade function on KDS operates wirelessly. It is not necessary to perform the upgrade via USB cable.**

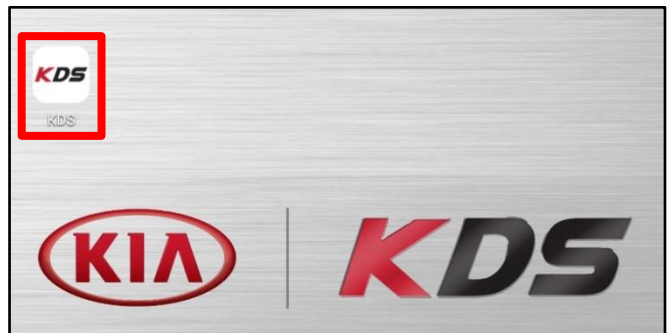
2. With the ignition ON, turn ON the KDS tablet. Select **KDS** from the home screen.

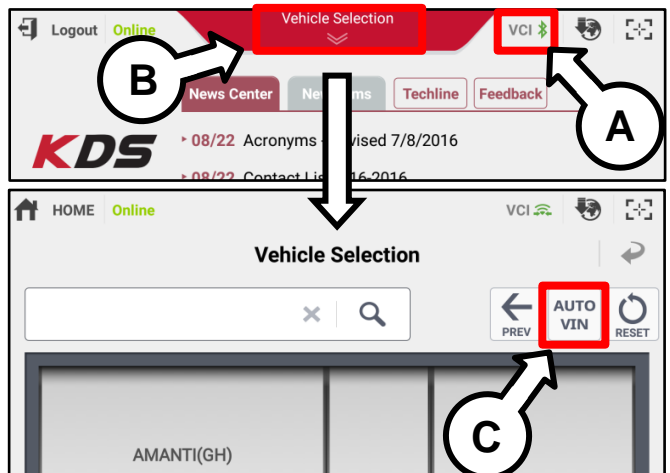
3. Confirm communication with VCI (A) and then configure the vehicle (B) using the **AUTO VIN** (C) feature.

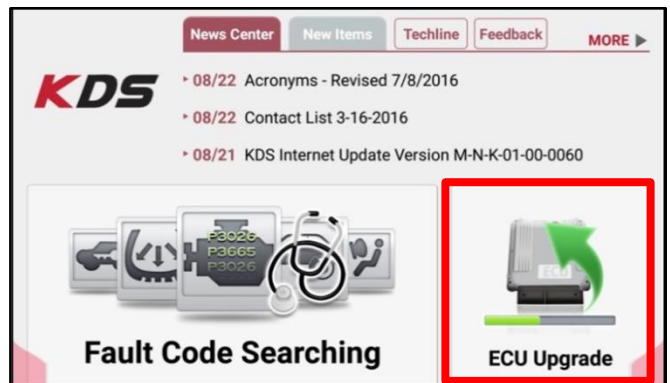
4. Select **ECU Upgrade**.

- The KDS will check the server for recently uploaded Events and then automatically download **Upgrade Event #364**.

After the download is complete, the program will shut down to install.  
Please wait until the program restarts.

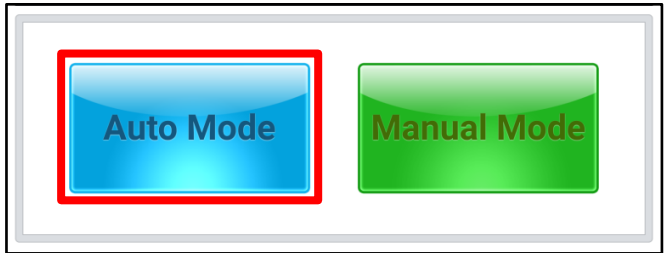
- Select **Auto Mode**.

Do NOT attempt to perform a Manual Mode upgrade UNLESS Auto Mode fails. Always follow the instructions given on the KDS in either Auto or Manual mode.

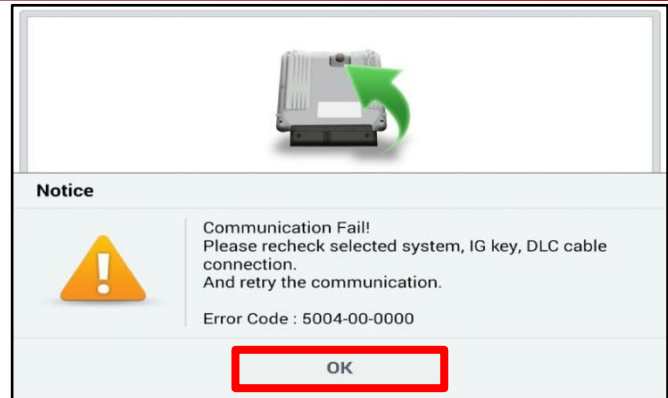
9. If a "Communication Fail" screen appears, verify that the VCI-II and KDS are communicating properly. Touch **OK** and restart the procedure from step 4.

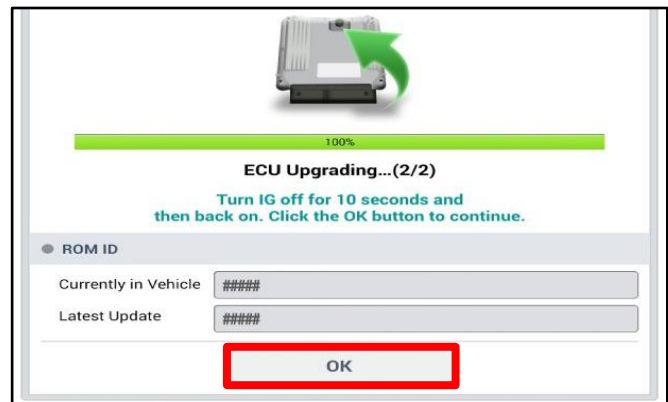
10. When instructed on the KDS, turn the ignition **OFF** for ten (10) seconds then back on. Touch **OK** to continue.

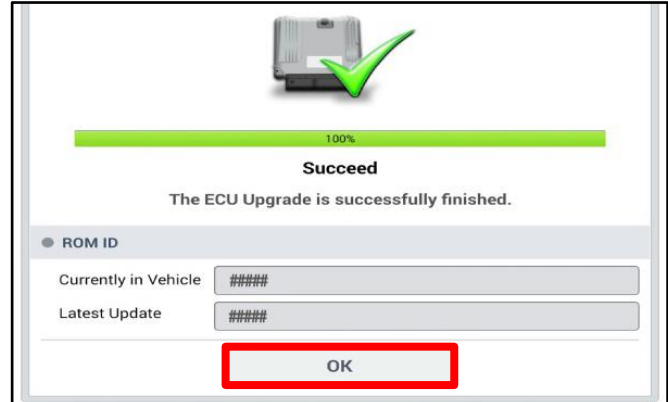
11. Once the upgrade is complete, touch **OK** to finalize the procedure.

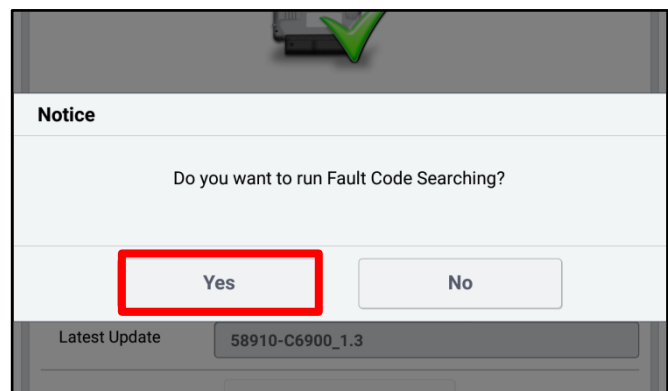
12. When prompted, select **YES** to check for Diagnostic Trouble Codes (DTC) and ensure to erase any DTCs in any control modules after fault code searching.
