GROUP Service Campaign	MODEL 2018MY Sportage SX (QL)
	NUMBER SC161	DATE January 2018
VOLUNTARY SERVICE CAMPAIGN		
SUBJECT: ECM SOFTWARE UPGRADE INSTRUMENT CLUSTER LOGIC (SC161)

This bulletin provides information related to updating the Electronic Control Module (ECM) software to improve the Instrument Cluster Logic on some 2018MY Sportage (QL) SX vehicles manufactured from July 10, 2017 through January 9, 2018. Due to a change in the supplier's data communication parameters, the instrument cluster, even with the ignition off, will continue to communicate with the vehicle's network, which may then cause a continuous power draw from the vehicle's battery. To correct this condition, Kia is requesting the completion of this voluntary service campaign on all affected vehicles. Before conducting the procedure, verify the vehicle is included in the list of affected VINs.

ECU Upgrade Procedure:

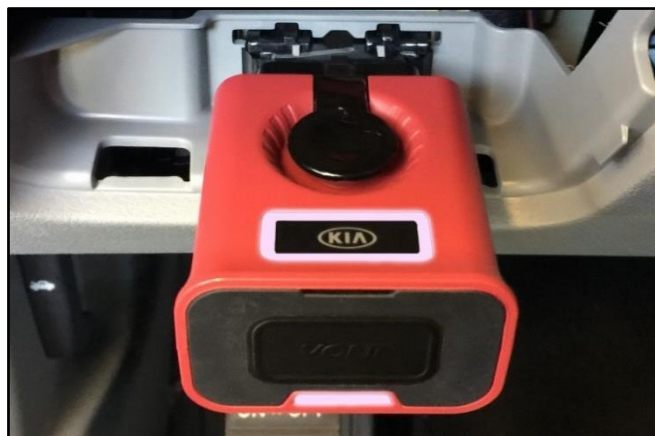
1. Connect the VCI-II to the OBD-II connector, located under the driver's side of the instrument panel.

The ECU upgrade function on KDS operates wirelessly. It is not necessary to perform the upgrade via USB cable.

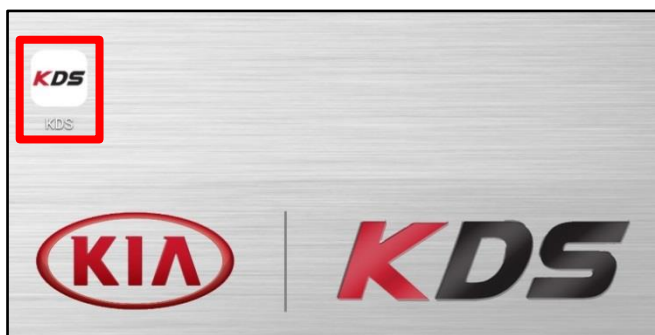
2. With the ignition ON, turn ON the KDS tablet. Select **KDS** from the home screen.

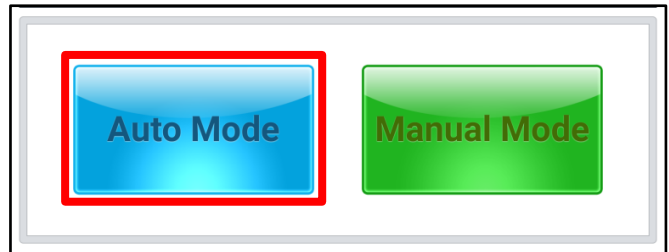
- Select **Auto Mode**.

CAUTION
 Do NOT attempt to perform a Manual Mode upgrade UNLESS Auto Mode fails. Always follow the instructions given on the KDS in either Auto or Manual mode.

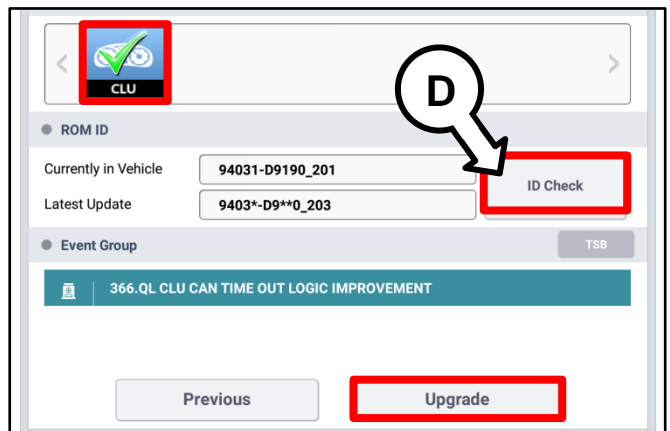
- Select the **CLU** system under the System selection menu.

Touch **ID Check** (D) and confirm that the latest update is available.

Select **Upgrade Event #366** and select **Upgrade** to continue.

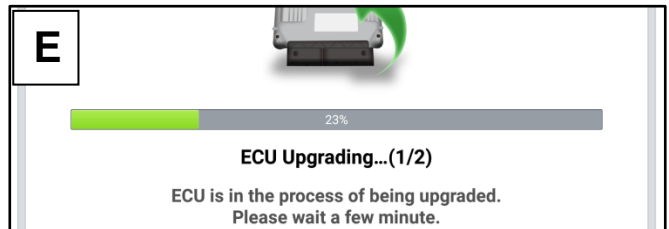
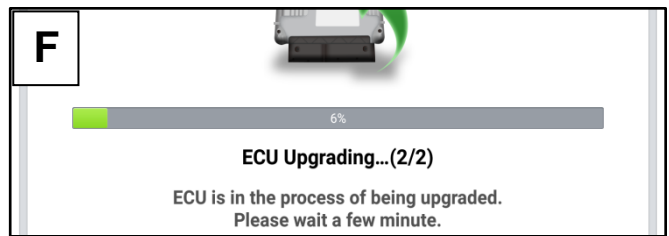
- The ECU upgrade will begin and the progress of the upgrade will appear on the bar graph. Upgrade part (1/2) (E) will download the upgrade event to the VCI-II. Upgrade part (2/2) (F) will upgrade the ECU.

CAUTION
 Do not touch the system buttons (like 'Back', 'Home', 'etc.') while performing ECU Upgrade.

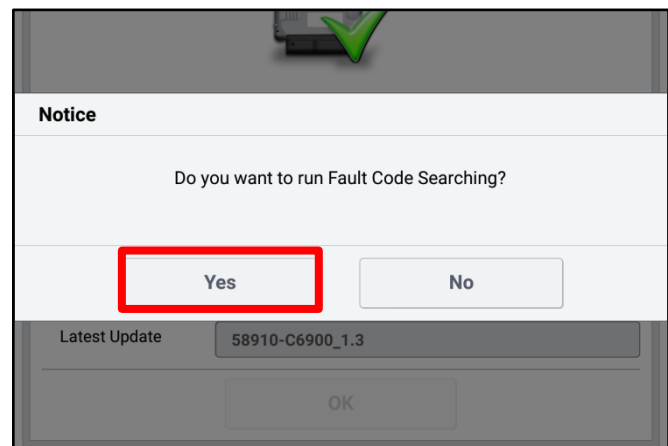
12. When prompted, select **YES** to check for Diagnostic Trouble Codes (DTC) and erase any DTCs stored such as EPS, ESC, and TPMS that may have been set during the upgrade.
