SERVICE BULLETIN

2016-2017 TITAN XD; DTC P207F AND DEF SYSTEM ERROR IS DISPLAYED ON THE VEHICLE INFORMATION DISPLAY

APPLIED VEHICLES: 2016-2017 Titan XD (A61)
APPLIED ENGINE: Cummins 5.0L V8 Diesel

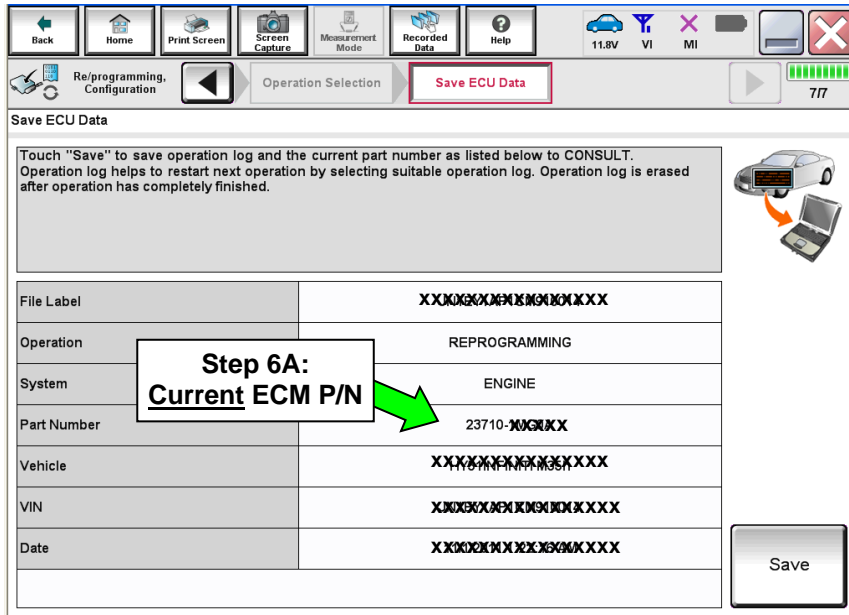
6. When you get to the screen shown in Figure 2, confirm this bulletin applies as follows.
- A. Find the ECM **Part Number** and write it on the repair order.

NOTE: This is the current ECM Part Number (P/N).

5. Follow the on-screen instructions and navigate C-III plus to the screen shown in Figure 2 on the next page.

- B. Compare the P/N you wrote down to the numbers in the **Current ECM Part Number** column in **Table A** below.

- If there is a match, continue with the reprogramming procedure.
- If there is no match, this bulletin does not apply. Close C-III plus and refer to ASIST for further diagnostic information.
