**Title (customer effect)** Volvo Chassis - Diagnostic Trouble Code ( DTC ) P2459 Lighting The Malfunction Indicator Lamp ( MIL ); Possible Frequent Regeneration Requests - OBD15 And Newer Chassis

**Cause** OBD15 and newer chassis may log DTC P2459 - Diesel Particulate Filter Regeneration Frequency (Bank 1). P2459 may log with or without frequent regeneration requests. Guided Diagnostic steps may complete with No Fault Found.

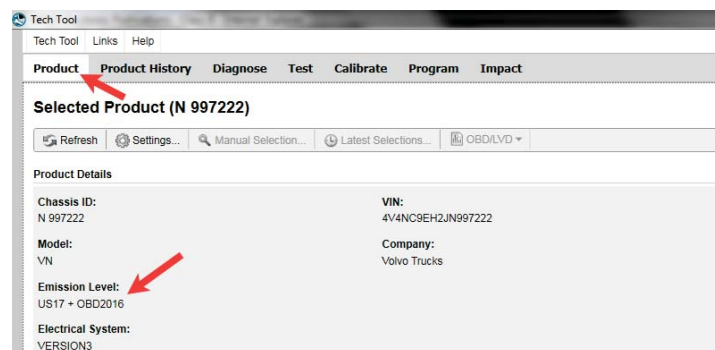
- Details can be found in the Product Details box on the Product tab in PTT as seen below:
