Service Campaign

CC-18-00-01

MODEL: Karma Revero

TITLE: Baseline BL1035 Firmware Release

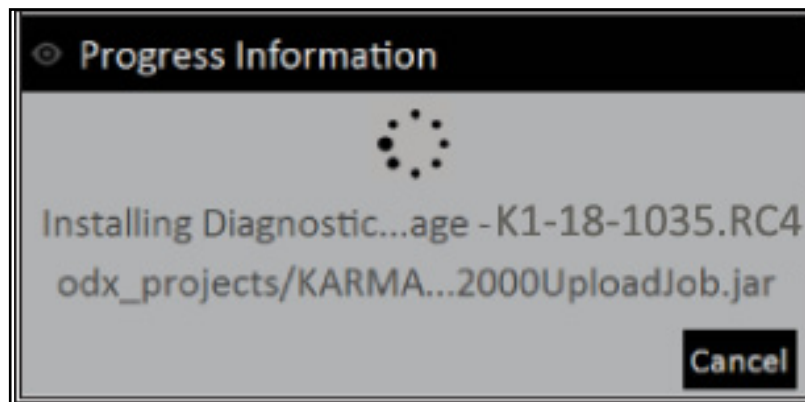
fig.7b

A progress screen will pop up after (fig.7b)

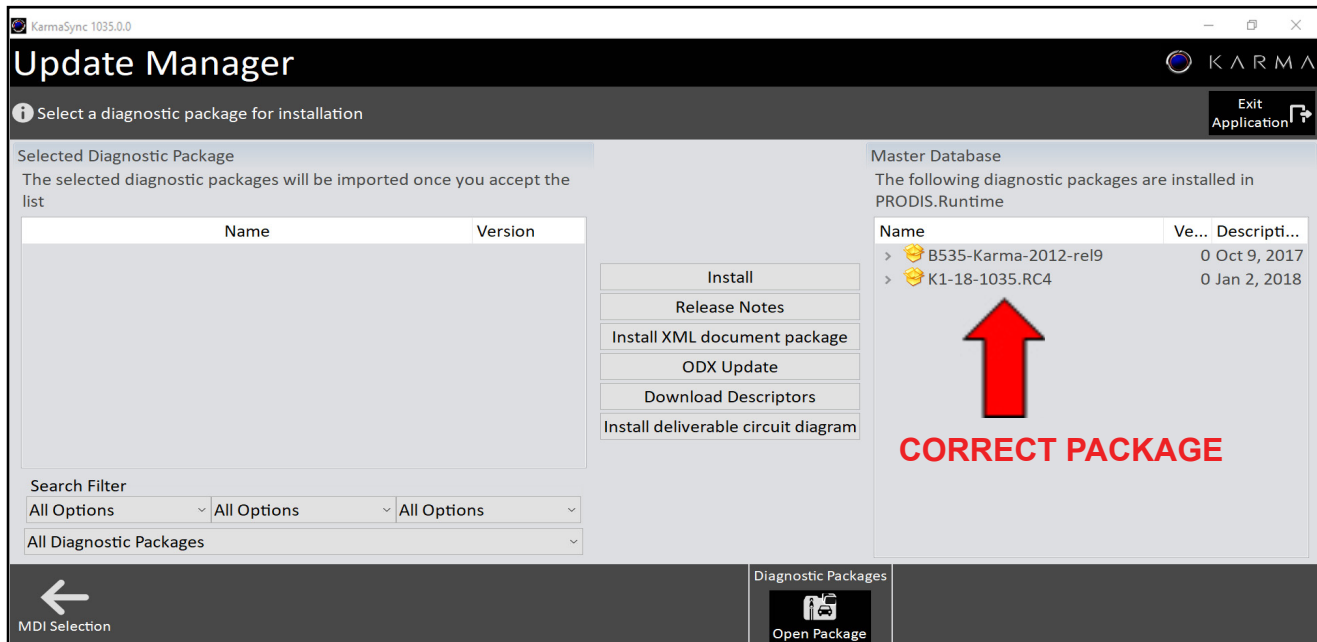
fig.9

10. Verify the package is installed successfully by verifying that “K1-18-1035.RC4” is displayed in the Update Manager (fig.9)

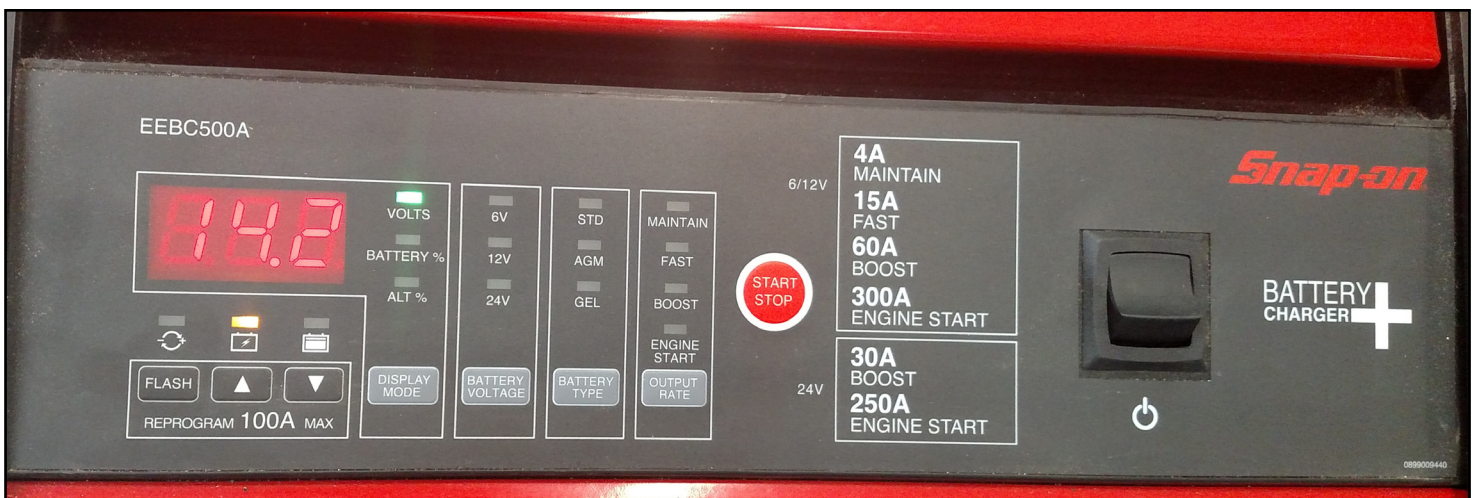
fig.10b

Below is an example of a suitable and recommended power supply (fig.10b)

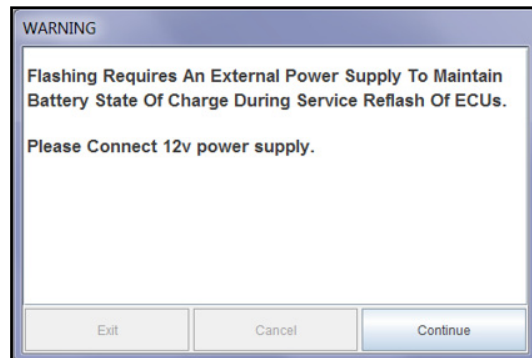
fig.12

20. Follow the prompts and make sure that a suitable 12V power supply is connected to the vehicle. Click continue (fig.12)

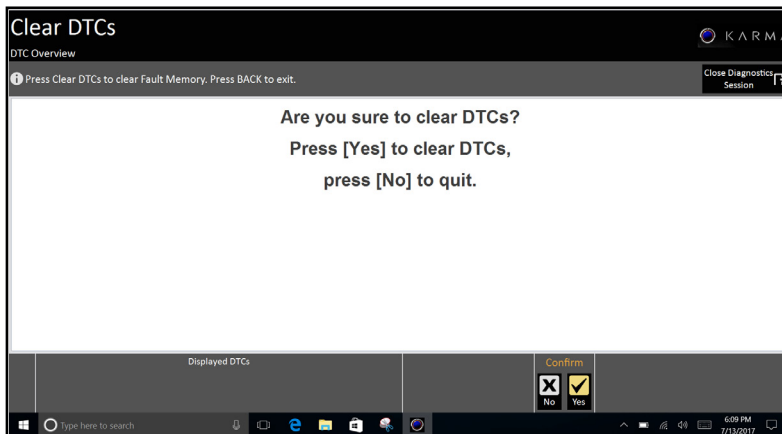
24. The update is complete with Karma Sync. Any codes need to be cleared in READY state. Ignore the pop-up of cycling state to ACCESSORY in Karma SYNC. Proceed to clear any DTC's present in the system. (fig.16a, 16b, 16c)
