# Service Action

**NUMBER: 3.90.16.0043.05**

**MODEL: MY12 and MY13 Fisker KARMA**

**TITLE: Baseline 535 Release Overview**

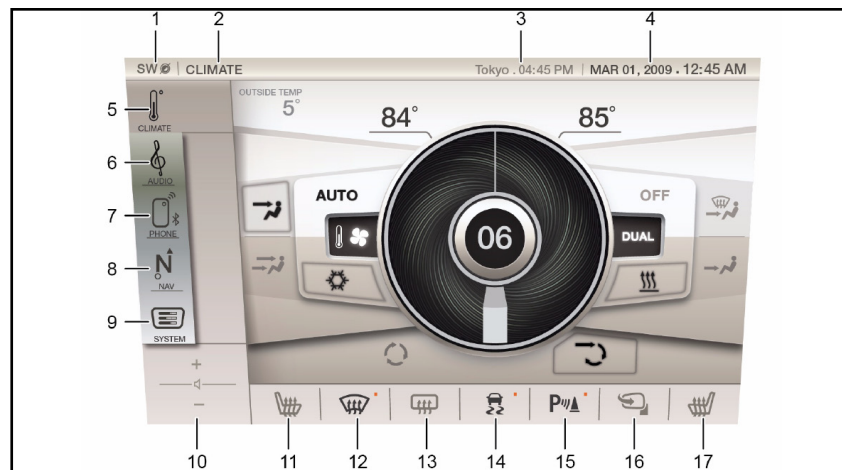
**System button Item #9.**

The Central Infotainment Unit Software, VIP, NAV, and HOST versions must be checked using the System Information screen on the TPI. This can be accessed by pressing and holding the “SYSTEM” button for 8 seconds.

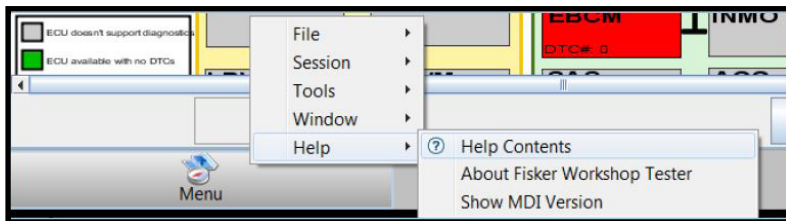
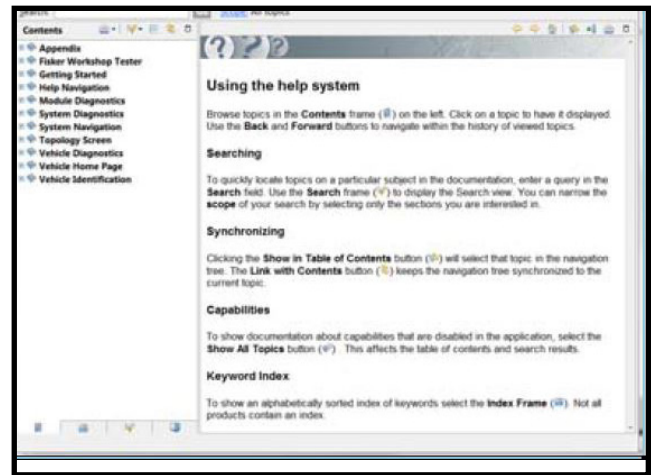
**Note:** For additional help on procedures, reference the Help File in the scantool software.  
 > Menu > Help > Help Contents

\* Indicates ECU has a Post Flash requirement.

\*\* Indicates ECU has both a Pre and Post Flash requirement.
